## ON-SITE ROLLOVER INVESTIGATION

CASE NUMBER - IN-06-021

VEHICLE - 2006 NISSAN MURANO

CRASH DATE - May 2006

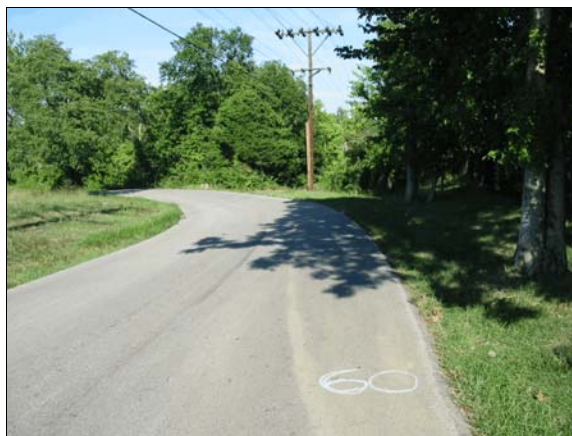
**Pre-Crash:** The case vehicle was traveling east in the eastbound lane and was approaching a left curve (**Figure 1**). The driver was intending to continue through the curve. The case vehicle's driver stated that a deer entered the roadway from the right. The driver steered left and braked in an attempt to avoid the deer. The driver then steered right and ran off the right side of the roadway where the crash occurred.

**Figure 1:** Case vehicle approach to roadway departure, number on roadway shows meters to area of rollover initiation

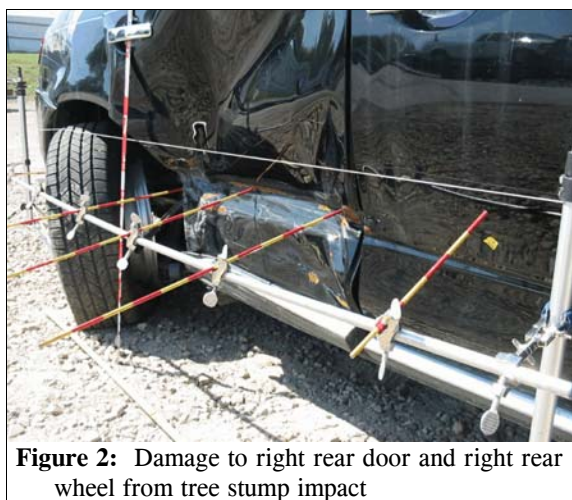
**Figure 2:** Damage to right rear door and right rear wheel from tree stump impact

**Exterior Damage:** The case vehicle’s impact with the stump (event 1)involved the right side. The right rear door was crushed inward and the right rear wheel was displaced rearward and angled outward. Direct damage began 138 centimeters (54.3 inches) rear of the right front axle and extended 180 centimeters (70.9 inches) along the right rear door and right rear wheel. Residual maximum crush was measured as 15 centimeters (5.9 inches) occurring at C<sub>4</sub>. The table below shows the case vehicle’s right side crush profile.

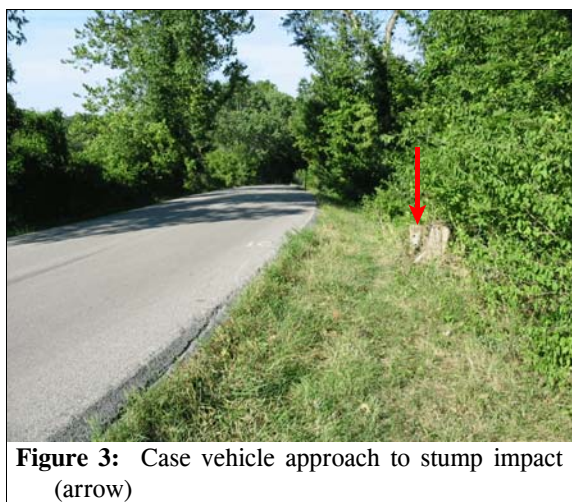
**Crash:** As the case vehicle ran off the right side of the roadway, it rotated slightly counterclockwise as the driver attempted to steer back onto the roadway. As the vehicle was in the slight counterclockwise yaw, the right rear door and right rear wheel (**Figure 2**) impacted a tree stump (event 1, **Figure 3**) on the roadside deploying the right side curtain air bag and the front right seat back-mounted side impact air bag. This impact caused the case vehicle to rotate clockwise and the back end of the vehicle reentered the roadway. As the case vehicle rotated clockwise due to the impact, it began to rollover driver side leading (event 2). The left rear wheel rim (**Figure 4** below) gouged the roadway (**Figure 5** below), the vehicle continued to roll left and it ran off a steep embankment on the right roadside and essentially fell into a group

**Figure 3:** Case vehicle approach to stump impact (arrow)

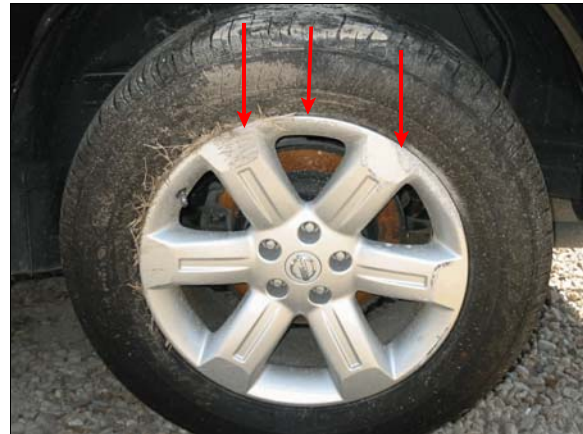
**Figure 4:** Arrows show rim abrasions to left rear wheel from gouging roadway surface, gras was also jammed in bead when case vehicle rotated clockwise off tree stump impact

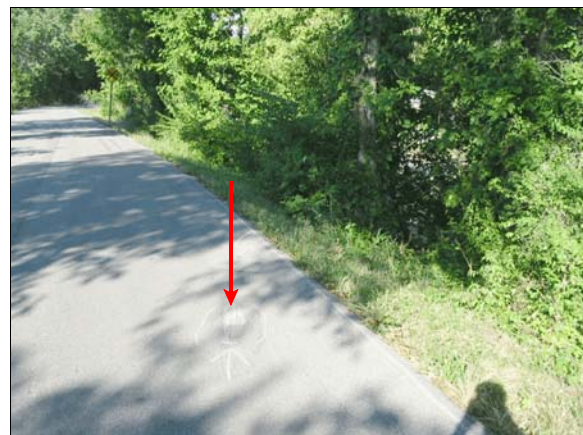
of trees (**Figure 5**) damaging the hood (event 3) and rear hatch (event 4). The case vehicle's left side curtain air bag deployed as a result of the rollover. The case vehicle rolled over a total of two quarter rolls.

**Figure 5:** Left rear wheel gouge in roadway (arrow) and embankment case vehicle rolled down

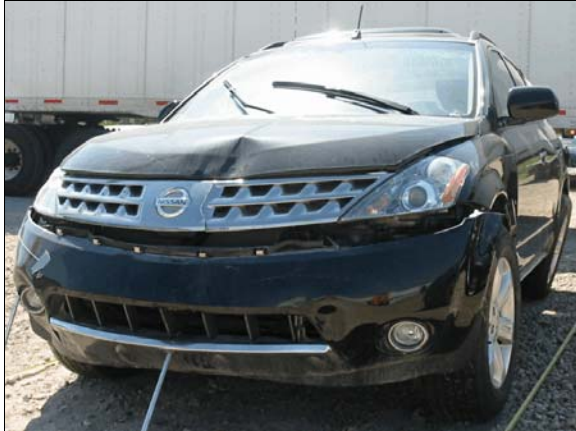
The damage occurring during the rollover (event 2) involved multiple areas of the case vehicle as follows: The vehicle’s hood was directly damaged and minimally crushed rearward from contact with a tree (event 3). The hatch was also directly damaged and minimally crushed forward as well as downward, also due to contact with a tree (event 4). The lower portion of the hatch was made of composite material and broke free from the vehicle. Finally, the left rear wheel was directly damaged from it’s contact with the roadway, and the left fender, left rear door and left quarter panel were directly damaged as well.

The case vehicle’s left side wheelbase was extended 2 centimeters (0.8 inches) while the right side wheelbase was extended 17 centimeters (6.7 inches). Induced damage involved the hood, right rear door and both quarter panels. The front bumper fascia was pulled partially off by the fork lift that moved the vehicle to the inspection site. No obvious induced damage or remote buckling was noted to the remainder of the case vehicle’s exterior. **Figures 6 and 7** below show overviews of damage to the case vehicle.

**Figure 6:** Overview of front and left side of case vehicle

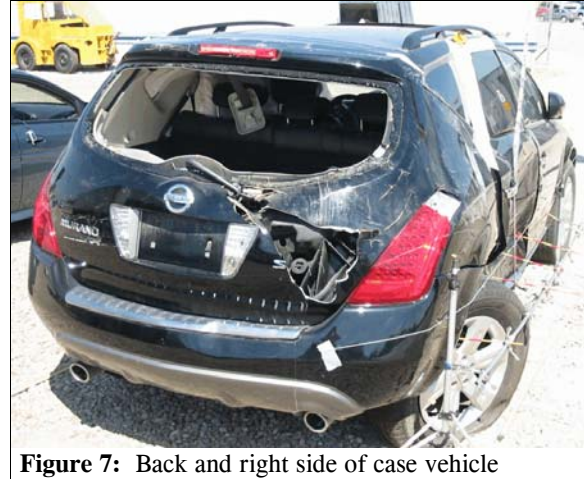
**Figure 7:** Back and right side of case vehicle

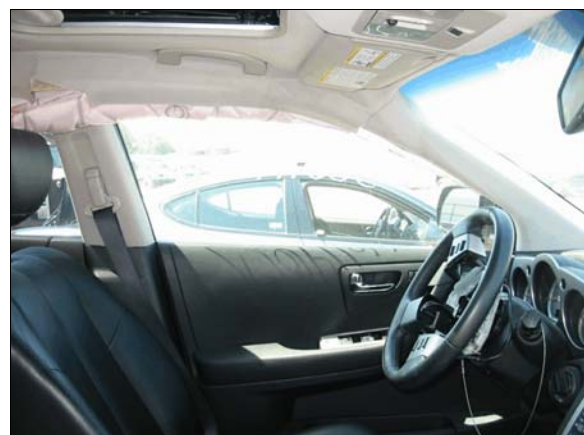
**Vehicle Interior:** Inspection of the case vehicle’s interior ( **Figure 8** and **Figure 9** below) revealed loading evidence to the driver’s safety belt webbing. No other occupant contacts were noted. In addition, there was no evidence of occupant compartment intrusions or deformation of the steering wheel and energy absorbing energy column.

**Figure 8:** Case vehicle’s steering wheel and left front door

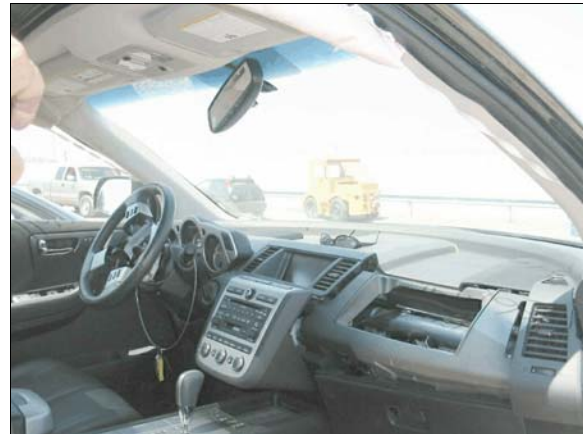
The case vehicle's driver air bag was located in the steering wheel hub and the front right passenger air bag was located in the middle of the instrument panel. Neither of these air bags deployed because the case vehicle did not sustain a longitudinal deceleration severe enough to require their deployment. Both air bag modules had been removed prior to this contractor's investigation (**Figure 8** above and **Figure 9**). The modules were most likely salvaged for resale.

**Figure 9:** Case vehicle's instrument panel, windshield and steering wheel, driver and front right air bag modules had been removed, probably for salvage

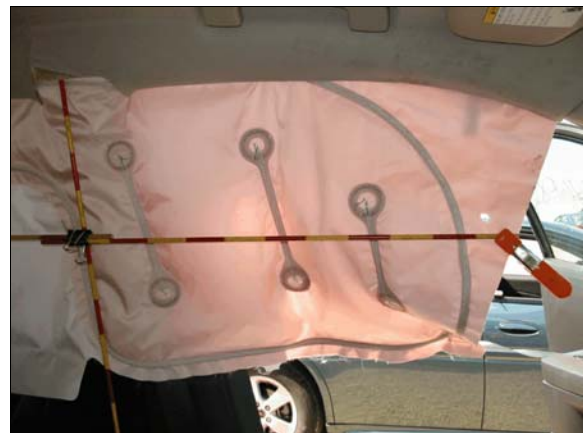
The case vehicle's left side curtain air bag (**Figures 10** and **11**) deployed as a result of the rollover. It was located along the roof side rail below the headliner. There was no evidence of damage to the air bag due to deployment. The side curtain air bag was approximately 142 centimeters (55.9 inches) in length and 40 centimeters (15.7 inches) in height. The curtain was constructed of two primary inflatable sections. The front section measured approximately 48 centimeters (18.9 inches) in length and 40 centimeters (15.7 inches) in height and was adjacent

**Figure 10:** Forward section of left side curtain air bag, each increment on rods is 5 cm (2in)

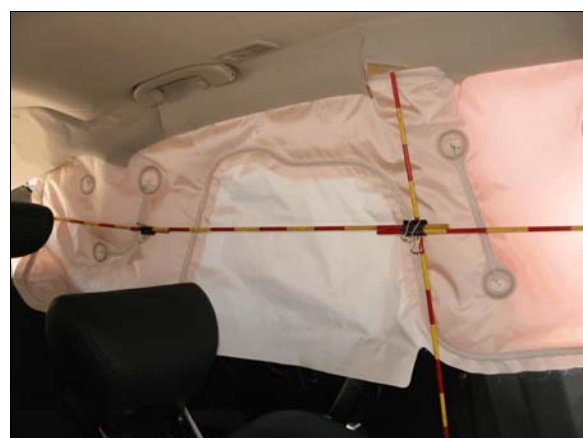
**Figure 11:** Rear section of left side curtain air bag

to the driver’s seat. The rear section measured approximately 42 centimeters (15.5 inches) in length and 40 centimeters (15.7 inches) in height and was adjacent to the back left seat position. The front inflatable section included three approximately 15 centimeter (5.9 inches) long double stitched “tethers,” bonding the inboard and outboard walls of the curtain to control curtain inflation width. The rear inflatable section included an L-shaped, double stitched “tether.” It is likely that the driver contacted the side curtain air bag, but no obvious occupant contact marks were observed on the air bag.

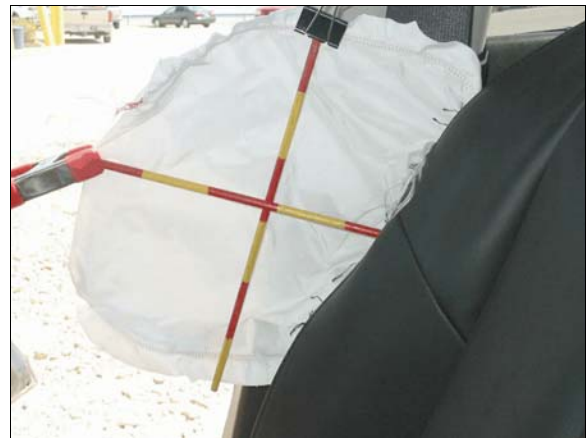
The case vehicle’s front right passenger seat back-mounted side impact air bag (**Figure 12**) deployed as a result of the case vehicle’s right side impact with the stump. The air bag was located in the outboard side of the front right passenger’s seat back. This air bag was approximately oval-shaped and measured approximately 23 centimeters (9 inches) in width and 27 centimeters (10.6 inches) in height. It was constructed without tethers and vent ports. There were no occupant contacts or damage to this air bag.

**Figure 12:** Front right seat back-mounted side impact air bag

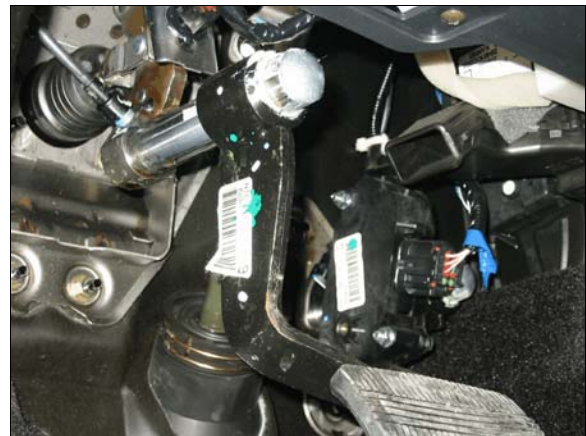
Immediately prior to the crash the case vehicle's driver [50-year-old, White (Hispanic) female; [163 centimeters and 52 kilograms (64 inches, 145 pounds)] was seated in an upright position with her back against the seat back and both hands on the steering wheel. The driver stated she was braking, so her right foot was most likely on the brake and her left foot was most likely on the floor. Her seat track was located between its middle and rear-most positions, the seat back was slightly reclined, the tilt steering column was located in its center position and the adjustable foot controls (**Figure 13**) were located in the full-rear position.

**Figure 13:** Case vehicle’s adjustable brake pedal
