**CALSPAN ON-SITE SIDE IMPACT INFLATABLE OCCUPANT PROTECTION
SYSTEM INVESTIGATION**

SCI CASE NO. – CA06-029

SUBJECT VEHICLE – 2005 FORD ESCAPE

CRASH DATE – SEPTEMBER 2006

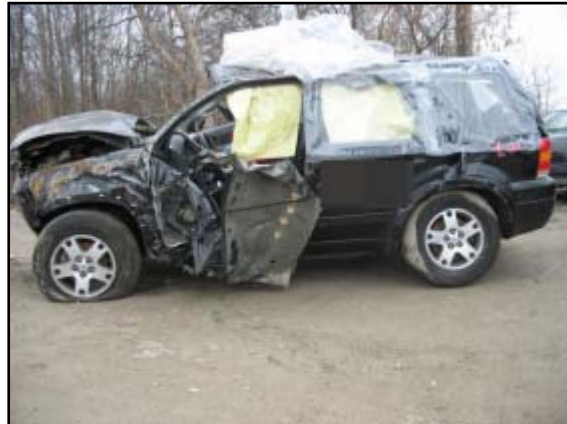
Figure 1. Subject vehicle 2005 Ford Escape Limited.

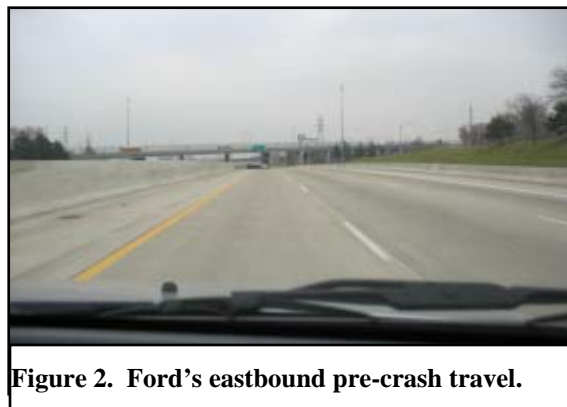
The restrained 31-year-old male driver of the Ford was operating the vehicle eastbound in the outboard lane **(Figure 2)** on the three-lane divided interstate roadway. As the vehicle approached the slight left curve, the driver relinquished directional

Figure 2. Ford’s eastbound pre-crash travel.

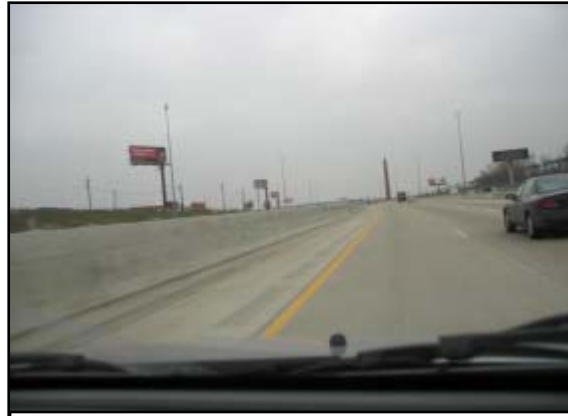
Figure 3. Approximate area of the median barrier impact, rollover, and final rest of the Ford.

As the Ford disengaged the barrier, the right rear tire folded under the alloy wheel exposing the rim bead to the concrete road surface. The right rear rim bead contacted the concrete surface which induced a tripped rollover event. The rim contact was confirmed by a 23 cm (9") section of the rim bead that was fractured during the ground contact. The Ford began a right side leading rollover event which triggered the deployment of the left and right side canopy air bags. The left seatback mounted side impact air bag deployed during probable ground contact; however, the timing of the deployment was unknown within the rollover sequence. The vehicle rolled ten-quarter turns and came to final rest on its roof facing a westerly direction. **Figure 3** is a view of the approximate area of the median barrier impact, rollover, and final rest.

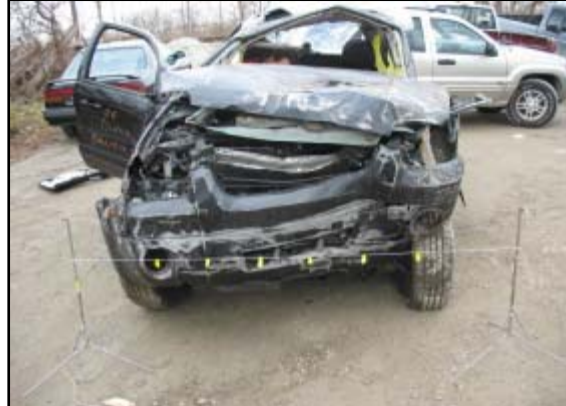
The 2005 Ford Escape sustained moderate severity frontal damage as a result of the impact with the median barrier (**Figure 4**). The direct contact damage extended from the front left bumper corner to the front right bumper corner and measured 140 cm (55.1"). The damage consisted of abrasions and deformation of the front bumper fascia, bumper beam, upper and lower radiator supports, and the hood. Maximum crush was located at the front left end of the bumper beam and measured 40 cm (15.7"). Six crush measurements were documented across the bumper beam using a combined direct and induced damage width of 115 cm (45.2") and were as follows: C1 = 40 cm (15.7"), C2 = 37 cm (14.6"), C3 = 29 cm (11.4"), C4 = 24 cm (9.4"), C5 = 17 cm (6.7"), C6 = 11 (4.3"). The Collision Deformation Classification (CDC) for this impact was 01-FDEW-2.

Figure 4. Resultant frontal damage.

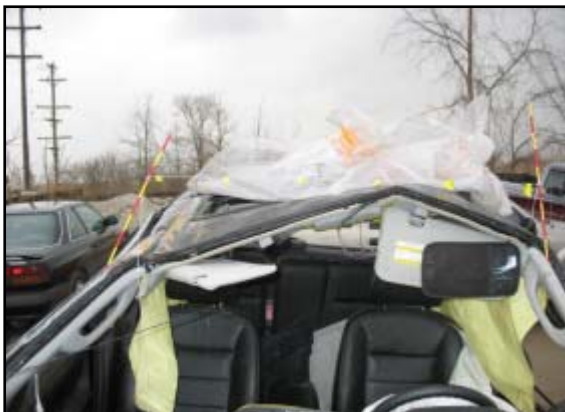
The Ford sustained severe damage as a result of the rollover event. The damage consisted of abrasions to all planes and vertical crush to the roof and windshield header area (**Figure 5**). A vertical crush profile was used to document the crush along the windshield header. The crush was as follows: C1 = 0 cm, C2 = 0 cm, C3 = 0 cm, C4 = 0 cm, C5 = 3 cm (1.2"), C6 = 9 cm (3.5"). The maximum vertical and lateral crush was located at the right A-pillar and were (**Figure 6**): 19 cm (7.5") and 34 cm (13.4"), respectively. The CDC for this impact 00-TDDO-3.

Figure 5. Vertical crush profile at the windshield header.

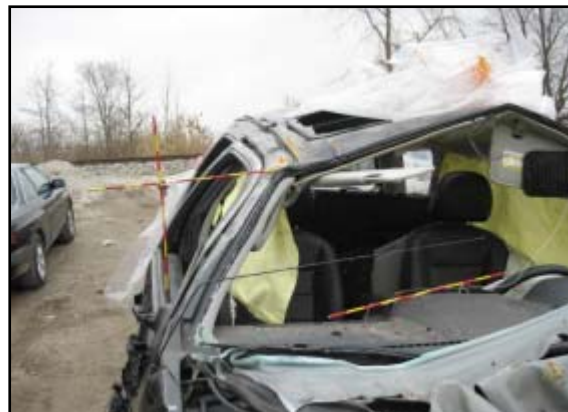
Figure 6. Location of maximum vertical and lateral crush at the A-pillar area.

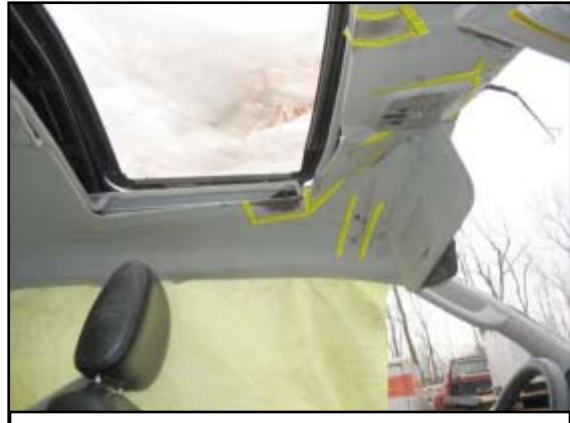
The interior damage to the Ford was moderate and was attributed to occupant contact points and intrusion of the passenger compartment. The driver’s contact points consisted of several areas of body fluid on the windshield header. These contact points were considered probable due to the spattering of the body fluid. An area of body fluid which appeared to be from contact with the driver’s head was located at the front left corner of the sunroof. This area appeared to be the final rest position of the driver’s head as the body fluid was saturated into the headliner. Located at the centerline of

Figure 7. Overall view of the front roof and windshield header contact points.

the windshield header was an overhead map light. This component contained smeared body fluid which was from probable contact with driver’s hand. The plastic trim panel on the center stack and the plastic panel under the steering column were displaced from contact with the driver. **Figure 7** is an overall view of the front roof and windshield header contact points. Numerous areas of the headliner were soiled and damaged from post-crash handling and storage of components that were separated from the vehicle during the crash. The passenger compartment intrusions were as follows:

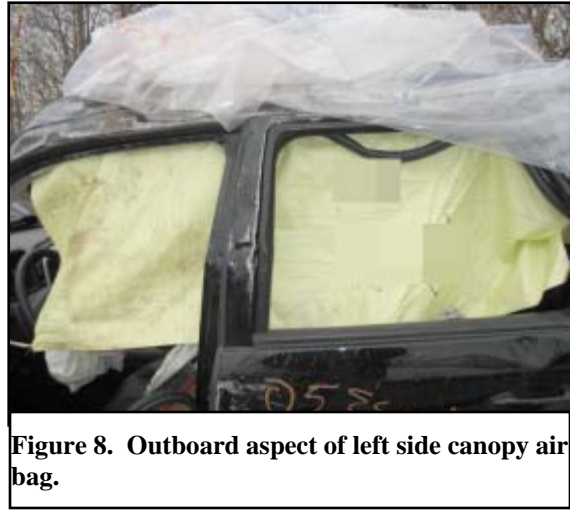
Figure 8. Outboard aspect of left side canopy air bag.

152 cm (60”) in length. The air bags were tethered by rope-type tethers at the A- and C-pillars. The A-pillar tether measured 42 cm (16.5”) in length and the C-pillar tether measured 8 cm (3.0”) in length. **Figure 8** is the outboard aspect of the left canopy air bag. The front tether of the right side air bag was cut by rescue personnel 5 cm (2”) forward of the air bag membrane. No occupant contacts were noted to the canopy air bags. The outboard aspects of the left and right air bags contained body fluid which was probably displaced onto the air bags when the vehicle was up righted from its final rest position on its roof. No damage or failures were noted to the canopy air bags. The following nomenclature was located on the outboard center aspect of the air bag membranes:

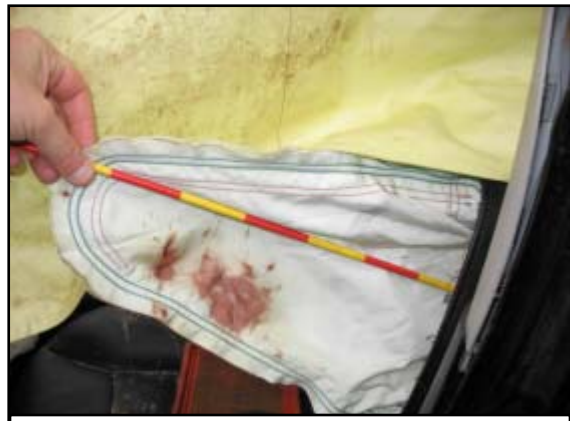
The Ford was equipped with seatback mounted side impact air bags. The left seatback mounted side impact air bag deployed (**Figure 9**) during probable ground contact; however, the timing of the deployment was unknown within the rollover sequence. The air bag was concealed in the outboard aspect of the left seatback. The air bag deployed through a 31cm (12”) vertical tear seam. The air bag membrane measured

Figure 9. Deployed driver's seatback mounted side impact air bag.

32 cm (12.5") in width and 25 cm (10") in height. An area of body fluid which began 9 cm (3.5") rear of the forward edge and measured 10 cm (4") in length was noted on the outboard aspect of the membrane. There was no damage noted to this air bag.

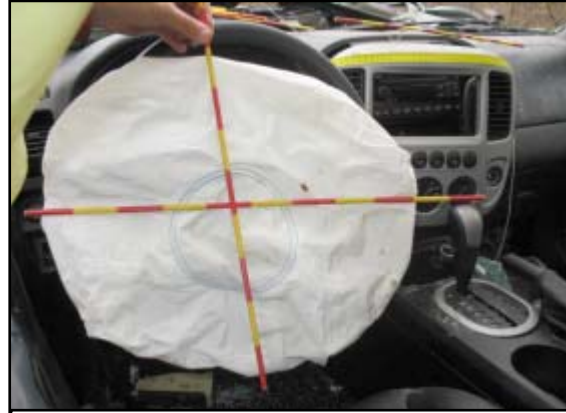
Figure 10. Driver's frontal air bag.

The top cover flap measured 15 cm (6") in width and 8 cm (3") in height. The lower cover flap measured 15 cm (6") in width and 5 cm (2") in height. The membrane was tethered by two wide band tethers at the 3 and 9 o'clock positions and was vented by two vent ports on the rear panel at the 3 and 9 o'clock sectors. An area of body fluid that contained strands of hair was noted on the face of the air bag. The body fluid/hair was located 9 cm (3.5") above the center and 9 cm (3.5") right of center. The front right seat was not occupied during the crash; therefore, the front right air bag was not commanded to deploy.
