Child Safety Seat Serious Injury Investigation / Vehicle to Vehicle
Dynamic Science, Inc. / Case Number: DS06029
1986 Honda Accord
Oregon
December 2006

1. Report No. DS06029	2. Government Accession No.	3. Recipient Catalog No.	
4. Title and Subtitle Child Safety Seat Serious Injury Investigation		5. Report Date April 23, 2007

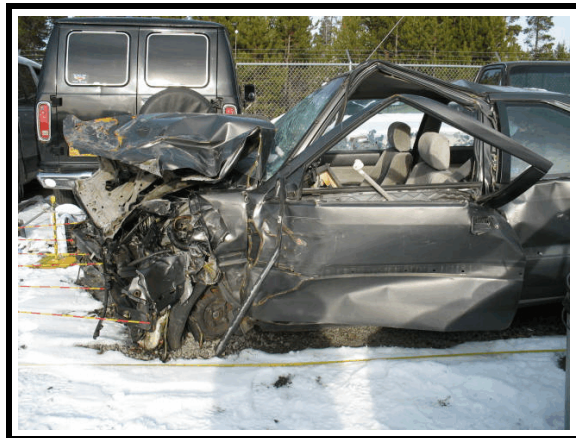
Figure 2. LF damage - 1986 Honda Accord

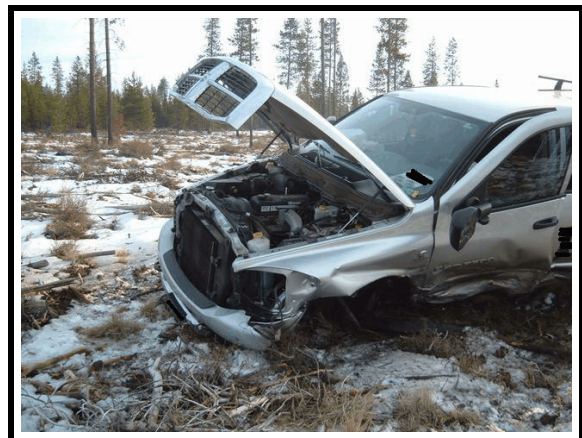
Figure 3. Damaged 2006 Dodge Ram (police photo)

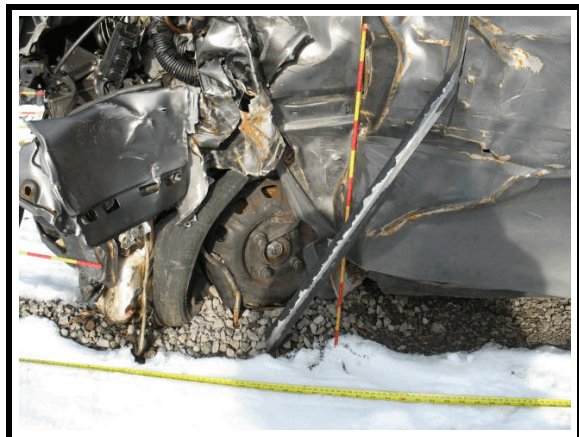
Position	Measured Pressure	Measured Tread Depth	Restricted	Damage
LF	Flat	2 mm (2/32 in)	Yes	Tire debanded; rim damaged (see Figure 8)
LR	165 kPa (24 psi)	4 mm (5/32 in)	No	No
RR	186 kPa (27 psi)	4 mm (5/32 in)	No	No
RF	89 kPa (13 psi)	2 mm (3/32 in)	No	No

Figure 8. Damage to LF tire/rim

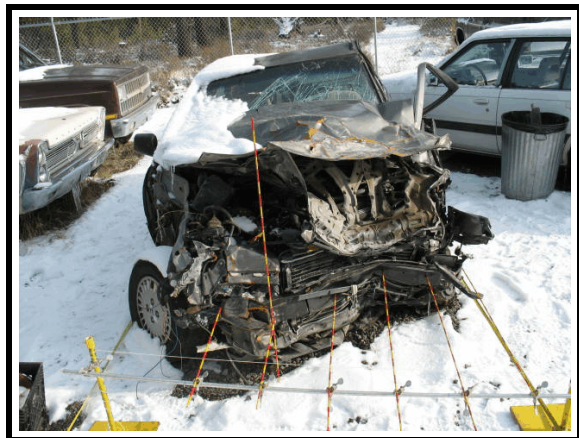
Damage Description: The 1986 Honda Accord sustained severe front end damage as a result of the impact with the Dodge Ram (see Figures 9-10). The direct damage began at the front left bumper corner and extended laterally 120.0 cm (47.2 in) across the front end. The front bumper cover and foam were no longer attached. A portion of the foam was found inside the passenger compartment, but the bumper cover was no longer with the vehicle. The right frame rail was shifted laterally and the left frame rail was shifted vertically downward. The right fender was no longer attached and was not with the vehicle. The left wheelbase was shortened by 52.0 cm (20.5 in). The right wheelbase was lengthened by 12.0 cm (4.7 in).

Six crush measurements were documented at the bumper level as follows: C1=97.0 cm (38.2 in), C2=75.0 cm (29.5 in), C3=73.0 cm (28.7 in), C4=53.0 cm (20.9 in), C5=28.0 cm (11.0 in), C6=24.0 cm (9.4 in). An additional 9.0 cm (3.5 in) of freespace was subtracted from each C measurement to account for the missing bumper cover and foam. Since an exemplar 1986 Honda Accord LX-I could not be located, front bumper freespace had to be estimated from a 1989 Honda Accord. Further efforts to locate and measure a 1986 Accord LX-I continued but were not successful. The maximum longitudinal crush was located at C1, the left front bumper corner. There was crush located above the front bumper but there was not enough crush at any of the C measurements to require crush averaging.

Figure 9. Front crush profile

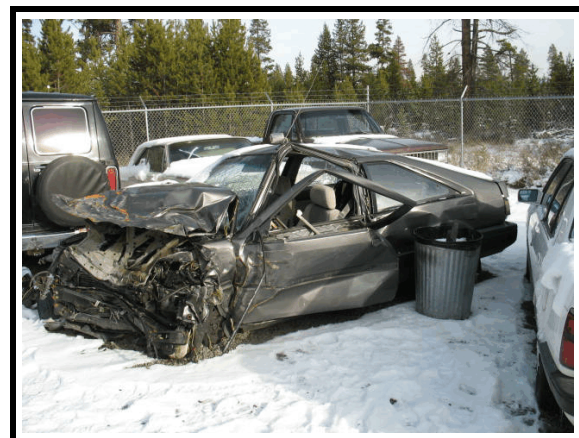
Figure 10. Front/Left - Case vehicle

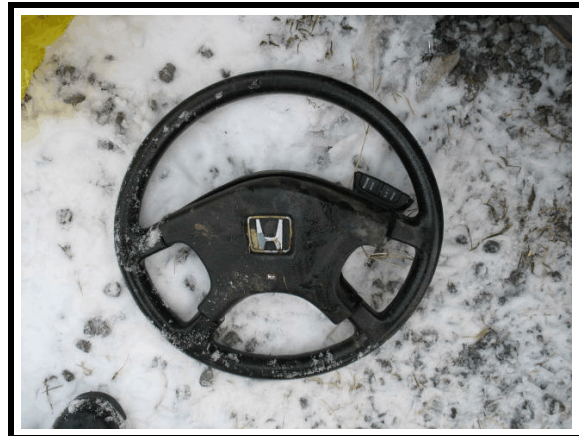
The top section of the steering wheel and the steering wheel hub were damaged due to occupant contact (see Figures 12-13). The deformation to the top half of the wheel measured 5.0 cm (2.0 in). There was blood and tissue found on the hub. The steering wheel was found completely separated from the column. The driver told her mother that the steering wheel broke off during the crash.

Figure 12. Steering wheel (cut out of vehicle)

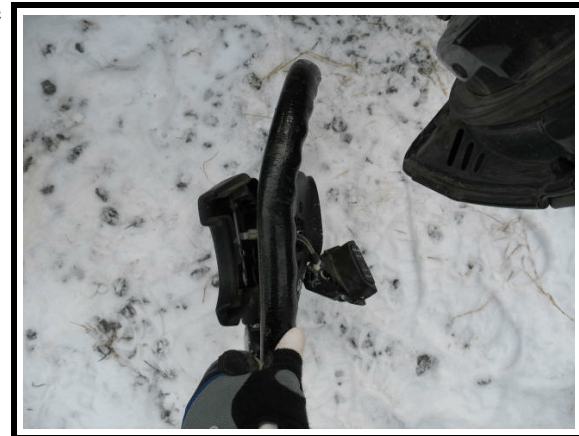
Figure 13. Deformed steering wheel rim

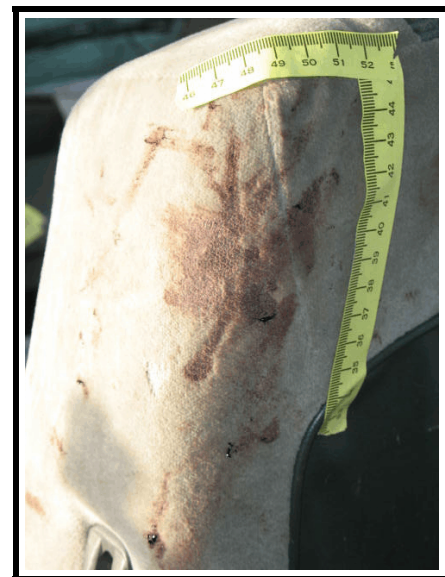
A control lever mounted on the right side of the steering column and a control knob mounted on the left center instrument panel were displaced due to occupant contact. The lower steering column panel was cracked and deformed in two areas due to contact from the driver's knees. There was blood found on the upper right instrument panel and on the left side of the front right seat back (see Figure 14) that was likely due to post-crash driver contact.

Figure 14. Blood on the left side of the RF seat back

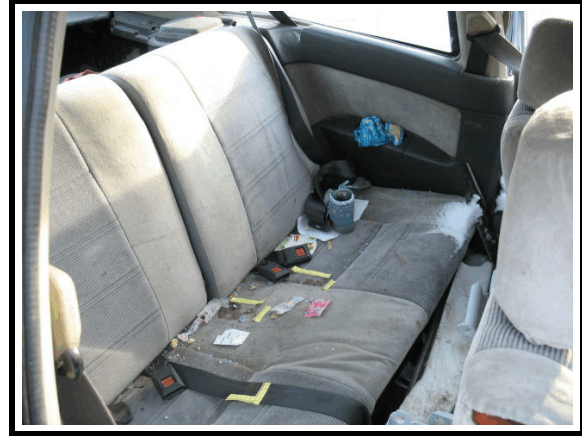
The second row center seat belt webbing had a visible bloodstain with several white hairs embedded in the blood (see Figure 15). There were bloodstains on the center seat cushion as well. It is possible that the blood was from the injured child that was seated in the left rear seating position. According to the driver of the Dodge Ram, the child had a bloody lip post-crash. The blood may have also come from the injured driver, who may have reached back into the second row in order to assist her child.

Figure 15. Location of blood stains on second row seat cushion and center lap belt

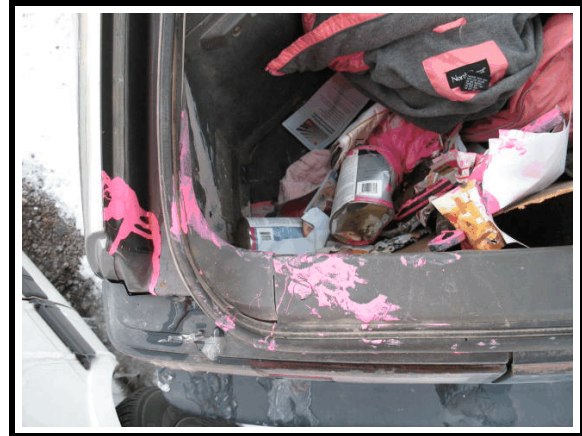
The left front door was jammed shut due to damage. The right front door remained closed and operational. The hatchback came open during the crash. There was no visible damage to the latch or striker, but the hatch had obviously come open at some point during the collision. A can of pink paint that was in the rear cargo area spilled during the crash and paint was found outside of the cargo area (see Figure 16). According to the driver's mother, a portion of the child's clothing was stained with the pink paint following the crash.

Figure 16. Hatchback opened during crash - paint found outside of rear cargo area

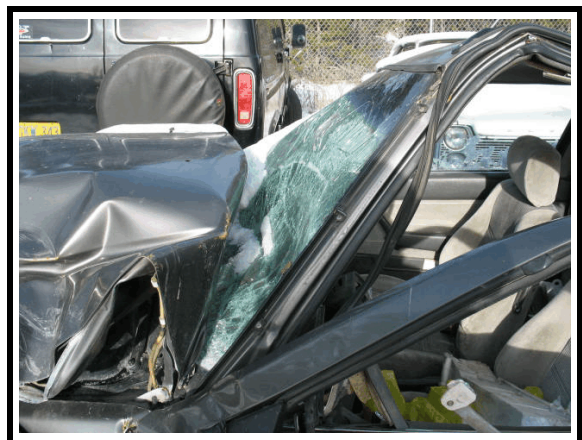
There was integrity loss to the left front glazing area, leaving an opening that measured 85.0 cm (33.5 in) wide by 42.0 cm (16.5 in) high. The deformed left front window frame was due to post-crash driver extrication efforts. The windshield was cracked and in place post-crash. The case vehicle's hood impacted a portion of the windshield, causing it to intrude longitudinally into the passenger compartment (see Figure 17).

Figure 17. Windshield damage/intrusion

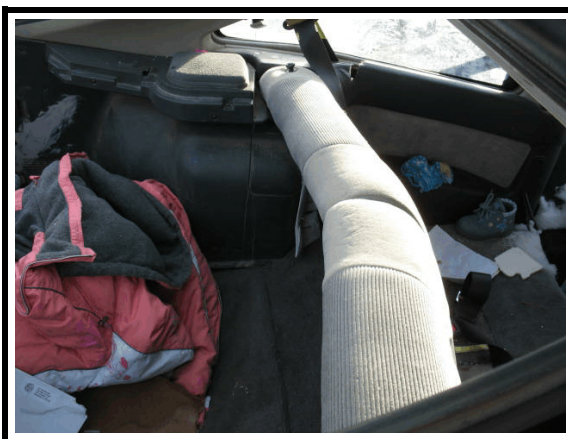
The second row seat backs were deformed from contact with rear cargo. The spare tire was out of its storage area and it is possible that it impacted the back of the second row seat backs during the collision. The other cargo was not large or heavy enough to have caused the deformation.

Figure 18. Second row seat back deformed from impact of rear cargo

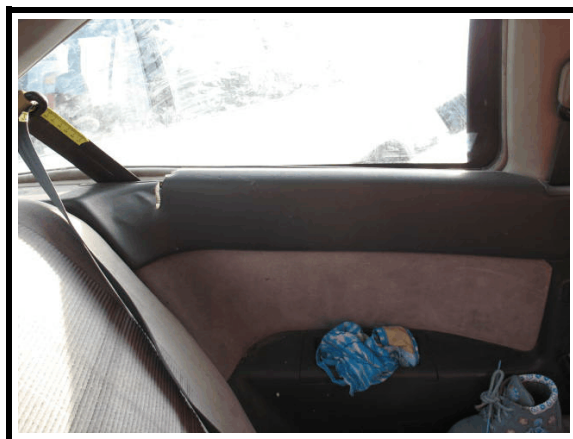
There were multiple longitudinal and lateral intrusions into the passenger compartment seating areas (see Figures 18-19). The magnitude of three intruded components had to be estimated. The specific passenger compartment intrusions were documented as follows:

Figure 19. Damage/Intrusion to left rear side panel

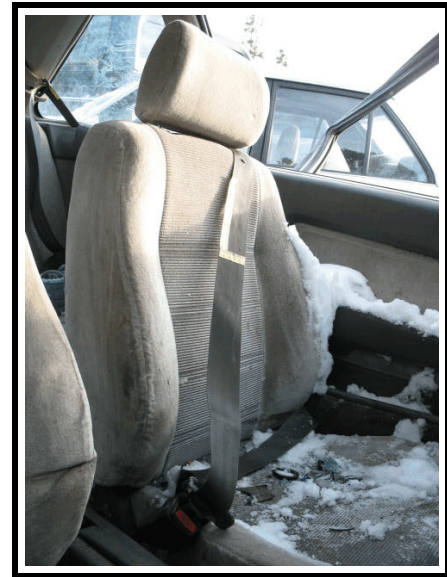
Both the driver and left rear passenger seat belts showed signs of being used during the crash. The driver's shoulder belt had bloodstains on a section that would have been retracted into the B-pillar had it not been in use. The left rear seat belt webbing showed signs of loading in several areas. The driver reported that her seat belt "broke" during the crash, but there were no obvious failures found during the vehicle inspection. It is possible that the driver's seat belt emergency locking retractor did not hold her in place during the impact. Police reported that the driver's seat was found "slammed forward" with the driver leaning over the steering wheel. According to the driver of the Dodge Ram, a passerby had to "break" the driver's seat back while he was helping get her out of the vehicle, but further details were not able to be obtained.

Figure 20. Driver's seat belt (blood on shoulder belt)

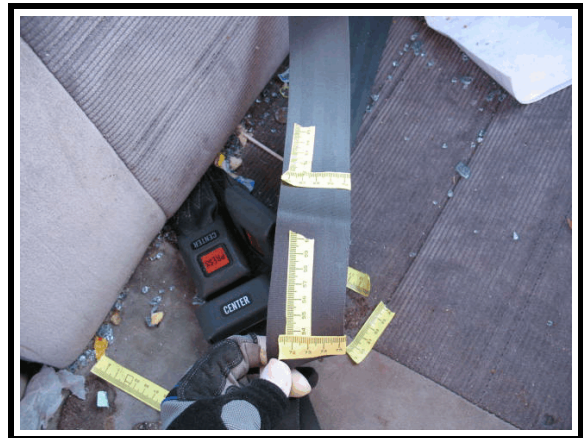
The second row left seat belt was used to secure the child in the safety seat (see Figure 21). According to the driver of the Dodge Ram, the lap and shoulder belt were routed across the front of the child.

Figure 21. Scuffs and indentation on LR seat belt

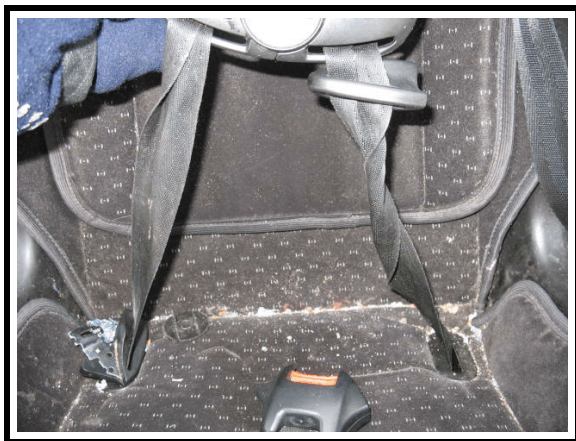
The harness straps were found buckled, with the top straps threaded through the top harness slots. The retainer clip was found connected and fairly low on the harness straps. There were pieces of padded fabric around the upper harness straps (original equipment). The harness straps were twisted on both sides (see Figure 24). The plastic shell showed signs of stress in several areas (see Figures 25-27). There were stress marks on the right center section and to the bottom center area of the seat. There were no signs of occupant loading or contact to the harness straps, retainer clip, or to the shell padding.

Figure 24. Twisted harness straps

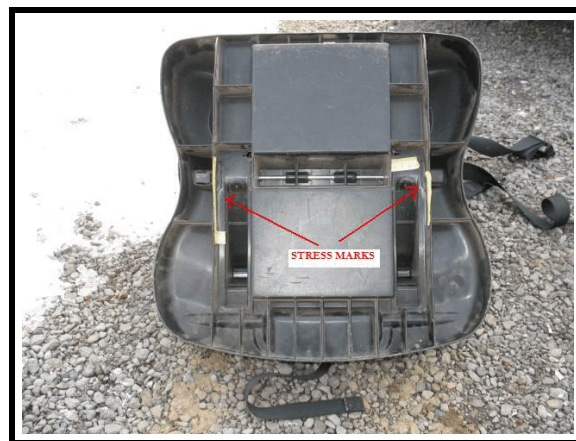
Figure 25. Visible stress marks on bottom of the CSS

At the time of the CSS inspection there were no visible problems with the seat itself, other than the stress marks visible on several sections of the CSS's plastic shell. These stress marks are presumed to have occurred as result of this crash. The child's grandmother reported that she purchased the CSS new and it had never been involved in any other crashes.

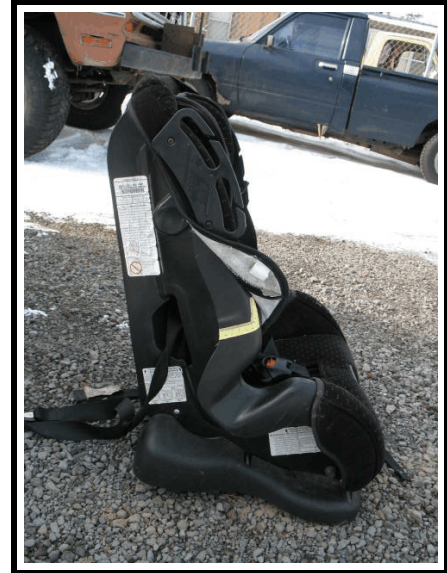
Figure 26. Stress mark on right side of CSS (highlighted with yellow tape)

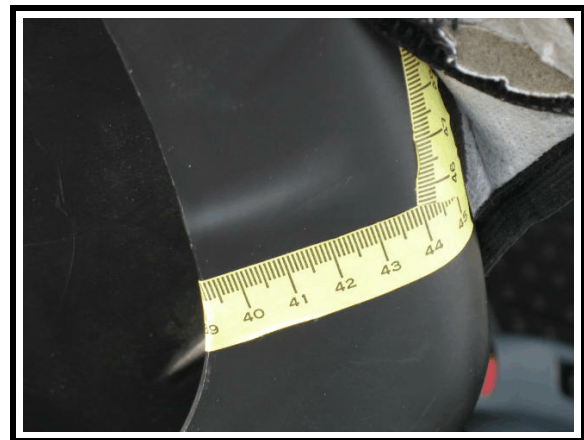
Figure 27. Close-up – stress mark on right side of booster seat

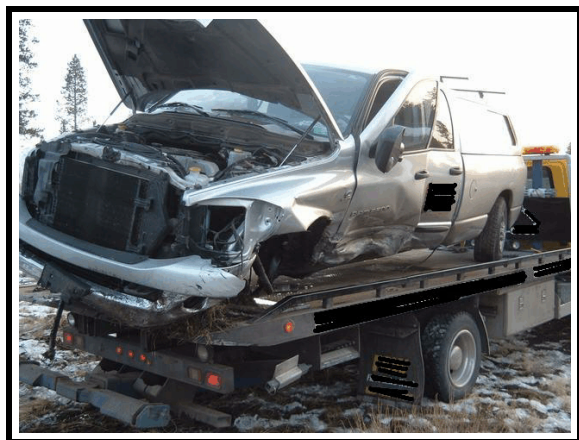
The 2006 Dodge Ram pickup sustained moderate damage to its left side (see Figures 28-29). The direct damage from the impact with the Honda began at the Ram's left front bumper corner and extended down the left side of the pickup to the front section of the left rear door. The majority of the direct damage to the Ram's left side was to the lower to mid-door level. The left front tire and drive line were ripped off the vehicle during the collision. This damage description was based off of police on-scene photographs. Attempts were made to locate and inspect the pickup, but they were not successful.

Figure 28. 2006 Dodge Ram damage (police photo)

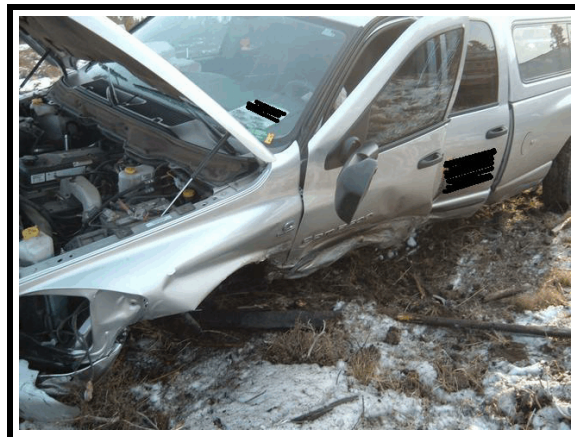
Figure 29. Damaged 2006 Dodge Ram (police photo)

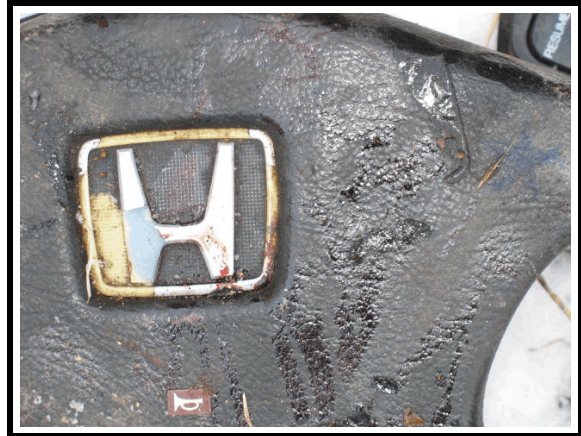
Figure 30. Close-up - blood and tissue transfers on steering wheel hub

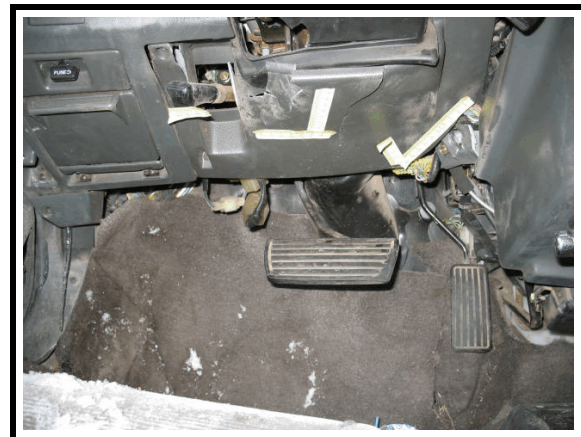
Figure 31. Occupant contacts to steering column and left instrument panel

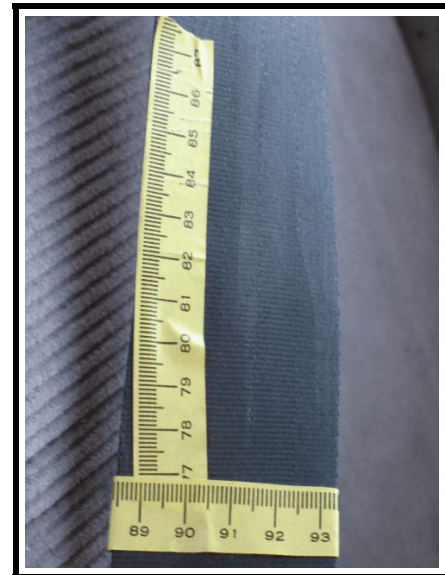
Figure 33. Evidence of loading to the second row left seatbelt
