Certified Advanced 208 Compliant Air Bag Investigation/ Vehicle v. Tree  
Dynamic Science, Inc. / Case Number: DS06030  
2007 Chevrolet Suburban  
Colorado  
November 2006

1. Report No. DS06030	2. Government Accession No.		3. Recipient Catalog No.	
4. Title and Subtitle Certified Advanced 208 Compliant Air Bag Investigation			5. Report Date April 20, 2007

**Dynamic Science, Inc.**  
**Crash Investigation**  
**Case Number:DS06030**

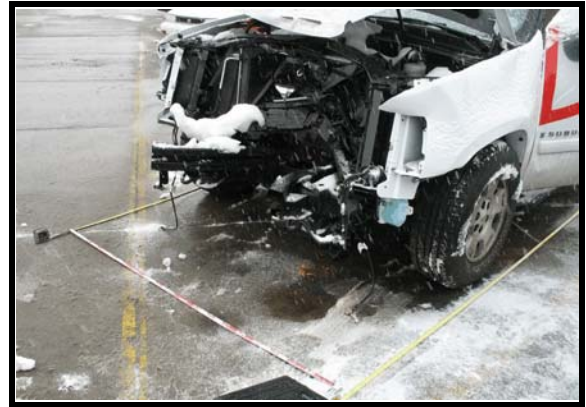
The 2007 Chevrolet Suburban sustained moderate front end damage as a result of the impact with the tree. The direct damage began 23.0 cm (9.0 in) from the left bumper corner and measured 50.0 cm (19.7 in) laterally. The maximum longitudinal crush was located at C3 and measured 68.0 cm (26.8 in). The bumper fascia was knocked off during the crash. The left wheelbase was shortened by 4.0 cm (1.6 in). The left front tire was slightly restricted. The right front door was jammed shut. The remaining doors remained closed and operational.

Six crush measurements were documented at the backing bar level as follows: C1 = 0 cm (0 in), C2 = 29.0 cm (11.4 in), C3 = 68.0 cm (26.8 in), C4 = 67.0 cm (26.3 in), C5 = 35.0 cm (13.8 in), C6 = 0 cm (0 in).

The Collision Deformation Classification (CDC) for the impact with the tree was 12FYEW3.

**Figure 3.** Front left, Chevrolet Suburban

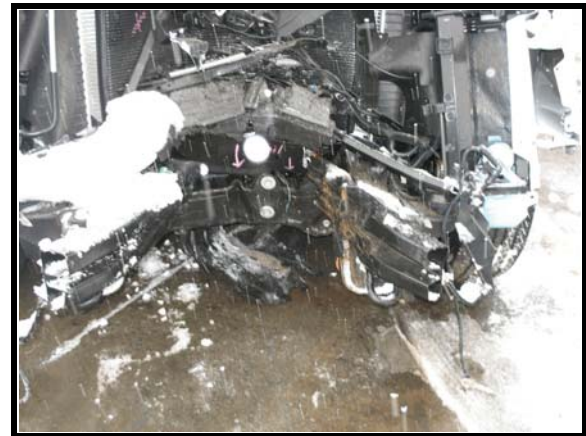
**Figure 4.** Close up of backing bar

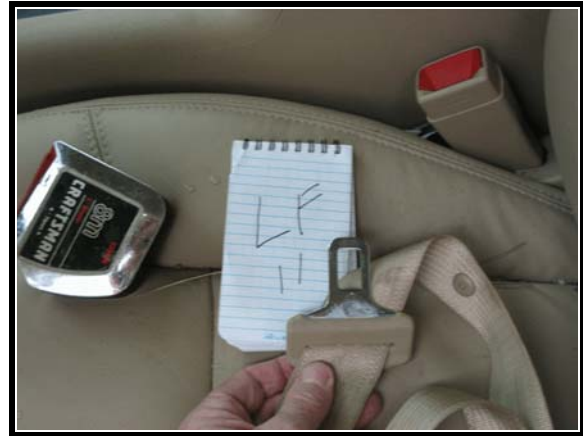
The 2007 Chevrolet Suburban was configured with manual 3-point lap and shoulder belts for each of the seven seating positions. Both front seat safety belts were equipped with retractor pretensioners and adjustable D rings that were in the up full down position for the driver and in the full up position for the front right seat position. The driver's safety belt was configured with a sliding latch plate and an Emergency Locking Retractor (ELR). At the time of the vehicle inspection, the driver's retractor was restricted in the used position as a result of pretensioner actuation; the front right passenger's retractor was restricted in the stowed position as a result of pretensioner actuation. The second row seat belts were configured with sliding latch plates and switchable retractors. The third row seat belts were configured with sliding latch plates and switchable retractors.

**Figure 5.** Driver's seat belt tang

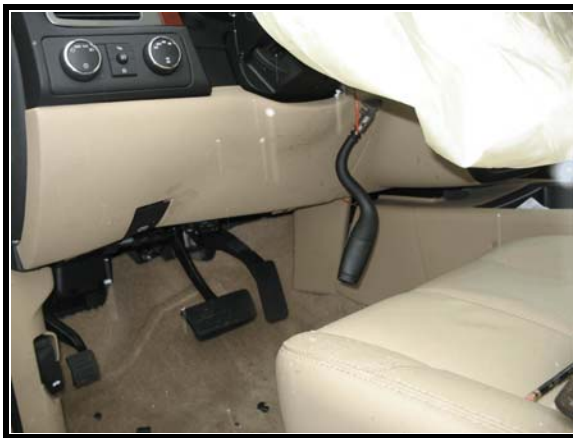
The Chevrolet Suburban sustained minor interior damage as a result of occupant contacts the driver's air bag deployment. There was a faint scuff on the left side of the knee bolster. The shifter stalk was broken away. Blood was found on the seat bottom on the second row left seat.

**Figure 6.** Scuff to knee bolster

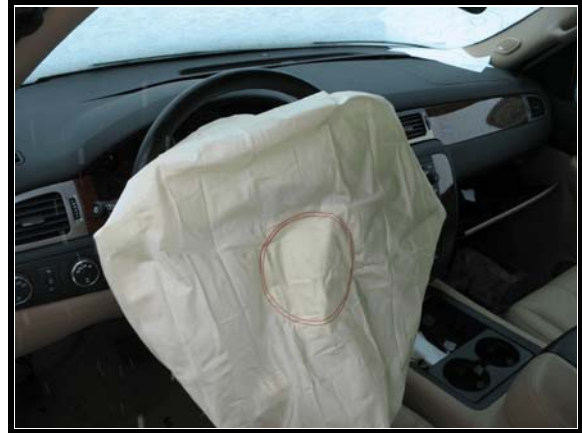
The driver's air bag deployed from the center of the steering wheel hub through symmetrical H-configuration module cover flaps. Each flap measured 18.0 cm (7.0 in) high, 10.0 cm (3.9 in) wide at the top, and 5.0 cm (1.9 in) wide at the bottom. The deployed driver's air bag measured 50.0 cm (19.7 in) in diameter in its deflated state. There were 10 vertical folds across the air bag face. The air bag was tethered by a single internal strap that was attached to a 15.0 cm (5.9 in) circular stitch in the center of the air bag face. Two circular vent ports were located at the 11 and 1 o'clock aspects on the rear of the air bag. There were no indications of any damage or contact to the driver's air bag.

**Figure 8.** Driver's frontal air bag

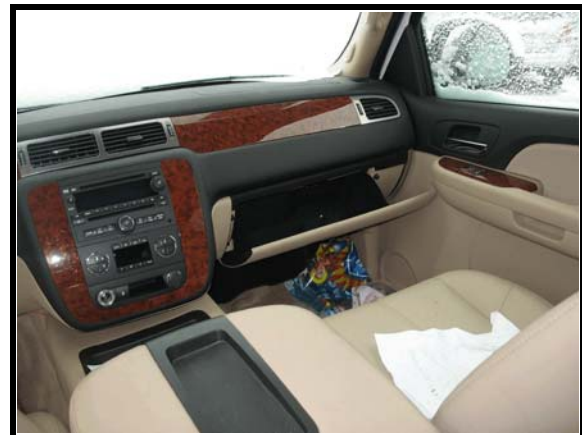
The 2007 Chevrolet Suburban was equipped with dual-stage frontal air bag and safety belt retractor pretensioners for the driver and front right passenger positions. The driver's air bag and both front safety belt pretensioners deployed as result of the longitudinal deceleration of the Suburban during the impact with the tree. The front right passenger air bag did not deploy. The Suburban was also equipped with side air curtains that cover all six outboard seat positions. The side air curtains did not deploy.

**Figure 9.** Front right passenger air bag location
