ON-SITE ROLLOVER INVESTIGATION

CASE NUMBER - IN-06-031

VEHICLE - 2005 CHEVROLET SILVERADO CREW CAB PICKUP TRUCK

CRASH DATE - July 2006

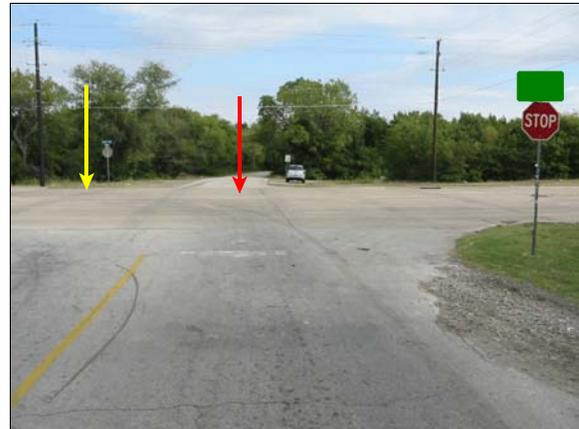
Pre-Crash: The case vehicle was northbound in the northbound lane (**Figure 1** below) approaching the intersection at an EDR recorded speed of 84 km.p.h. (52 m.p.h). The case vehicle's driver was intending to continue northbound. The Ford was westbound in the left through lane also approaching the intersection (**Figure 2** below). The Ford's driver was intending

Figure 1: Approach of case vehicle northbound to intersection, red arrow shows area of initial impact, yellow arrow shows area of rollover

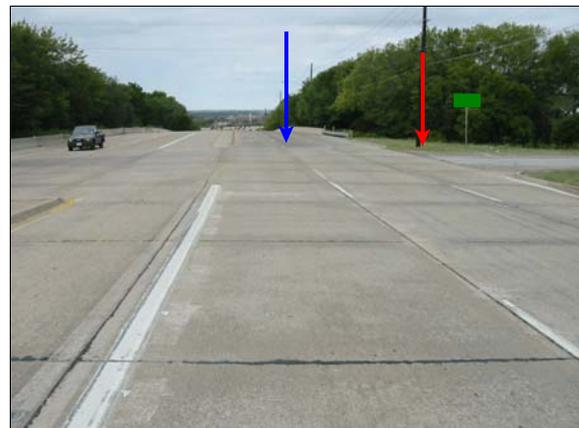
Post-Crash: The case vehicle traveled off the roadway and came to final rest on its left side heading northeast on the northwest corner of the intersection (Figure 2). The Ford rotated clockwise and came to rest in the westbound lanes in the northwest leg of the intersection heading east (Figure 2).

Figure 2: Approach of Ford westbound to area of impact, blue arrow shows area of Ford's final rest, red arrow shows area of case vehicle final rest

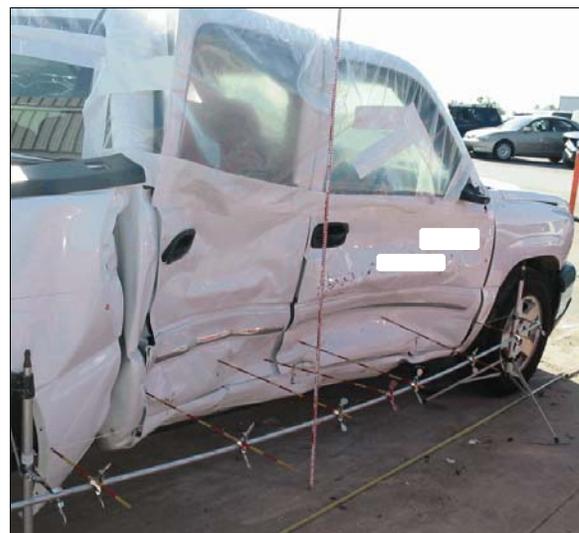
Figure 3: Damage to case vehicle's right side from impact with front of Ford

Exterior Damage: The case vehicle's impact with the front of the Ford (event 1) involved the right side of the vehicle. The right front door, right rear door and the front of the truck bed were crushed inward. The direct damage began 65 centimeters (25.6 inches) rear of the right front axle and extended 228 centimeters (89.8 inches) along the right side of the vehicle. Crush measurements were taken at the mid-door level. The maximum residual crush was measured as 40 centimeters (15.7 inches) occurring 17 centimeters (6.7 inches) rear of C₄ (**Figure 6** below). The table below shows the case vehicle's right side crush profile.

The case vehicle sustained several intrusions to the right side of the vehicle due to the impact with the Ford. There was 20 centimeters (7.9 inches) of right “B”-pillar intrusion and 15 centimeters (5.9 inches) of right rear door intrusion into the back right seat position, and 10 centimeters (3.9 inches) of right front door intrusion into the front right seat position. Finally, there was no evidence of compression of the energy absorbing steering column, and no deformation of the steering wheel rim was observed.

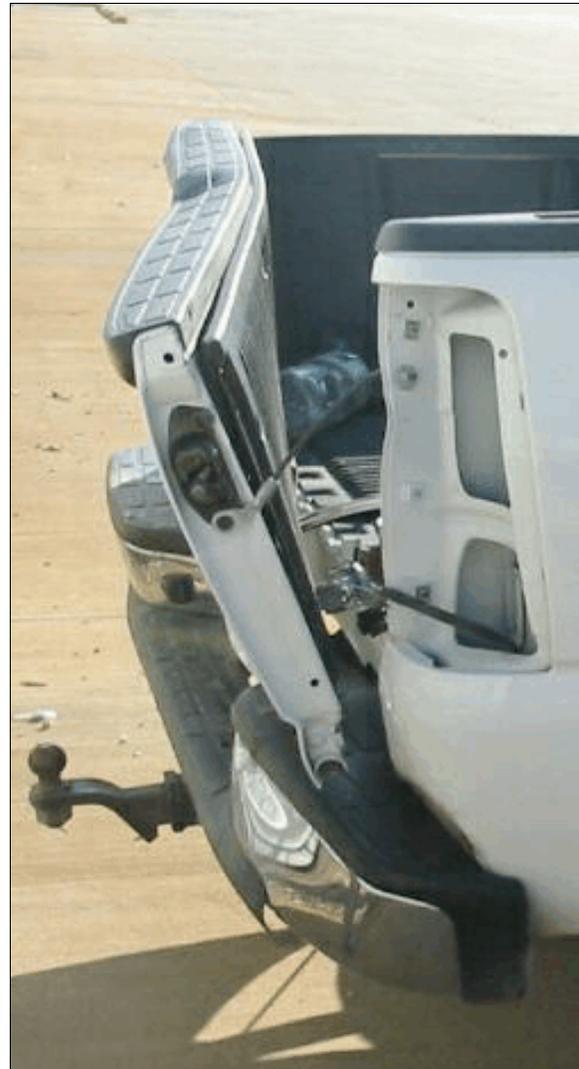
Figure 4: Damage to back bumper and tailgate from secondary impact with Ford

The case vehicle’s back impact with the left rear corner of the Ford (event 2) involved the back bumper and tailgate. The direct damage began at the back right bumper corner and involved the right portion of the tailgate. The rollover involved the left side of the vehicle. The direct damage involved the left fender, left side doors and pillars and the left roof side rail. There was grass jammed into the seam between the left front and left rear doors and into the front of the left rear door window frame. In addition, the left side view mirror was broken off.

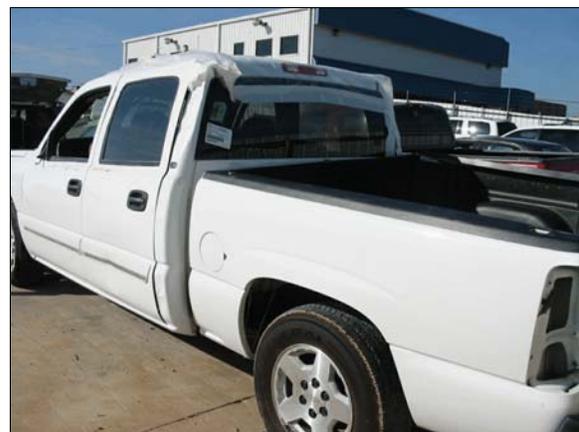
Figure 5: Overview of minor rollover damage to left side a case vehicle's cab

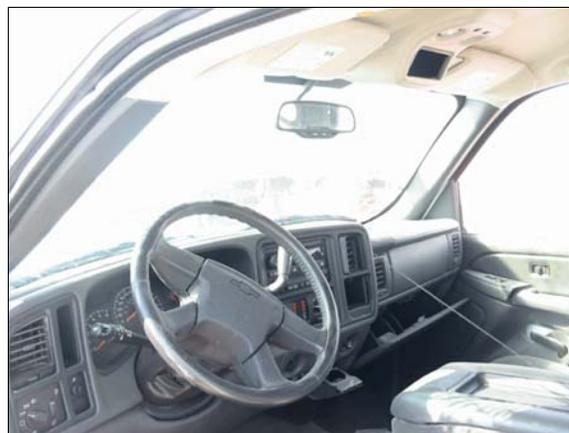
Vehicle Interior: Inspection of the case vehicle’s interior (Figures 7, 8 and 9 below) revealed a hair in the top of the left front window frame and a few scuffs and dirt on the roof near the left front window and a few scuffs on the roof near the back left window. In addition, a few scuffs

Figure 7: Overview of case vehicle's steering wheel, windshield and instrument panel

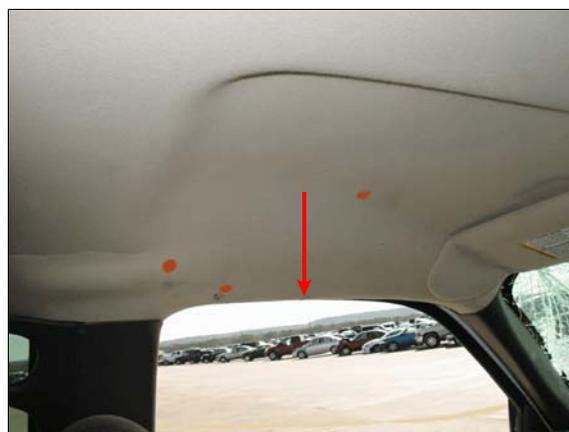
Figure 8: Orange dots shows marks on left front roof area, arrow shows location of strand of hair embedded in left front window frame

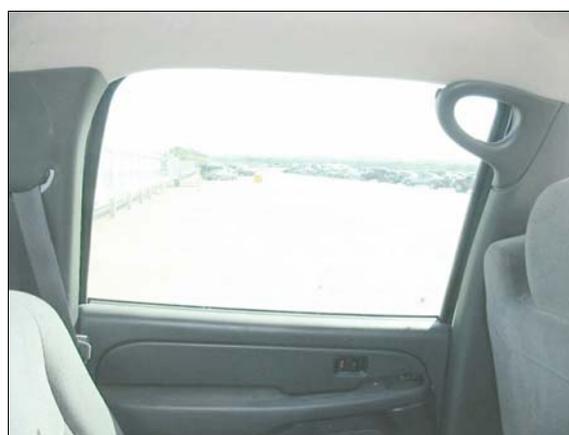
were found on the left rear window. No other occupant contact evidence was found.

Figure 9: Overview of left rear window and door

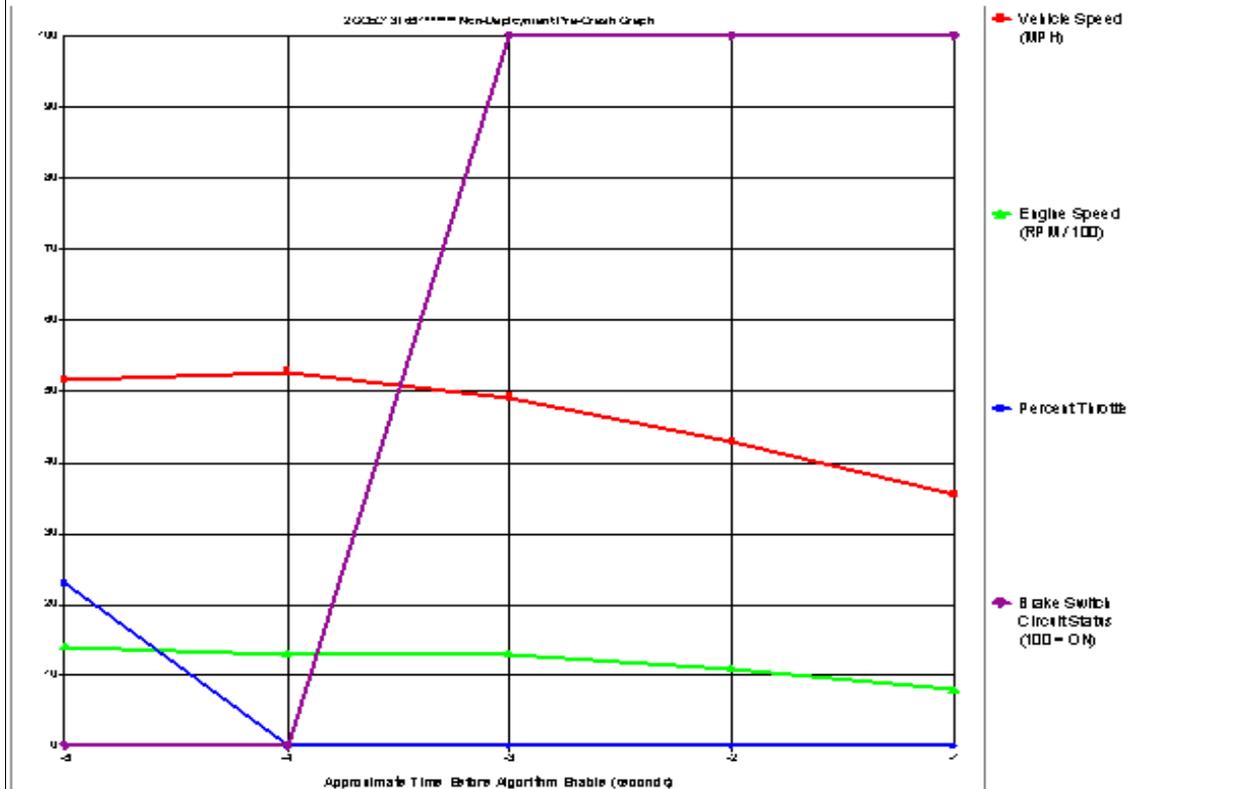
The pre-crash data graph indicates the case vehicle was traveling 84 km.p.h. (52 m.p.h.) at five seconds prior to AE. At three seconds prior to AE the brake switch is recorded as on, percent throttle is recorded as zero and vehicle speed is recorded as 79 km.p.h. (49 m.p.h.). The brake switch is recorded as on for the remaining two seconds of the pre-crash data.

Figure 12: Case vehicle's System Status at non-Deployment report

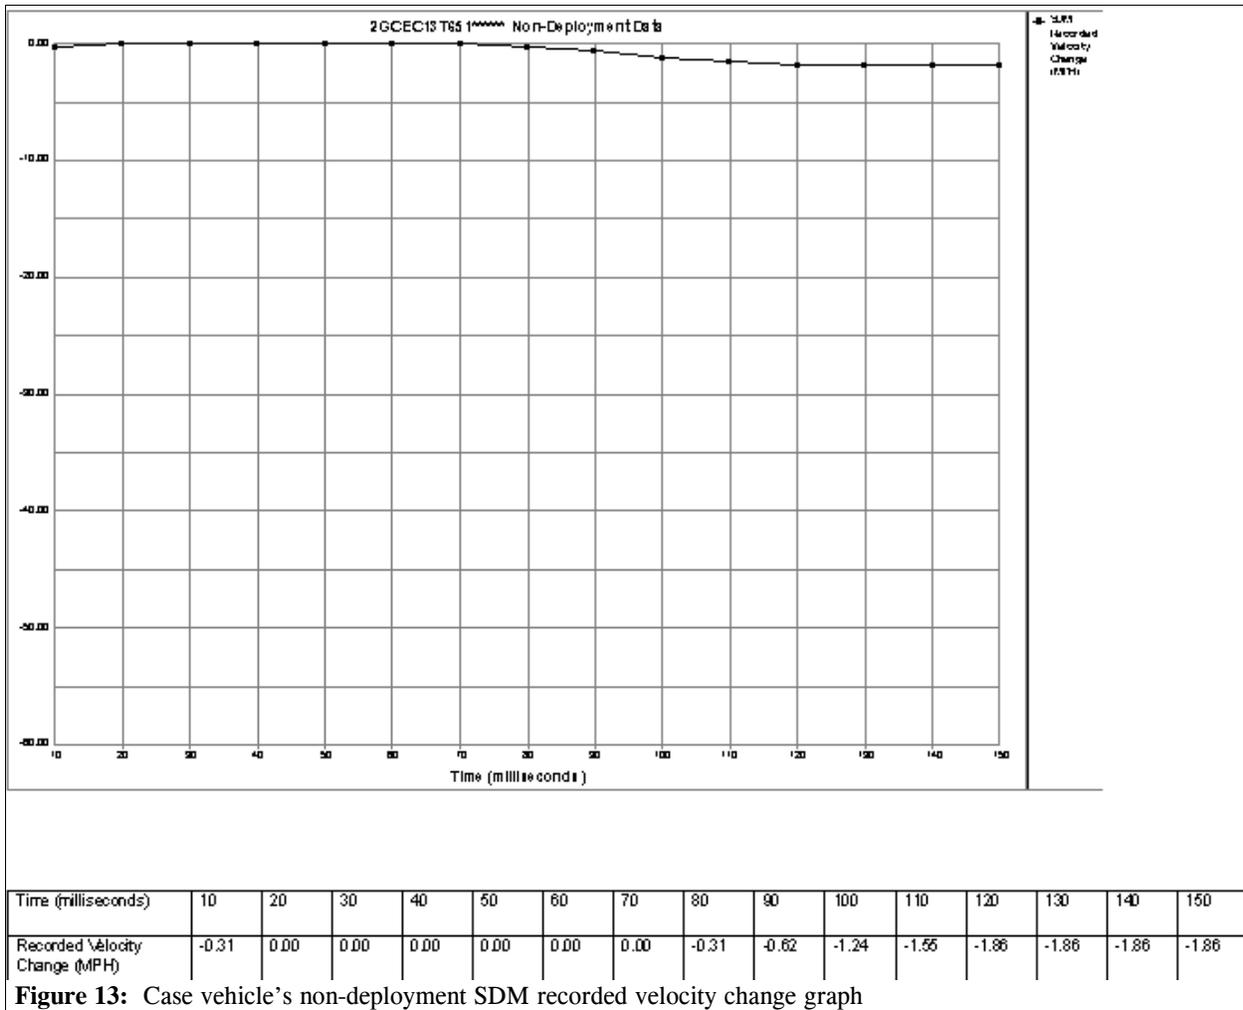
Figure 13: Case vehicle's non-deployment SDM recorded velocity change graph
