**CALSPAN ON-SITE SIDE IMPACT INFLATABLE OCCUPANT PROTECTION
INVESTIGATION**

NASS/SCI COMBO CASE NO.: 2007-45-174A

VEHICLE: 2007 VOLVO S80

CRASH DATE: OCTOBER 2007

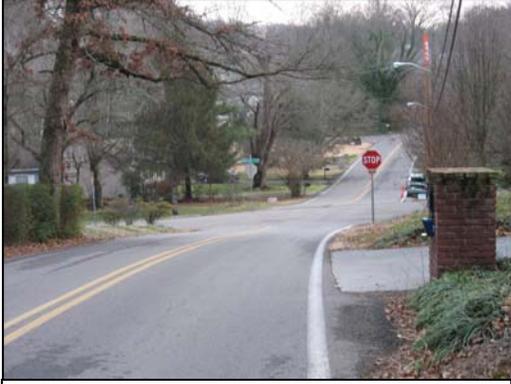
The 33-year old male driver of the Volvo was operating the vehicle in a southbound direction and was approaching the hillcrest at a high rate of speed (**Figure 2**), as reported by the left rear passenger. The driver and the 24-year old front right female passenger were reportedly engaged in an argument. As the Volvo crested the hill, it became airborne and landed in the southbound lane 7 m (23 ft) beyond the crest. This was evidenced by two 1 m (3 ft) gouge marks in the asphalt roadway from the front tires. The operator of the Volvo then lost directional control and the vehicle began to rotate counterclockwise (CCW) toward the southeast quadrant of the intersection. As the vehicle rotated, the right front and rear tires left yaw marks of 19 m (62 ft) and 22 m (72 ft), respectively. Both yaw marks continued onto the roadside leading to the point of impact with the stop sign. **Figure 3** is a look back from the Volvo's southbound approach.

Figure 2 - Southbound approach of the Volvo.

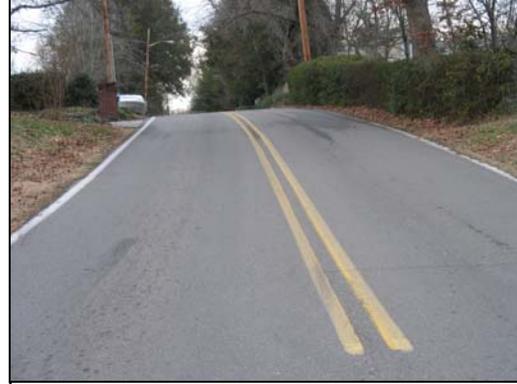
Figure 3 - Look back at the southbound approach of the Volvo.

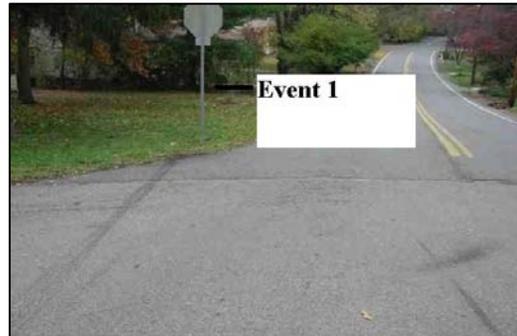
The right fender of the Volvo impacted a stop sign post (**Event 1**) that was mounted 5 m (16 ft) south of the intersection on the southeast corner (**Figure 4**). At impact with the signpost, the Volvo had rotated CCW approximately 110 degrees from its original heading. The signpost sheared at the ground level, wrapped around the hood, and became attached to the front right aspect of the vehicle. This impact did not alter the vehicle's trajectory as it continued its southeast trajectory while in the CCW rotation.

Figure 4 - Event 1 - stop sign.

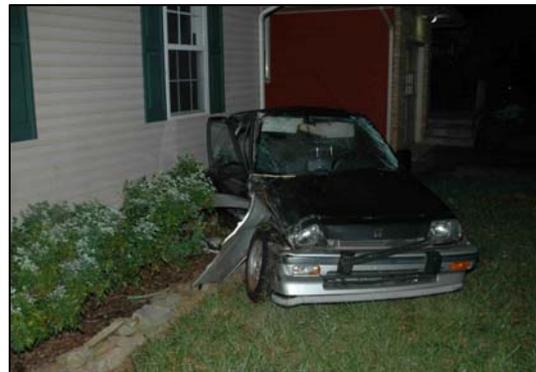
The vehicle continued its CCW rotation for approximately 28 meters (92 feet) where the left rear plane impacted the right side of a Honda Civic that was parked in the residential driveway, (**Event 2**). At impact with the Honda, the Volvo had rotated approximately 250 degrees from its original heading. The direction of force for the impact with the Honda was in the 8 o'clock sector. A Collision Deformation Classification (CDC)-only damage algorithm of the WinSMASH program computed a total delta-V of 11 km/h (4.3 mph) for the Volvo and 25 km/h (9.8 mph) for the Honda. The respective longitudinal and lateral velocity changes were 7 km/h (2.8 mph) and 9 km/h (3 mph) for the Volvo and -16 km/h (-6.3 mph) and -19 km/h (-7.4 mph) for the Honda. The Honda was displaced approximately 15 m (50 ft) in the southeast direction from the point of impact and came to rest against the private home facing the northwest (**Figure 5**).

Figure 5 - Final rest position of the Honda.

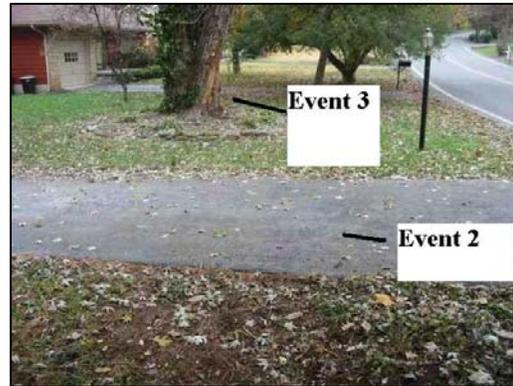
The rotation of the Volvo was further amplified by the impact with the Honda. The Volvo continued approximately 6 meters (20 feet) and rotated CCW an additional 30 degrees where it struck a 63 cm (25”) tree with the left front door and B-pillar areas, (**Event 3**). The direction of force for this impact was in the 10 o’clock sector. The damage algorithm of the WinSMASH program computed a total delta-V of 25 km/h (15.5 mph). The specific longitudinal and lateral velocity changes were -9 km/h (-5.6 mph) and 24 km/h (15 mph), respectively. Due to the removal of the left side doors and B-pillar, the sill level crush measurements resulted in the delta-V being computed too low for this event. It is therefore not representative of the severity of this impact. The impact was sufficient to deploy the right side IC and seatback mounted air bags. **Figure 6** illustrates the locations of the second and third crash events.

Figure 6 - Events 2 and 3.

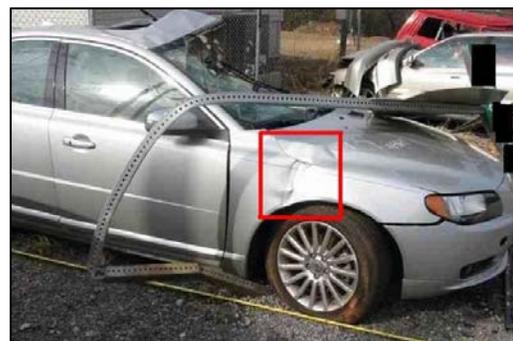
The 2007 Volvo S80 sustained severe damage as a result of the multiple impacts within this crash sequence. The impact with the stop sign post caused only minor damage to the right fender (**Figure 7**). The direct contact damage began 8 cm (3”) aft of the front right axle and extended rearward 12 cm (4.7”). The maximum crush was 2 cm (1”) in depth and was located at 14 cm (5.5”) aft of the axle. The CDC for this impact was 03-RFEN-1.

Figure 7 - Damage to right side of Volvo from signpost.

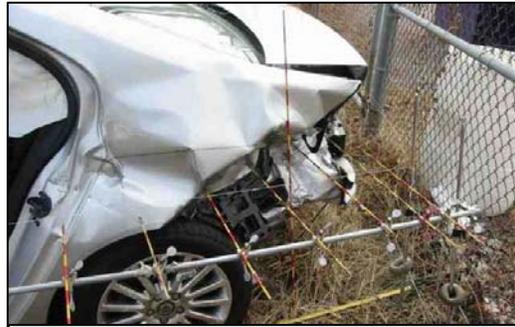
The impact with the parked 1987 Honda CRX resulted in moderate damage to the left quarter panel of the Volvo (**Figure 8**). The direct contact damage began 10 cm (4") aft of the left rear axle and extended 74 cm (29") rearward. The combined direct and induced damage began at the left rear axle and extended rearward 84 cm (33"). The maximum crush was located 69 cm (27") aft of the left rear axle and was 30 cm (11.8") in depth. Six equidistant crush measurements were taken along the mid-door level of the vehicle and were as follows: C1 = 6 cm (2.4"), C2 = 30 cm (11.8"), C3 = 21 cm (8.3"), C4 = 13 cm (5"), C5 = 0 cm, C6 = 0 cm. The CDC for the impact with the Honda CRX was 08-LBEW-3.

Figure 8 - Damage to left quarter panel from Honda CRX.

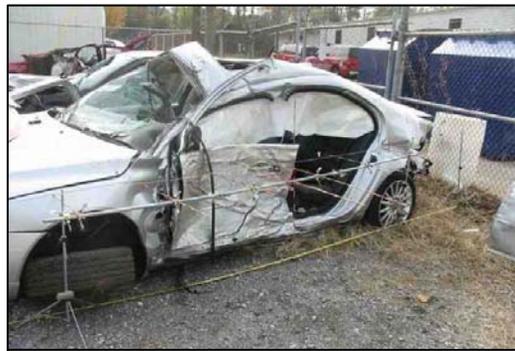
The third impact with the 63 cm (25") diameter tree resulted in severe damage to the Volvo's left side (**Figure 9**). The direct contact damage extended above the beltline to the A- and B-pillars and the roof side rail. The roof deformed laterally and was creased along the header at its midline. The roof damage resulted in a 40 cm (16") vertical x 85 cm (34") horizontal hole in the windshield. The glazing in the roof and left side windows disintegrated. Emergency personnel removed both left side doors and the B-pillar. Therefore, the crush profile was taken along the sill level and does not represent the severity of the damage. The direct contact damage began 102 cm (40") forward of the left rear axle and extended forward 115 cm (45.2"). The combined direct and induced damage began 28 cm (11") forward of the left rear axle and extended forward 270 cm (106"). The maximum crush was located 149 cm (58.6") forward of the left rear axle and measured 31 cm (12.2") in depth. Considering that direct damage was present on the roof side rail, it is probable that the dynamic crush exceeded the 31 cm (12.2") maximum crush before rebounding to its static post crash state. Six crush measurements were taken along the sill and were as follows: C1 = 1 cm (0.5"), C2 = 14 cm (5.5"), C3 = 19 cm (7.5"), C4 = 22 cm (8.7"), C5 = 8 cm (3.1"), C6 = 0 cm. The CDC for the impact with the tree was 09-LPAW-3.

Figure 9 - Damage to left side of Volvo from tree impact.

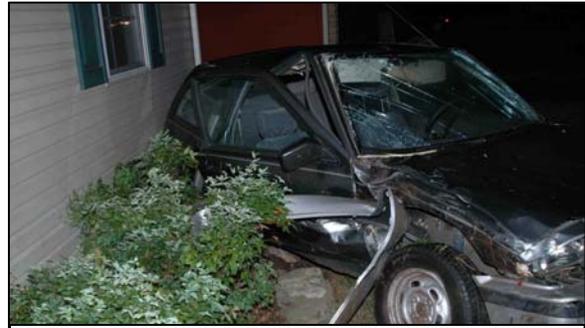
The parked 1987 Honda CRX sustained moderate damage as a result of being struck on the right side by the Volvo (**Figure 10**). The vehicle was removed from the scene and not available for an inspection by either the NASS or the SCI team. A review of the on-scene images revealed that the direct contact damage began at the right front corner of the vehicle and extended rearward to the forward aspect of the front right door. The front right door was deformed outboard from the vehicle and the right A-pillar was deflected upwards. The crush appeared to have extended into the second extent zone. The CDC derived from the on-scene images was 02-RYEW-2.

Figure 10 - Final rest position of the Honda CRX.

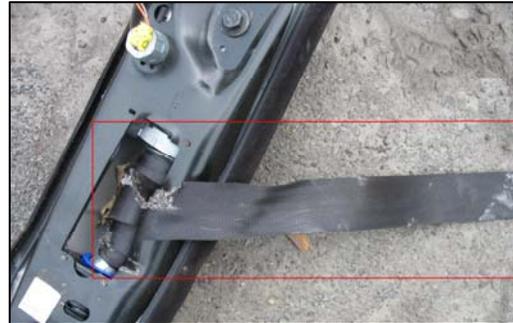
Figure 11 - Damaged B-pillar and retractor pretensioner.

with the absence of loading evidence to the latch plate and belt webbing, it was determined that the driver was not using the belt system. Analysis of the Volvo's EDR data confirmed that the driver was not belted during the crash sequence.

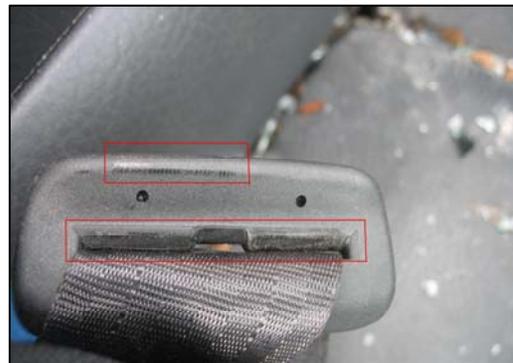
The front right passenger's belt was configured with a switchable ELR/Automatic Locking Retractor (ALR) and a retractor pretensioner that actuated during the crash. The belt webbing's full excursion was 230 cm (90"). Loading evidence in the form of a fabric crease was identified on the belt webbing 69 cm (27") above the belt's anchor point. Based on the location of the crease, and combined with the size of the front right passenger, the crease in the webbing would be near the latch plate if the belt was in use. Additionally, heavy abrasions were identified on the latch plate plastic housing (**Figure 12**).

Figure 12 - Loading evidence on RF latch plate housing.

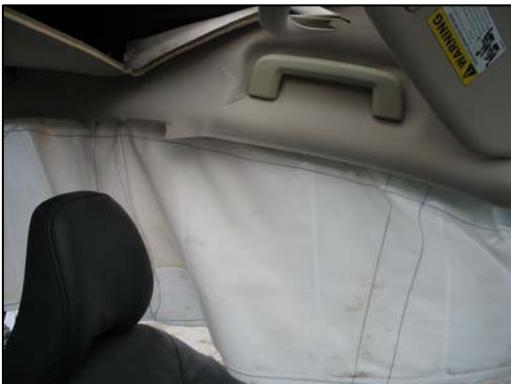
The IC deployed from the left roof side rail (**Figure 13**). The IC provided coverage from the A- to C-pillars; however, the triangular area around the A-pillar tether resulted in an opening of 24 cm (9.4”) in width and 18 cm (7”) in height. The tear seam was 190 cm (75”) in length. The air bag membrane was rectangular in shape and measured 41 cm (16”) vertically from the roof side rail and 178 cm (70”) in length. The inboard aspect of the air bag was attached to the A-pillar by a 25 cm (10”) tether. During the NASS inspection, the researcher documented body fluid and hair transfers to the outboard aspect of the air bag and scuffing from the tree. During the SCI investigation, the air bag was weathered and the majority of the physical evidence on the air bag had eroded due to the elements. However, a 20 x 24 cm (7.8 x 9.4”) area of the air bag, 30 cm aft of the forward most aspect, revealed a tree bark/body fluid transfer (**Figure 14**). It should be noted that no obstructions were noted within the path of the deployed air bag.

Figure 13 - Deployed IC air bag.

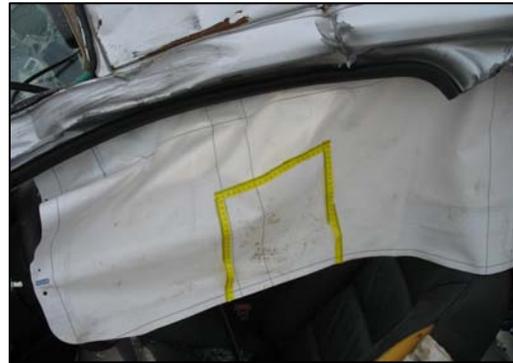
Figure 14 - Transfer evidence on outboard aspect of the IC air bag.

driver resulted in the near total decapitation at the angle of the mandible with massive skull fractures and an avulsion of the majority of the brain from the cranium. The contact to the tree was evidenced by the presence of the tree bark/body fluid transfers on the outboard aspect of the air bag.

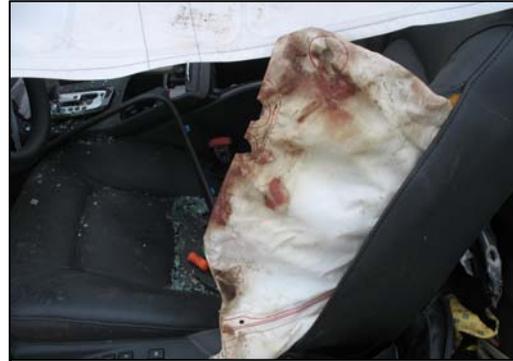
The seat mounted side air bag deployed forward through a 50 cm (20") tear seam in the seatback (**Figure 15**). The tear seam began 16 cm (6.3") below the top of the seatback and extended downward to the seat bight. The air bag membrane was a semi-circular shape and measured 50 cm (20") in height and 22 cm (8.7") in width. The bag was tethered by two 5 cm (2") wide straps. Two 4 cm (1.5") ports on the vertical seam and one 4 cm (1.5") port along the horizontal seam vented the bag. The first vertical vent port was located 20 cm (7.8") forward of the seatback and 11 cm (4.3") below the top aspect of the air bag. The second was located 20 cm (7.8") forward and 17 cm (6.7") below the same. The horizontal port was located 17 cm (6.7") forward of the seatback and along the horizontal seam. The air bag was saturated with blood from the driver and was weathered from the elements. The following nomenclature was stamped on the air bag:

Figure 15 - Deployed driver's seat mounted side air bag.

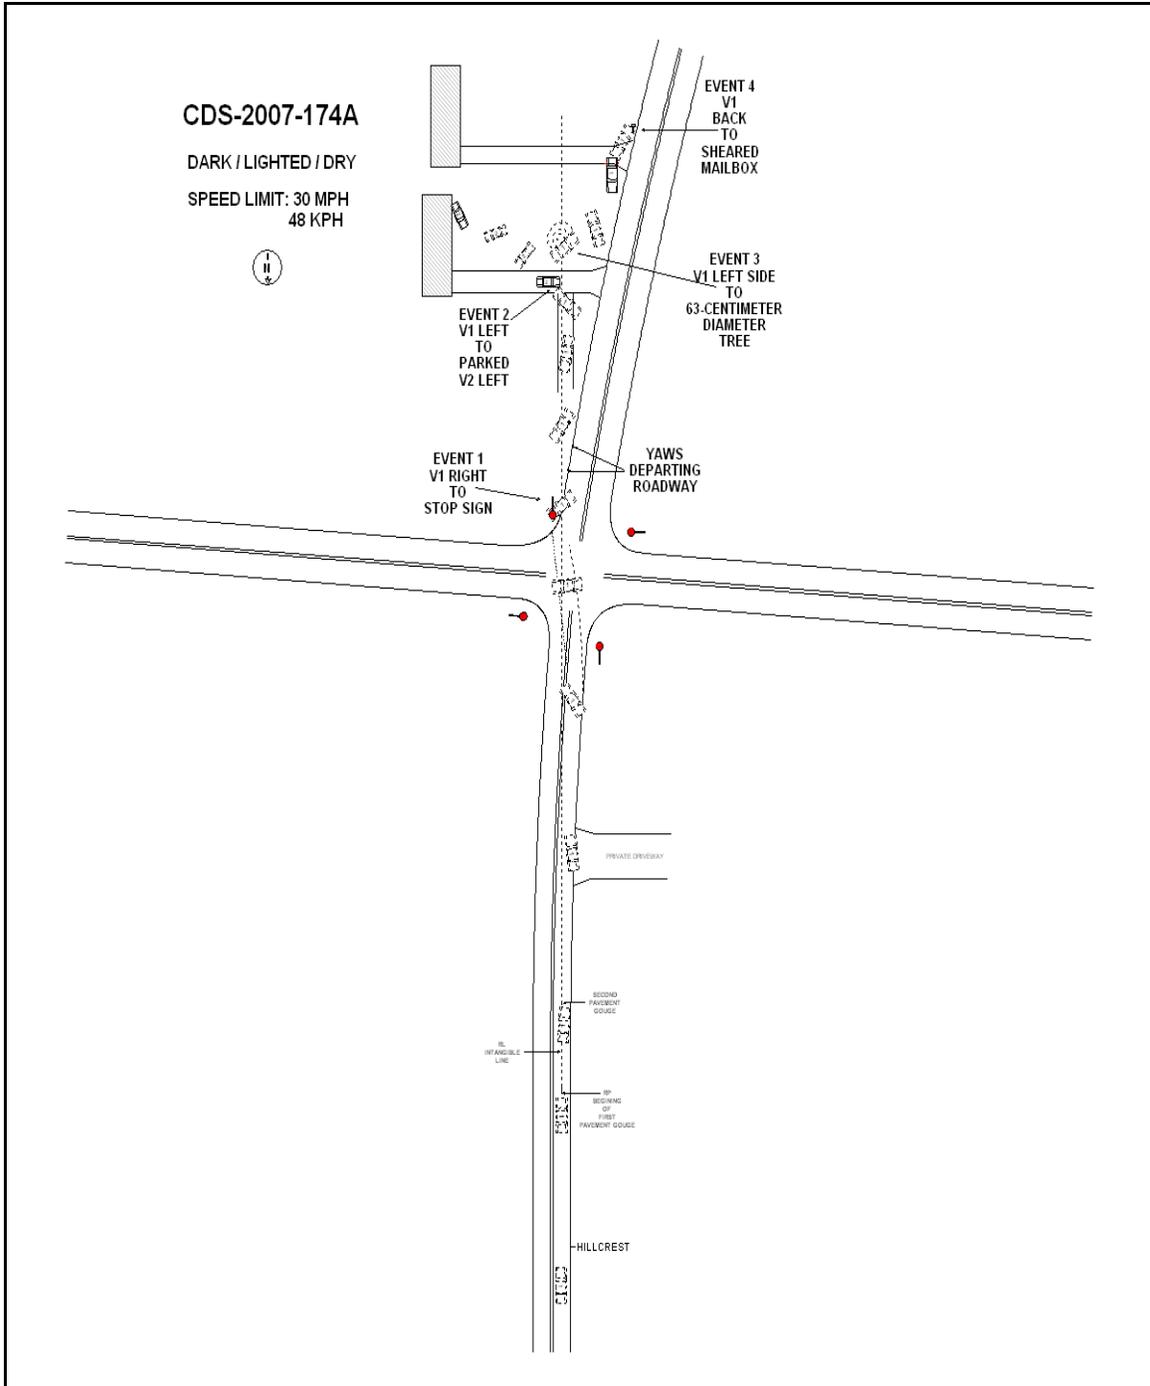
Figure 16 – NASS Crash Schematic

This single vehicle crash occurred during the early morning hours of October 2007 in the state of Tennessee. At the time of the crash, there were no adverse weather conditions and the asphalt roadway surface was dry. The crash occurred on the east roadside of a two-lane, north/south roadway that intersected with a two-lane, east/west roadway. The north/south roadway was curved slightly to the right as it approached the four-leg intersection. Both roadways were configured with one lane in each direction and were delineated by double-yellow painted centerlines. The southbound approach of the north/south roadway ascended to a hillcrest located 67 m (220 ft) south of the intersection and experienced a slope of -10 percent leading to the intersection. The intersection was controlled in all four directions by stop signs on the corners. The roadway environment consisted of residential properties and natural growth. Two driveways leading to private homes were present on the east roadside south of the intersection. The driveways were located 41 m (135 ft) and 48 m (158 ft) south of the intersection, respectively. The 1987 Honda CRX was parked back end first in the first driveway. The posted speed limit for the north/south roadway was 48 km/h (30 mph). The NASS Crash Schematic is attached as **Figure 16** at the end of this narrative report.
