Remote Combination Adaptive Driving Equipment Investigation  
Dynamic Science, Inc. (DSI), Case Number 2007-76-131G  
1990 Ford Bronco  
Arizona  
October 2007

**Dynamic Science, Inc.**  
**Crash Investigation**  
**Case Number: 2007-76-131G**

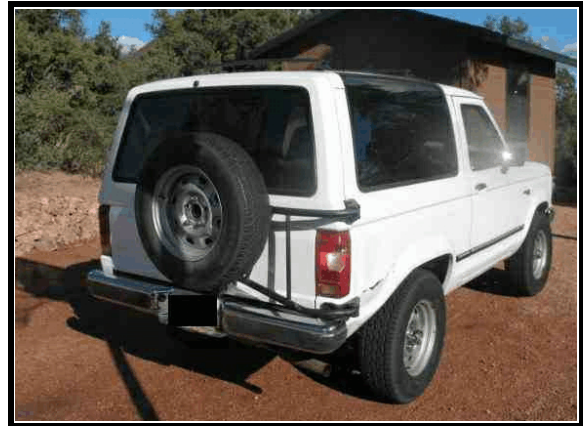
This remote investigation focused on the adaptive controls (mechanical hand controls and a spinner knob) that were installed in a 1990 Ford Bronco II sport utility vehicle (**Figure 1**). The Ford was being driven by a restrained 16-year-old male. The front right seat was occupied by a restrained 14-year-old male. The second row left seat was occupied by a restrained 16-year-old male. The second row right seat was occupied by a restrained 18-year-old male. The other vehicle was a 2007 Kia Sportage sport utility vehicle that was being driven by a restrained 45-year-old male. The front right seat was occupied by a restrained 15-year-old male. The second row left seat was occupied by a restrained 17-year-old male. The second row right seat was occupied by a restrained 15-year-old male. The Ford was traveling northbound in the second lane from the right. The Kia was traveling northbound in the right lane. The adaptive controls became caught on the Bronco driver's pant leg, causing the driver to lose control of the vehicle. The Ford then initiated a sharp right turn, crossed the centerline and traveled into the right lane. The Ford traveled across the path of the Kia, and the Kia's front end contacted the right side rear of the Ford. It was not possible to determine what part of the adaptive control snagged the driver's pants. It was not possible to determine what part of the adaptive control snagged the driver's pants.

**Figure 1.** Subject vehicle, 1990 Ford Bronco II

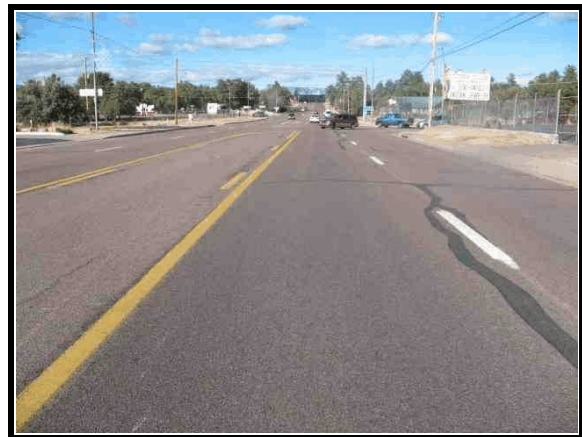
**Figure 2.** Approach to area of impact (north)

This two-vehicle crash occurred on a five-lane, undivided roadway in October 2007 at 2040 hours. At the crash location, there were two northbound lanes separated by a single broken white line (**Figure 2**). This section of the roadway was straight and level. The crash occurred at night, and there were streetlights present. The weather was clear and the asphalt roadway was dry. The posted

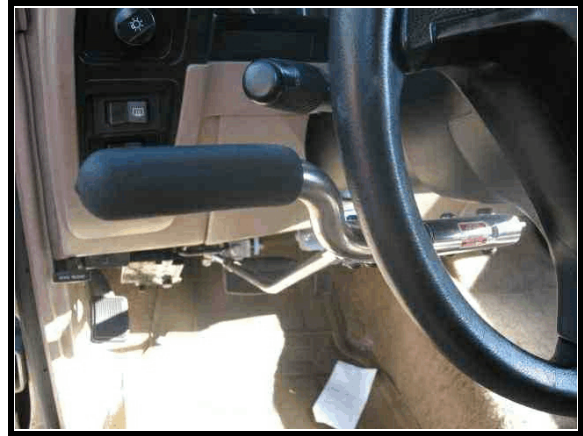
The Ford Bronco was traveling northbound in the second lane from the right. The Kia was traveling northbound in the outboard lane. The Ford was equipped with adaptive hand controls. The adaptive controls became caught on the driver's pant leg, causing the driver to lose control of the vehicle. The Ford then initiated a sharp right turn, crossed the centerline and traveled into the outboard lane.

The Ford Bronco was equipped with push/pull lever operated foot controls and a steering wheel spinner knob (Figures 3-5). The push/pull brake and accelerator lever was mounted on the left side of the steering column and was intended to be operated with the left hand. The control was designed to accelerate when moved forward and to brake when moved rearward. The adaptation was designed for use in a vehicle with an automatic transmission and for a person who is unable to use, or has difficulty using, their legs to operate the pedals for accelerating and braking.

**Figure 3.** Push/pull lever

The 16-year-old driver was seated in an unknown posture. His right hand was on the steering wheel and his left was operating the left side mounted hand control. The Ford was traveling on a straightaway. At some point, the adaptive control snagged on the driver's pant leg. This caused the Ford to veer to the right and contact the Kia Sportage in the right lane. This was a minor impact resulting in no injuries.

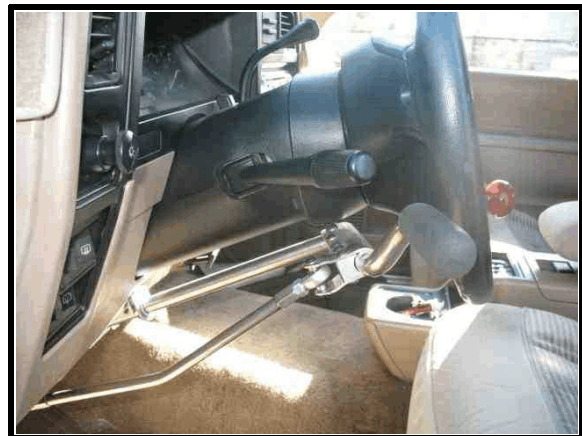
**Figure 4.** Side view of hand control installation

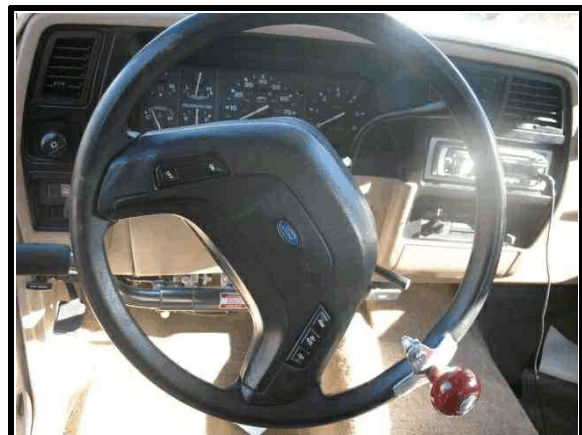
**Figure 5.** Steering wheel spinner knob

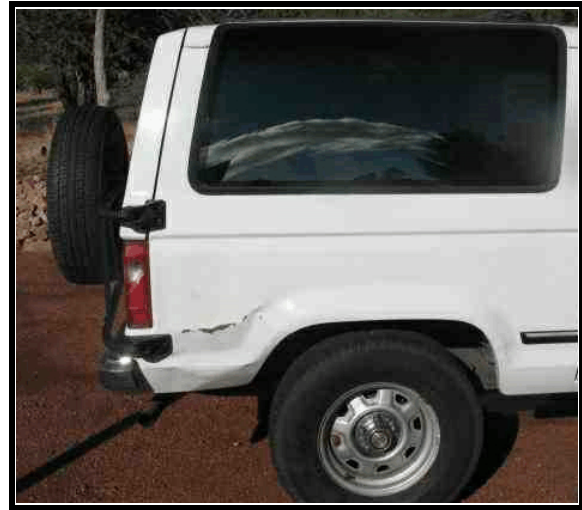
The front left corner of the Kia contacted the right rear quarter panel of the Ford resulting in minor damage. The NASS PSU did not obtain any specific crush measurements from the vehicle; therefore, no delta-V could be calculated.

The Ford sustained minor damage as a result of the impact with the Kia Sportage (**Figure 6**). The Collision Deformation Classification (CDC) for this impact was 03RBEW1. No crush measurements were taken by the NASS PSU.

**Figure 6.** Right side damage to Ford Bronco
