ON-SITE CHILD AIR BAG-RELATED FATALITY INVESTIGATION

CASE NUMBER - IN-07-001

VEHICLE - 1995 FORD MUSTANG

CRASH DATE - April 2006

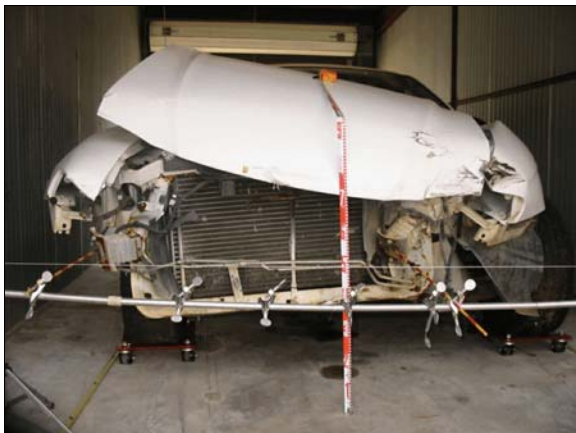
Figure 4: Damage to front of case vehicle from impact with the Five Hundred, vertical scale in tenths of meter

Exterior Damage: The case vehicle’s impact with the Five Hundred involved the totality of the front plane. The front bumper, grille, hood, both headlamp/turn lamp assemblies and the front of both fenders were directly damaged and crushed rearward and to the right. The direct damage began at the front left bumper corner and extended approximately 148 centimeters (58.3 inches) across the front end. The front bumper and front bumper fascia were not present on the vehicle, so the crush measurements were taken to the front unibody structure as well as the end of the bumper bracket on each unibody frame end. Comparison values were subsequently obtained from an exemplar vehicle. Since the primary engagement occurred to the bumper, it was decided that two crush measurements, one taken at each bumper bracket, yielded the most reasonable representation of the frontal crush. As a result, the residual maximum crush was determined to be approximately 26 centimeters (10.2 inches) occurring at C₁. The table below shows the case vehicle’s front crush profile.

Units	Event	Direct Damage		Field L	C ₁	C ₂	C ₃	C ₄	C ₅	C ₆	Direct	Field L
		Width CDC	Max Crush								±D	±D
cm	1	148	26	94	26	20	N/A	N/A	N/A	N/A	0	0
in		58.3	10.2	37.0	10.2	7.9	N/A	N/A	N/A	N/A	0.0	0.0

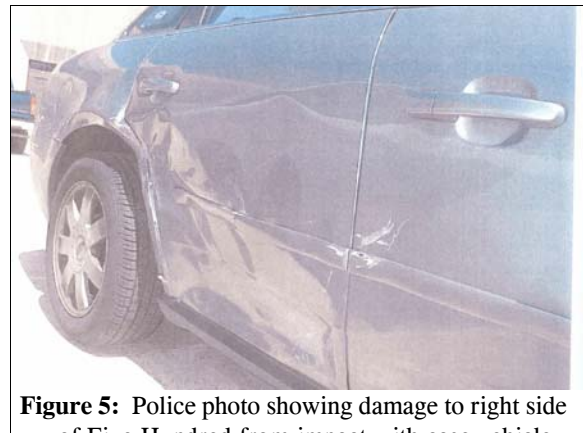
Figure 5: Police photo showing damage to right side of Five Hundred from impact with case vehicle

Exterior Damage: The Five Hundred's impact with the case vehicle involved the right side of the vehicle. The police photographs of the Five Hundred showed that direct damage involved a small portion of the back edge of the right front door, the right rear door, front portion of the right quarter panel, and the right rear wheel.

Damage Classification: Based on the police photographs of the Five Hundred, the CDC was determined to be **02-RZEW-1 (50 degrees)**. The WinSMASH reconstruction program, missing vehicle algorithm, was used to reconstruct the Five Hundred's Delta Vs. The Total, Longitudinal, and Lateral Delta Vs are, respectively: 22.0 km.p.h. (13.7 m.p.h.), -14.1 km.p.h. (-8.8 m.p.h.), and -16.9 km.p.h. (-10.5 m.p.h.). The crash fit the reconstruction model and the results were borderline but appeared reasonable. The Five Hundred was driven from the scene by the driver.

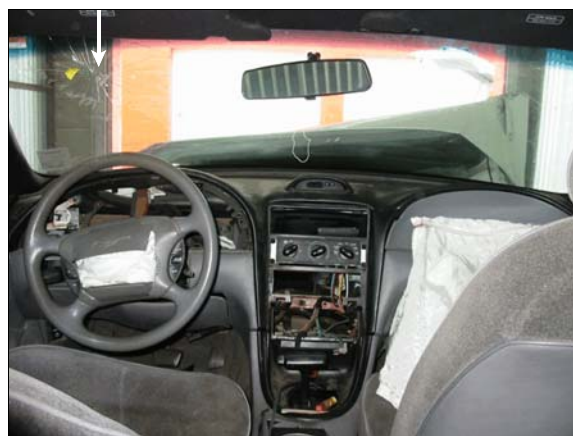
Vehicle Interior: Inspection of the case vehicle's interior revealed a "star burst" type fracture to the windshield left of the centerline of the steering wheel due to driver head contact (**Figure 7**). A few possible fluid spots were observed on the front right passenger's air bag. No other evidence of possible occupant contact was noted in the case vehicle's interior. Finally, there was no passenger compartment intrusion, and no evidence of compression of the energy absorbing steering column or deformation of the steering wheel.

Figure 7: Overview of case vehicle's front seat area, arrow shows "star burst" type fracture to windshield from driver's head contact

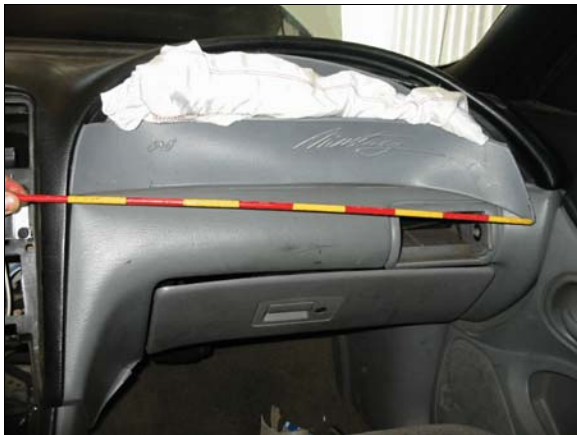
The case vehicle's front right passenger air bag was located in the middle of the right instrument panel (**Figure 8** below). The air bag module cover consisted of two cover flaps made of thick, pliable, vinyl. The upper cover flap was semi-circular in shape while the lower cover

Figure 8: Case vehicle's front right passenger air bag module, lower cover flap

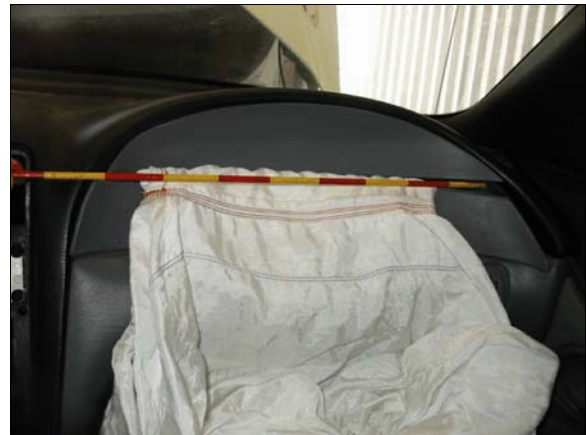
Figure 9: Case vehicle's front right passenger air bag module, upper cover flap

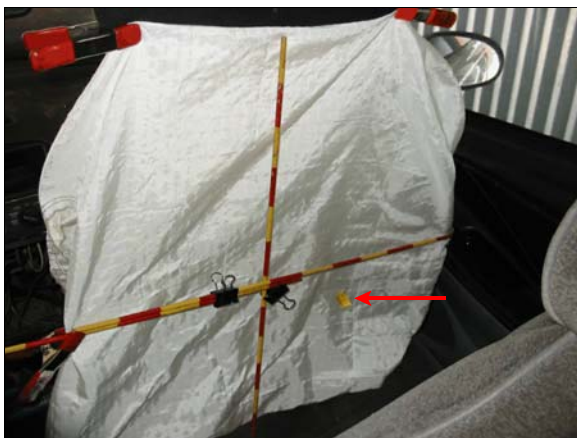
Figure 10: Case vehicle's front right passenger air bag, arrow shows location of small reddish/brown spot

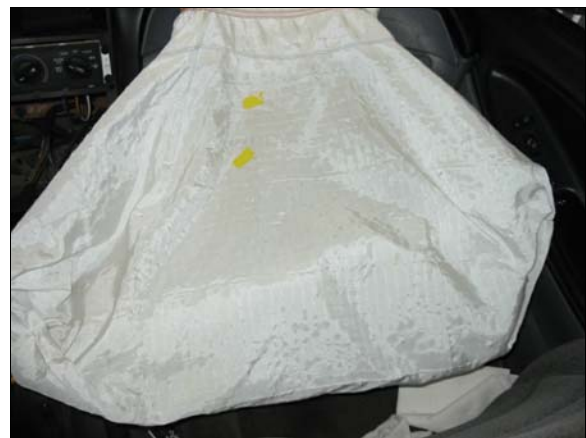
flap was trapezoidal-shaped. The upper cover flap was approximately 41 centimeters (16.1 inches) in length and 7 centimeters (2.8 inches) in height at the center. The lower cover flap was approximately 46 centimeters (18.1 inches) in length and 7.5 centimeters (3 inches) in height. The distance between the leading edge of the instrument panel and the leading edge of the module cover flaps was approximately 5.5 centimeters (2.2 inches). The distance between the mid-center of the front right passenger's seat back, as positioned at the time of the vehicle inspection, (i.e., seat at full forward position, seat back slightly reclined) and the front surface of the air bag's fabric at approximate full excursion was approximately 9 centimeters (3.5 inches). An inspection of the air bag module cover flaps and the air bag fabric revealed that the cover flaps opened at the designated tear points. There was no evidence of damage or occupant contact to the cover flaps (Figures 8 and 9). The deployed front right passenger air bag (Figure 10) was square with a height and width of approximately 60 centimeters (23.4 inches). The air bag was designed without tethers and had one vent port located on the left side of the air bag at the approximate 10:30 o'clock position. The vent port was 6 centimeters (2.4 inches) in diameter. Inspection of the air bag revealed no evidence of skin or cloth transfer. However, a reddish-brown spot was observed on the lower front right quadrant of the air bag (Figure 10) and a few yellow spots were noted on top of the air bag (Figure 11). It is possible these spots were fluid stains related to contact with the front right passenger.

Figure 11: Top of case vehicle's front right passenger air bag, yellow tape shows location of small yellow spots

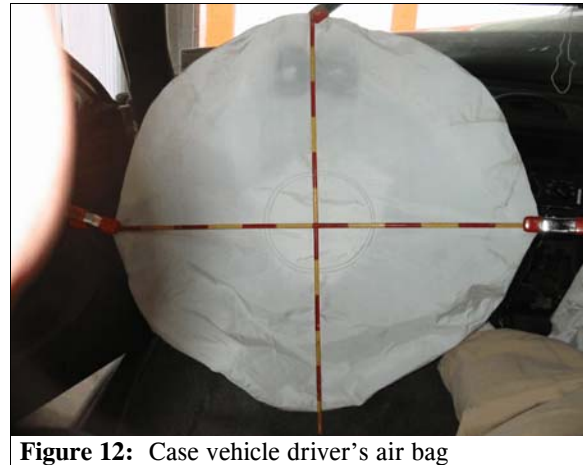
The case vehicle's driver air bag was located in the steering wheel hub. An inspection of the air bag module cover flaps and the air bag fabric revealed that the cover flaps opened at the designated tear points. There was no evidence of damage during the deployment to the air bag module cover flaps or the air bag. The deployed driver's air bag (**Figure 12**) was round with a diameter of approximately 62 centimeters (24.4 inches). The air bag was designed with three tethers, each 7.5 centimeters (3 inches) in width and had two vent ports, each 2.5 centimeters (1 inch) in diameter, located at the 11 and 1 o'clock positions. Inspection of the air bag was unremarkable. There was no evidence of occupant contact to the air bag.

Figure 12: Case vehicle driver's air bag

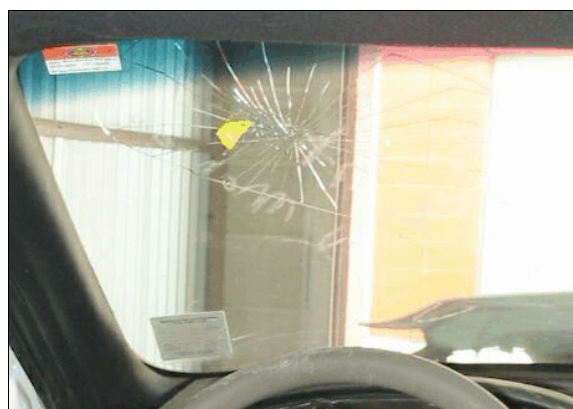
Although the driver stated she was restrained by the lap-and-shoulder safety belt, the evidence indicated she was not restrained. Inspection of the safety belt assembly showed no evidence of loading, and the driver's head contacted and fractured the windshield during the crash.

Figure 13: “Starburst” type fracture to the windshield due to contact by unrestrained driver’s head
