**NOT-IN-TRAFFIC SURVEILLANCE
CALSPAN REMOTE BACK OVER FATALITY INVESTIGATION**

SCI CASE NO: CA07-004

VEHICLE: 1996 CHEVROLET K1500 PICKUP

CRASH DATE: OCTOBER, 2006

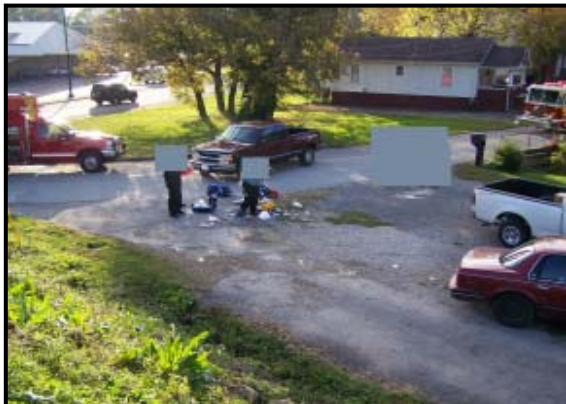
Figure 6: Overall view of the crash site.

Figures 6 through 9 are a series of on-scene police photographs obtained from the investigating police officers. The photographs depict the rest final position of the Chevrolet in relation to the parking lot. The police investigators were unclear as to which tire backed over the child. The relative positions of the truck, final rest position of the child and the mud puddle suggested the child was probably knocked down by the left aspect of the rear bumper and contacted by the left rear tire. The police investigators did not identify any physical evidence of the crash on the Chevrolet. There was no identifiable physical evidence on the pickup truck in the police photographs.

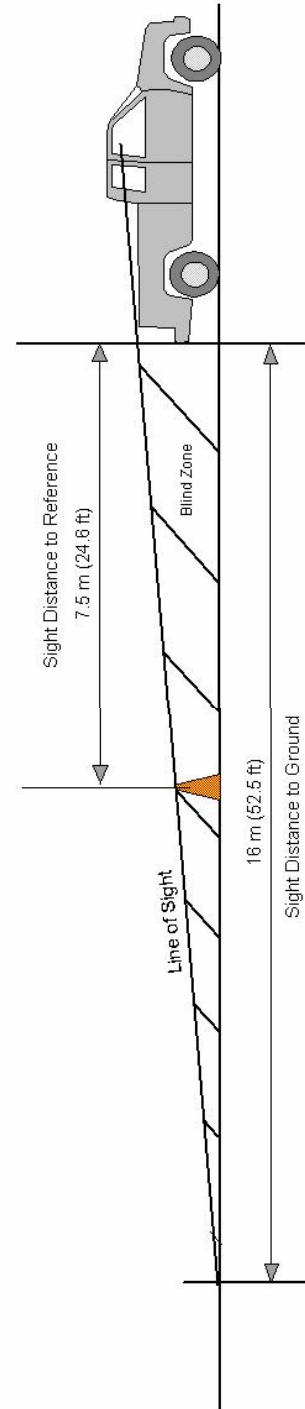
Figure 10: Exemplar Vehicle Visibility Diagram

The baseline rear visibility of an exemplar Chevrolet was measured in a level parking lot. The stature of the subject driver was not known, therefore, a 183 cm (72 in) tall substitute driver was used for this baseline visibility study. A 71 cm (28 in) tall red reflective target was placed on the vehicle's centerline and moved rearward to a location where the substitute driver could first see the red target by looking over his right shoulder. The centerline visibility distance was measured from the rear bumper. A second measurement was taken with the target placed at ground level. The measured distance is summarized below and depicted in a diagram attached to the end of this report, **Figure 10**.

- Sight distance to 71 cm (28 in) target: 7.5 m (24.6 ft)
- Sight distance to ground level target: 16 m (52.5 ft)

Given that the child knelt down to play at the mud puddle, his height would have been an estimated 61 cm (24 in) above ground. It was estimated by the police that the mud puddle was 1.5 m (5 ft) rearward of the Chevrolet's rear bumper. Based on the measured sight line, the child would not have been visible to the driver prior to backing.

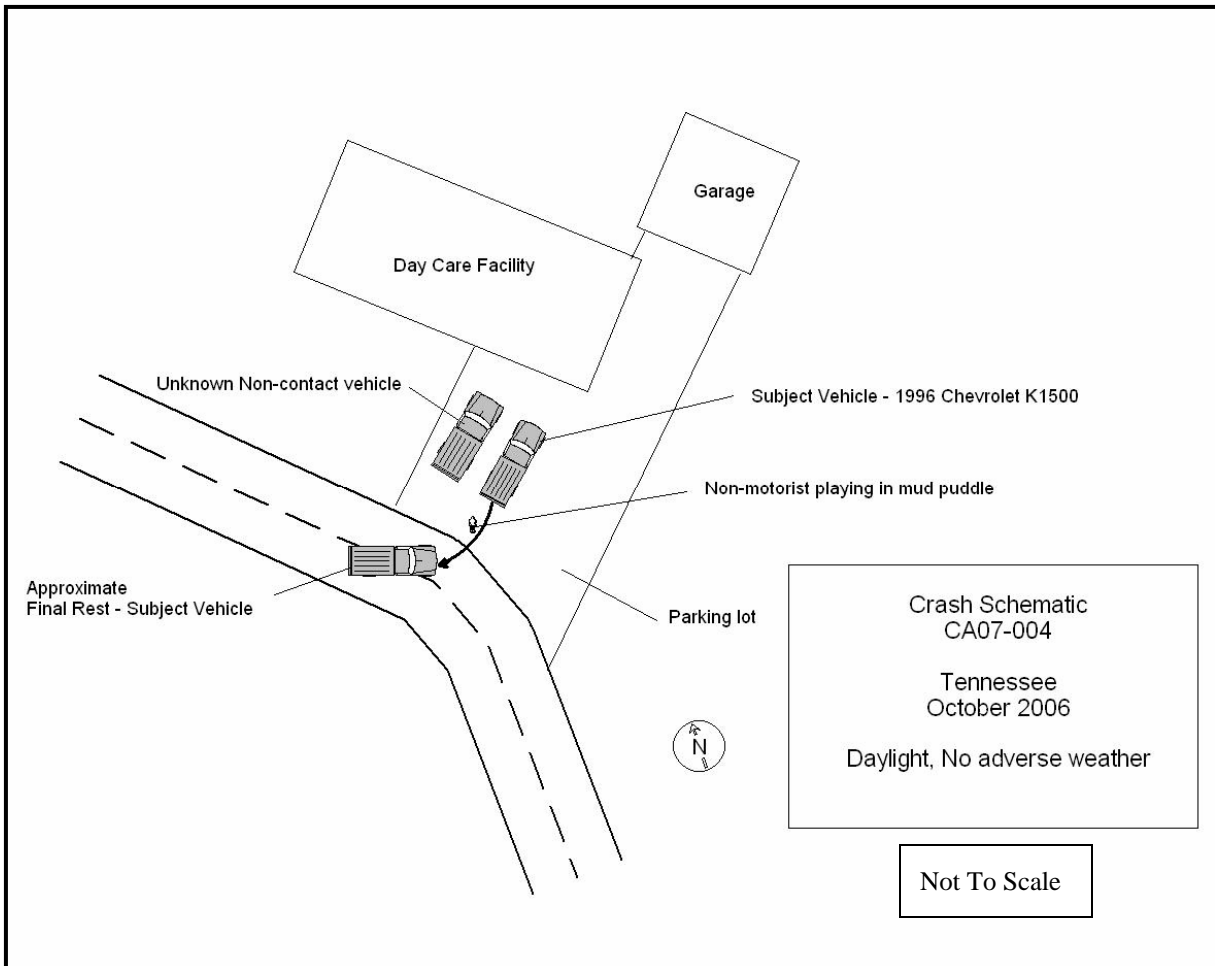
Figure 11: Crash schematic.

During these actions, the female driver of the adjacent truck exited the facility and was securing one of her other children in a child safety seat. The subject child exited the adjacent truck, walked behind the subject vehicle and knelt down to play in a mud puddle that was located near the road edge approximately 1.5 m (5 ft) behind the Chevrolet. The driver of the Chevrolet entered and started his vehicle and began to back out of the parking lot. A schematic of the crash is included at the end of this report as **Figure 11**.

The vehicle backed up and the driver steered the vehicle in a clockwise arc as it reached the road pavement. The driver recalled "feeling" a bump as he backed up. However, he thought the bump was caused by the transition from the gravel parking area to the asphalt pavement at the road edge. As the left front of the vehicle cleared the parking area, the driver observed the subject child lying adjacent to the mud puddle. He then realized that he had backed over him. The police estimated the Chevrolet backed up approximately 1.5 (5 ft) from its initial position to the impact. A reconstruction based on the available police photographs indicated the Chevrolet backed up an estimated 9.1 m (30 ft) from impact to final rest.
