Rollover Investigation / Vehicle to Object
Dynamic Science, Inc. / Case Number: DS07005
2006 Chevrolet Colorado
California
December 2006

1. Report No. DS07005	2. Government Accession No.		3. Recipient Catalog No.	
4. Title and Subtitle Rollover Investigation		5. Report Date May 22, 2007

14. Sponsoring Agency Code		
15. Supplemental Notes				
16. Abstract This on-site investigation focused on the rollover event and the Certified Advanced 208-Compliant air bag system in a 2006 Chevrolet Colorado pickup. The manufacture of this vehicle certified that it met the requirements of Federal Motor Vehicle Safety Standard No. 208. This single vehicle crash occurred in December 2006 at 0030 hours. The crash occurred in northbound lanes of a four-lane divided interstate highway. The case vehicle was being driven by a 25-year-old male. The driver of a non-contact vehicle apparently changed lanes to the right. The driver of the case vehicle steered to the right, crossed a narrow shoulder, and struck a concrete barrier on the right side of the roadway. The vehicle then rolled onto its left side. The vehicle came to rest blocking the second and third lanes of traffic. There were no reported injur

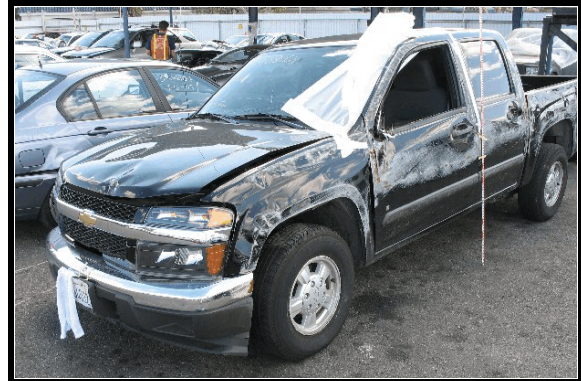
Figure 1. 2006 Chevrolet S10, left side rollover damage

There was moderate damage to the left side of the vehicle that occurred during the rollover. There was 490 cm (192.9 in) direct contact that extended 60 cm (23.6 in) forward of the front axle to the left tail light. The height of the direct damage on the left side was 115 cm (45.3 in). Maximum crush of 2 cm (0.8 in) was located at the B pillar. The CDC for the rollover was 00LDAO2.

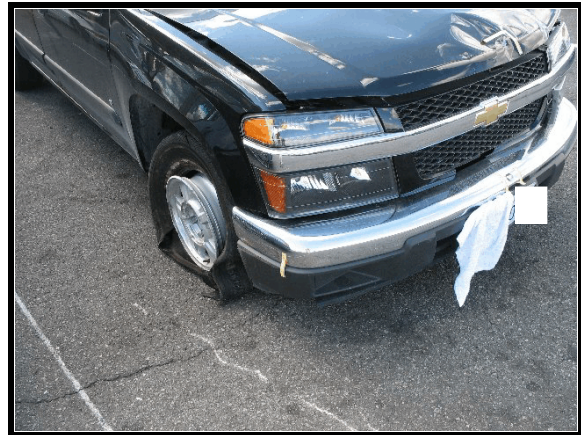
Figure 2. Front right bumper corner damage

The 2006 Chevrolet pickup sustained minor damage to right front of the vehicle due to contact with the barrier and curb. The direct damage began at the front right bumper corner area and extended 84 cm (33.0 in) rearward along the right side, including contact to the rim. The rim was damaged and the tire was flattened. As the vehicle began a clockwise rotation, the front of the vehicle contacted the curb. There was 36 cm (14.2 in) direct contact to the air dam that began 5 cm (2.0 in) right of the vehicle center line. The vehicle also struck a delineator post with its front end. There was 8 cm (3.1 in) direct damage to the hood line that began 11 cm (4.3 in) left of the vehicle center line. There was 7 (2.8 in) direct contact to the bumper that began 3 cm (1.2 in) left of the vehicle center line. The Collision Deformation Classification (CDC) for the initial barrier impact was 12RFES2. The CDC for the curb impact was 10FZLN1. The CDC for the delineator impact was 10FCEN1.

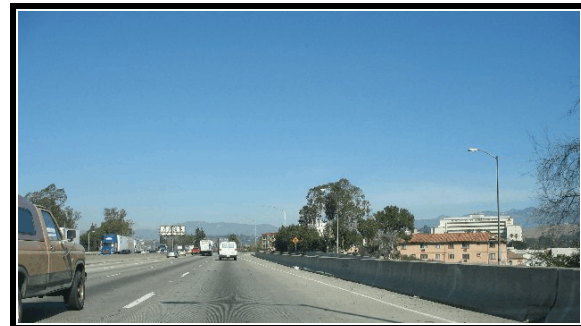
Figure 3. Approach to area of impact (north)

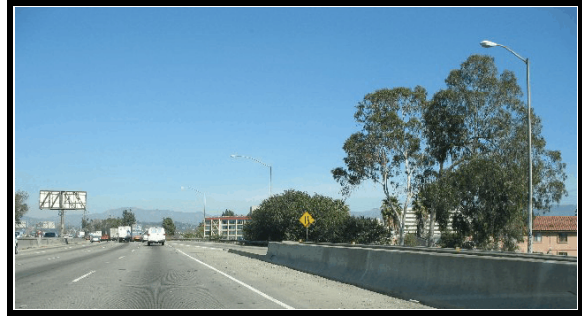
Figure 4. Area of impact (north)

The driver of the Camaro put on his turn signal and began to change lanes to the right. The driver of the Chevrolet Colorado steered to the right, crossed a narrow shoulder, and struck end of the concrete barrier and the curb with the right side of the front bumper and the right front tire. The tire blew out and the vehicle began a clockwise rotation. The front of the vehicle, at the air dam level, scraped along the curb. There were indications that the Colorado contacted a delineator with the hood and bumper as the vehicle rotated. The vehicle continued rotating until it tripped and rolled onto its left side. The vehicle came to rest blocking the second and third traffic lanes.

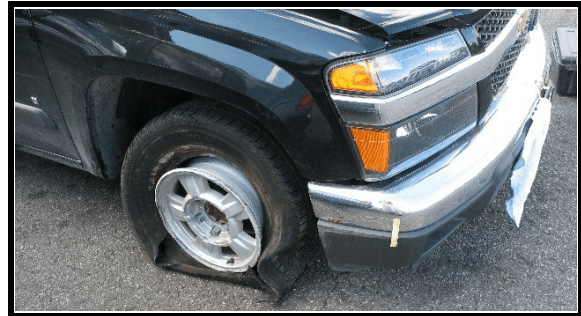
Figure 5. Initial impact, right corner

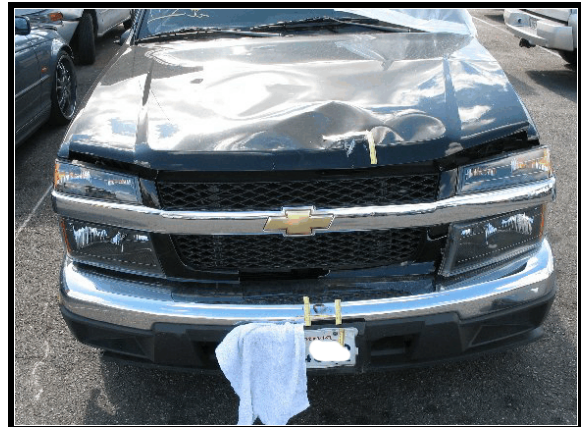
Figure 6. Contact damage during rotation

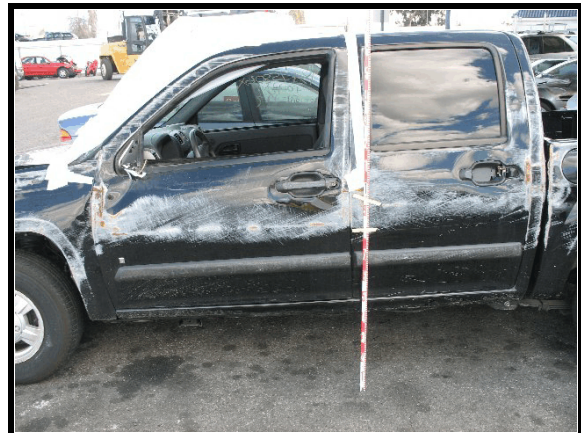
Figure 7. Overview of left side rollover damage

The mirror on the left side was knocked off as was the handle to the left rear door. All doors, however, remained closed and operational.

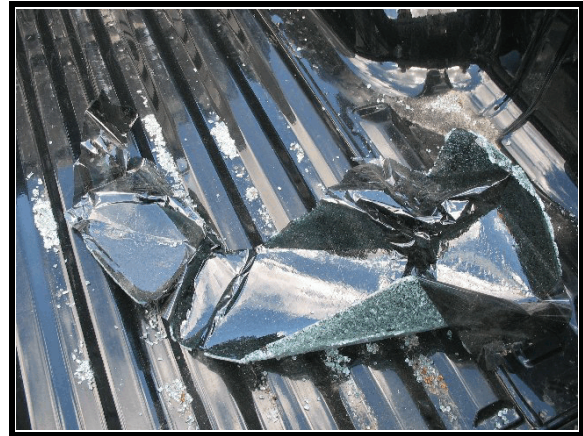
The left front side glass disintegrated during the rollover. The glass was tinted using a plastic film. The film held the glass fragments in place. The windshield was fractured on the left side, primarily near the left A-pillar.

Figure 8. Left front side glass

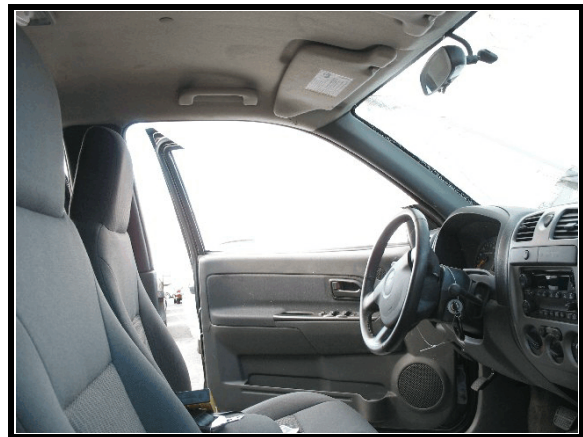
The 25-year-old male driver was likely seated in an upright manner and was not restrained by the manual lap and shoulder belt. The seat track was in the full rearward position. The seat back angle was 21 degrees from vertical; the seat bottom angle was 10 degrees from horizontal. There were no indications of any driver braking. At impact with the curb, the driver did not experience any significant motion and stayed in place. As the tire deflated, and the vehicle began its clockwise rotation, the driver was displaced slightly to the left. As the vehicle overturned onto its left side, the driver contacted the side door panel, but there were no indications of any damage or injury. The driver was able to exit the vehicle under his own power. There were no reported injuries.

Figure 9. Driver's seated position
