**NOT-IN-TRAFFIC SURVEILLIANCE
CALSPAN REMOTE POWER WINDOW FATALITY INVESTIGATION**

SCI CASE NO.: CA07-010

**VEHICLE: 2007 PONTIAC VIBE
LOCATION: MICHIGAN
DATE: DECEMBER 2006**

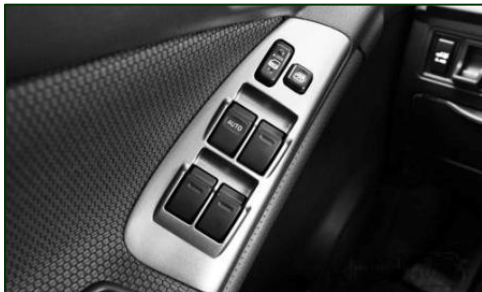
The Pontiac Vibe was a four-door station wagon that was identified by Vehicle Identification Number (VIN) 5Y2SL65807Z (production number deleted). The passenger compartment of this vehicle was configured with front bucket seats with adjustable head restraints and a three-passenger rear bench with split, forward folding seat backs. The rear outboard positions were equipped with adjustable head restraints. Standard equipment also included power windows for the four doors with the driver's switch console mounted to the forward aspect of the driver's door panel (**Figure 2**).

Figure 2. Driver's door power window switch console (exemplar vehicle).

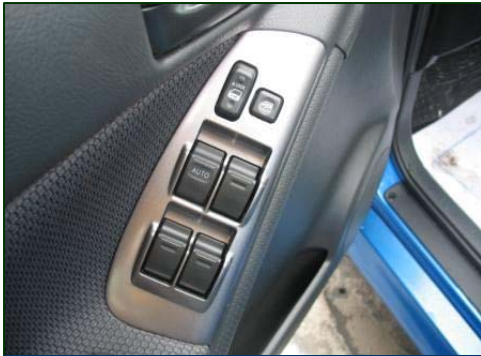
An exemplar 2007 Pontiac Vibe was inspected at a local new car dealership. By coincidence, the temperature at the time of this inspection was approximately 4 degrees C (40 degrees F), similar to the temperature at the time of this incident. A cursory inspection of the power window switches was conducted. The driver's power window switch console was located at the forward aspect of the integrated door panel armrest (**Figure 4**). The switches were arranged in a two-by-two cluster with the front door switches forward of the rear door switches. The driver's door window was the only window equipped with the auto-down feature. This was achieved by depressing the forward aspect of the switch and momentarily holding the switch to activate the auto-down mode. Upon releasing pressure on the switch, the window powers to the full down position. To raise any window from the driver's position, the forward aspect of the switches required upward pressure. This window and the other door windows were NOT equipped with an auto-up feature. A lock-out switch to turn-off the door switches for the front right passenger and rear doors was positioned at the top right aspect of the driver's switch console. This function required depressing the switch to the detent that disabled the other door window switches and pressing again to restore the door switch functions.

It is suspected that this switch was not activated to the lock-out mode at the time of this incident.

Figure 4. Driver's power window switch console (exemplar vehicle).

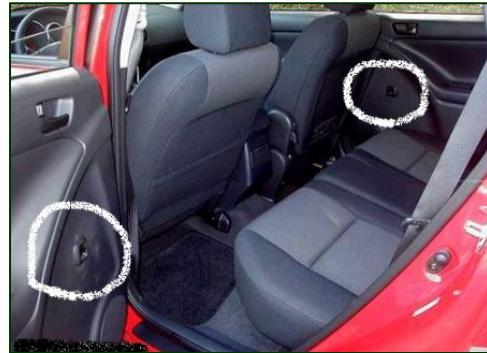
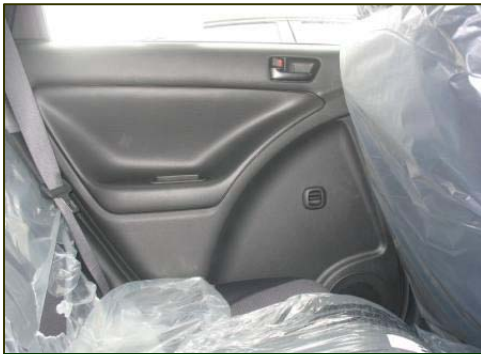
Figure 5. Rear door window switches on an exemplar Pontiac Vibe.

The rear door power window switches were mounted on the vertical surface at the forward third area of the rear door panels (**Figures 5 and 6**). The rear door window switches were spring return toggle-type switches (**Figure 7**) that measured 25 mm (1") in width and 6 mm (0.25") in height. The switches rested in the neutral position and moved approximately 3 mm (0.125") in both the up and down directions for window operation. The switches required constant pressure to operate the windows. Once pressure is removed from the switch, it automatically returns to the neutral position and the window immediately stops. The switch was considered a light-duty switch that required minimal effort to operate the switch.

Figure 6. Left rear door panel and power window switch of an exemplar vehicle.

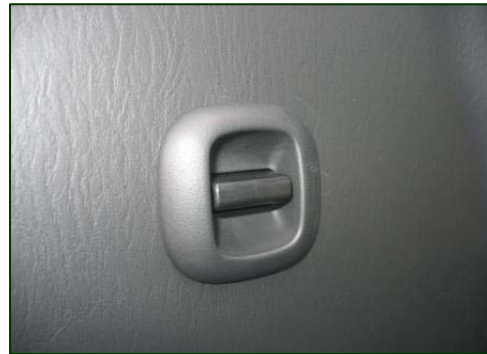
Figure 7. Close-up view of the exemplar left rear door power window switch.

The switches were mounted within a trim face plate that had outside dimensions of 5 cm (2 1/16") horizontally and 5 cm (2") vertically. The toggle switch was recessed approximately 2 mm (1/16") from the trim plate. The midpoint of the toggle switch was positioned 31 cm (12.375") below the top sill of the door panel, 18 cm (6.9") aft of the leading edge of the door panel, and 37 cm (14.375") above the left rear door sill. Additionally, the center point of the switch was located 3 cm (1.25") forward of the leading edge of the left rear seat cushion.

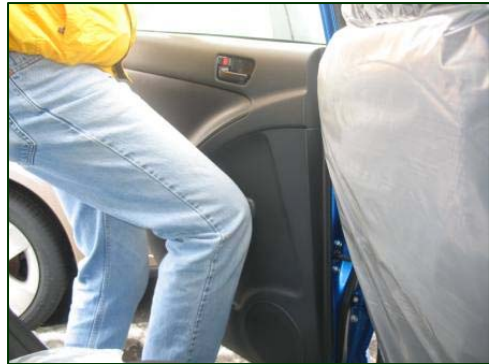
During the inspection of the exemplar vehicle, an SCI investigator was able to activate the power window switch with his right knee. The switch required constant pressure to raise the window. This is depicted in **Figure 8**.

Figure 8. SCI investigator activating power window switch with his right knee.

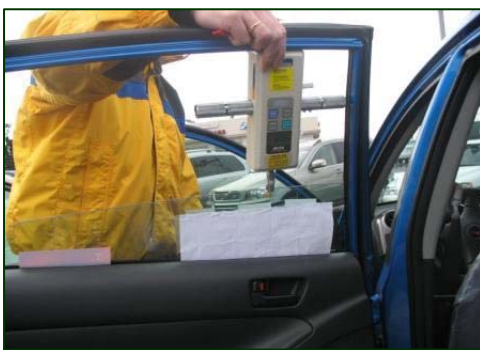
The closing force of the left rear power window of the Exemplar 2007 Pontiac Vibe was tested by the SCI team using an IMADA Digital Force Gauge that was calibrated to 311 N (70 lbs) of force on 11/6/2006. The gauge consisted of a plunger with a duck-bill cut on the bottom that was placed over the top surface of the glazing. The top of the gauge was positioned against the top of the door window frame. **Figure 9** is a view of the force gauge positioned in the window frame. The power window was raised using the driver’s door mounted window switch. With the gauge in position and no force applied to the unit, the digital read-out was zeroed out. The window was closed against the gauge using the driver’s door switch. The method was repeated several times. The procedure was also repeated using the left rear door window switch to close the glazing against the gauge. The gauge displaced readings of 282.5-286.5 N (63.6-64.4 lbs) of force (**Figure 10**). The window stalled against the gauge at these readings and maintained the readings when pressure was released from the power window switch. It should be noted that these closure force measurements were taken with the engine off, on battery power only.

Figure 9. Force gauge positioned in the left rear window of the exemplar vehicle.

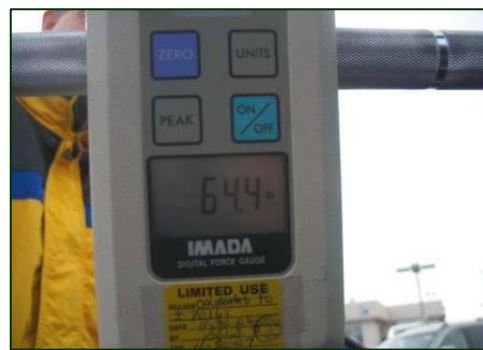
Figure 10. Highest reading exerted by the power window with battery power only.

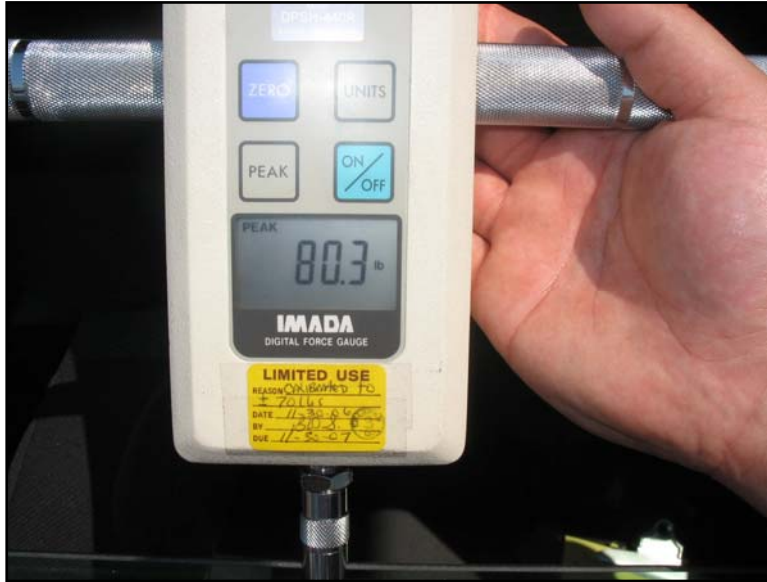
A second series of closure force measurements were taken with the engine running. The peak closure force measured 356.8 N (80.3 lbs). Refer to **Figure 11**. The typical measured force after the closing window stalled against the force meter ranged from 335.0-343.4 N (75.4-77.3 lbs).

Figure 11. Peak closure force with the engine running.
