NOT-IN-TRAFFIC SURVEILLANCE CALSPAN REMOTE BACK OVER INVESTIGATION

SCI CASE NO.: CA07-024

VEHICLE: 2001 JEEP CHEROKEE

CRASH DATE: JUNE 2007

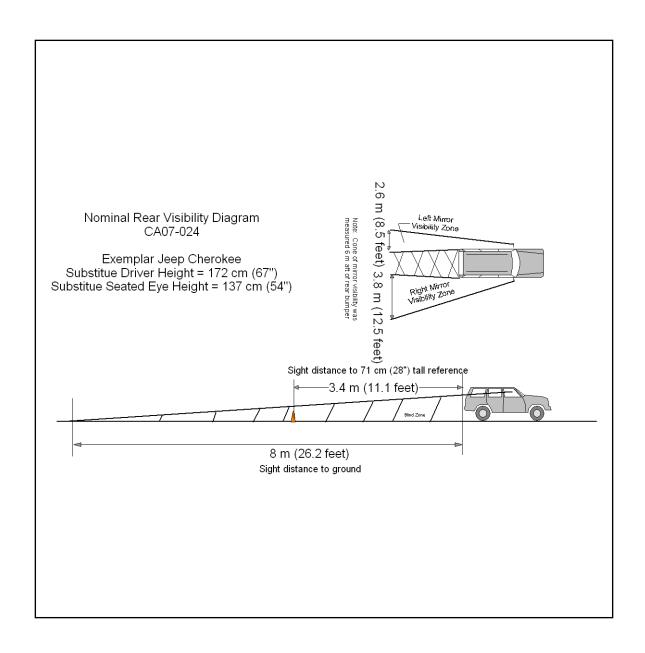
Figure 6: Rear Visibility Diagram

A 71 cm (28 in) tall red reflective target was placed on the vehicle's centerline and moved rearward to a location where the substitute driver could fully see the red target by looking at the rearview mirror. The centerline visibility distance was measured from the rear bumper to the location of the target and to the visible ground location. The visibility distance is summarized below and depicted in a diagram attached as (**Figure 6**):

Sight distance to 71 cm (28 in) target: 3.4 m (11.1 ft)
Sight distance to ground level target: 8 m (26.2 ft)

Cones of visibility were also established using the outside mirrors. A 6 m (20 ft) distance from the rear bumper was used as an arbitrary reference location. The substitute driver was asked to locate the 71 cm (28 in) target using the outside mirrors. The target location was then measured from the centerline of the vehicle. The cone for the left mirror began inboard of the vehicle centerline and extended 2.6 m (8.5 ft) left. The cone for the right mirror began inboard of the vehicle centerline and extended 3.8 m (12.5 ft) right.

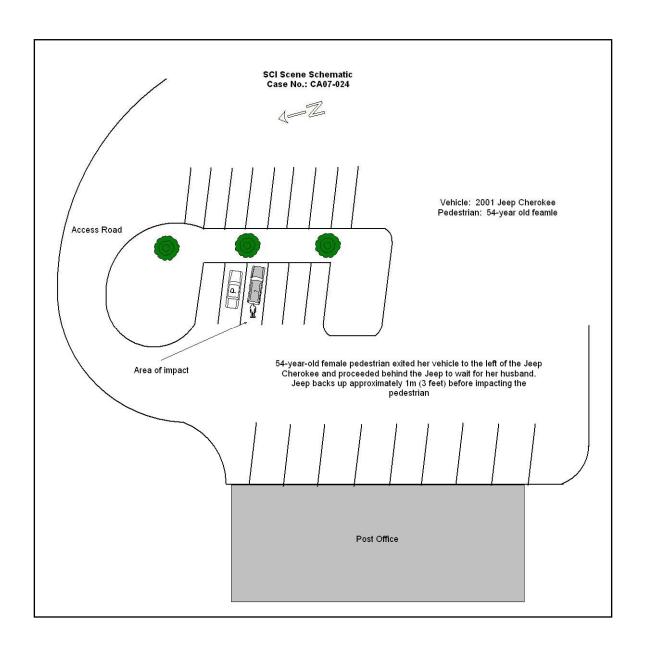
Figure 7: Scene Schematic

service road began at the roadway and circled the parking area. The parking lot was configured with numerous diagonally oriented parking spaces. The parking spaces measured 3 meters (9.8 feet) wide and 9.6 meters (31.5 feet) in length. A raised curbed median that contained crushed stone and landscaping was located in the center of this parking lot. The Scene Schematic is included at the end of this report as **Figure 7**.
