CALSPAN ON-SITE BACK OVER INCIDENT INVESTIGATION

SCI CASE NO.: CA07-025

VEHICLE: 2002 CHEVROLET YUKON XL

CRASH DATE: JULY 2007

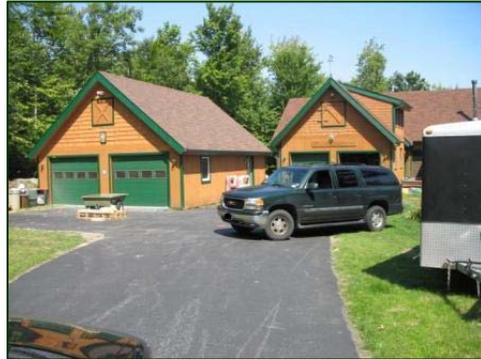
Figure 1. Overall view of the scene and the final rest position of the GMC Yukon.

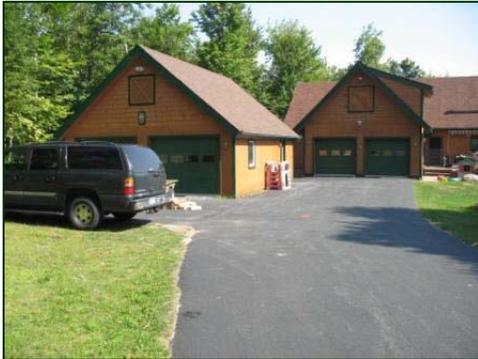
Figure 2. Overall view of the incident site.

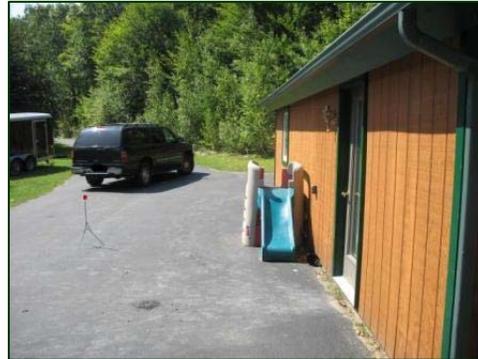
Figure 3. Trajectory of the child pedestrian.

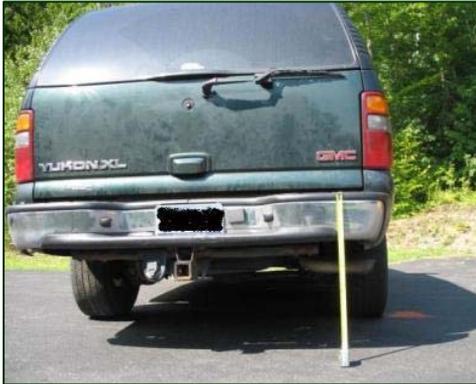
Component	Measurement From Ground
Beltline at mid point of the right rear quarter window	131 cm (51.5”)
Base of backlight	129 cm (50.75”)
Bottom of rear bumper	50 cm (19.5”)
Top of rear bumper	70 cm (27.75”)
Undercarriage	
Bottom of receiver hitch (without ball mount)	37 cm (14.25”)
Hitch safety chain plate	35 cm (13.75”)
Spare tire	34 cm (13.375”)
Tailpipe	32 cm (12.5”)
Sway bar	12 cm (10.5”)
Sway bar bracket	24 cm (9.5”)
Differential	21.2 cm (8.375”)
Axle tube	12.25 cm (12.25”)

Figure 5. Back view and bumper height of the GMC Yukon.

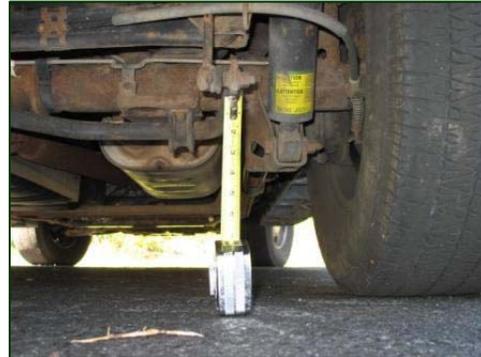
Undercarriage	
Rear shock mount	20 cm (8")

Figure 6. Undercarriage components and height of sway bar stabilizer mount.

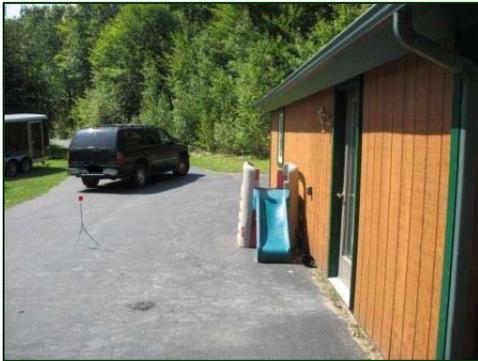
His 19-month old son proceeded up the driveway (**Figure 7**), heading in a westerly directly toward the Yukon that was parked straddling the west edge of the driveway turnaround (**Figure 8**). The vehicle was parked facing in as northerly directly with the right side exposed to the path of travel of the pedestrian non-motorist.

Figure 7. Trajectory of the child pedestrian.

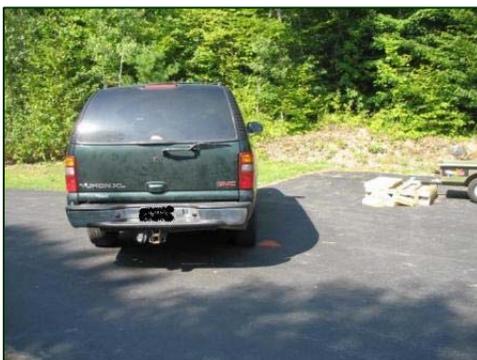
As the driver backed the approximate length of the Yukon and while turning counterclockwise, the back right bumper area of the GMC struck the child and knocked him to the asphalt driveway surface (**Figure 9**). This contact sequence was not detected by the driver as he continued on his backing trajectory. The right rear tire subsequently ran over the child resulting in fatal head injuries. The driver felt the thump associated with the run over and stopped the vehicle within 4.5 meters (15'). **Figure 10** is a view of the final rest positions of the GMC and the pedestrian (arrow).

Figure 9. Backing trajectory of the Yukon to impacts with the child pedestrian.

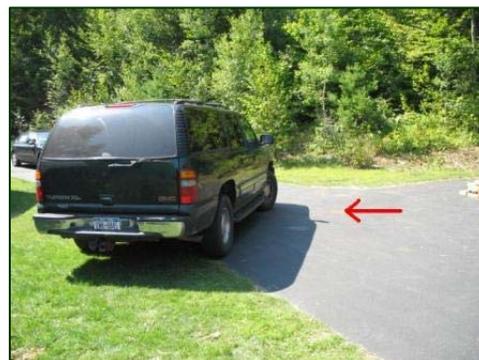
Figure 10. Final rest positions of the Yukon and child (arrow)

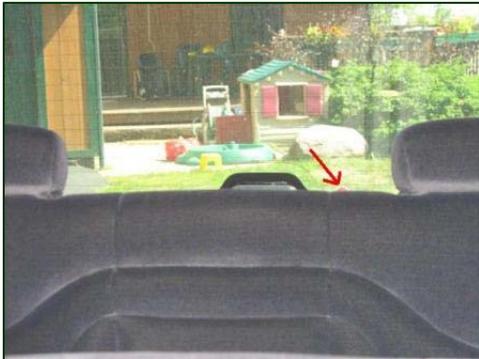
The driver was utilized for this rear visibility procedure. He was positioned in the driver's seat and an eye height of 154 cm (60.5") was measured vertically from the driveway surface. He noted that he routinely turns his head to the right and looks directly out the backlight during all backing maneuvers. This procedure was repeated for the driver's detection of the 71 cm (28") tall red reflective target that was placed behind the vehicle. He fully observed the target 5.7 m (18.6') from the rear bumper (**Figure 11**). The driver extended his line of sight to where it intersected the ground. This point measured 12 m (39.5') from the rear bumper. **Figure 12** is a view of the reflective target in the right outside mirror.

Figure 11. Rear visibility of the 71 cm reflective target.

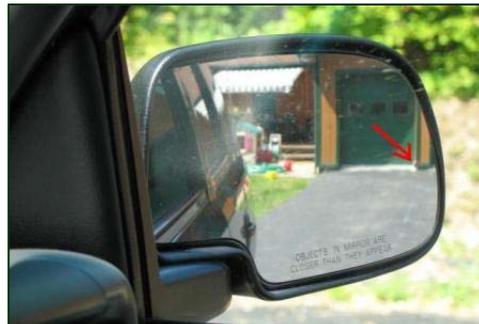
Figure 12. Target visibility in the right outside mirror.

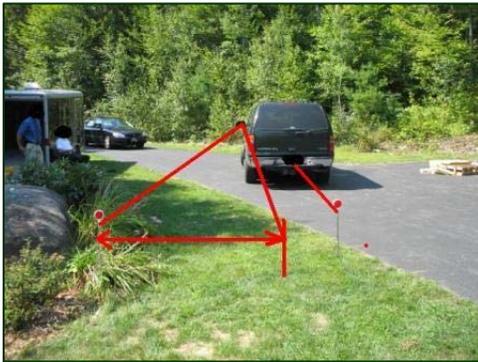
Cones of visibility were established using the outside rear view mirrors. These mirrors were mounted to the vehicle 314 cm (123.5") forward of the rear bumper. An arbitrary distance of 5.7 m (18.6') from the rear bumper was used to establish the lateral lines of sight. Again, the involved driver was utilized for this exercise. From the driver's position, the left rear view mirror provided a line of sight that extended 0.2 m (0.5') inboard of the left rear corner and extended 1.6 m (5.1') laterally outboard of the referenced corner (**Figure 13**). The right outside rear view mirror provided the driver with a lateral line of sight that began at the corner position and extended 2.8 m (9.3')

Figure 13. Cone of visibility from left outside mirror.

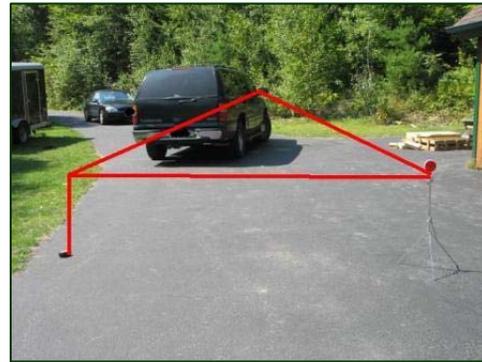
outboard of the vehicle body line (**Figure 14**). The Nominal Rear Visibility Diagram is included as **Figure 15**.

Figure 14. Cone of visibility from the right outside mirror.
