ON-SITE NOT IN TRAFFIC SURVEILLANCE BACK OVER INVESTIGATION

CASE NUMBER - IN-07-025
LOCATION - NEW MEXICO
VEHICLE - 2002 FORD F-150 SUPERCAB
CRASH DATE - March 2007

1. <i>Report No.</i> IN-07-025		2. <i>Government Accession No.</i>		3. <i>Recipient's Catalog No.</i>	
4. <i>Title and Subtitle</i> On-Site Not InTraffic Surveillance Back Over Investigation Vehicle - 2002 Ford F-150 Supercab Location - New Mexico			5. <i>Report Date:</i> September 10, 2007

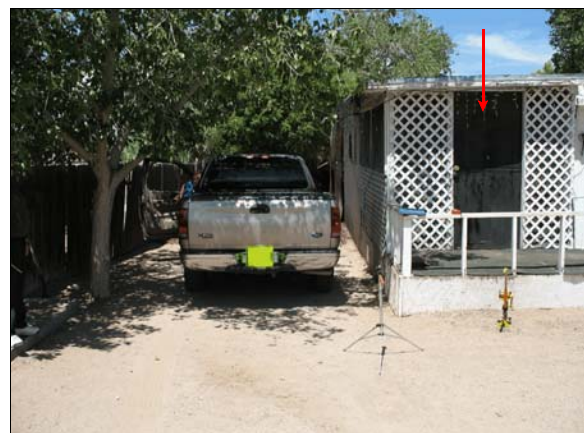
Figure 1: Overview of incident scene, case vehicle in same parked location as at time of incident, arrow shows front door to residence

Pre-Crash: The driver and her son exited the front door of the residence (**Figure 1** above), walked around the back of the case vehicle from right to left and approached the vehicle's left front door. The driver's son entered the vehicle first through the left front door and started the engine. He then crawled over the console to the front right seat. The driver entered the vehicle and they both put on their safety belts. The driver put her right foot on the brake and shifted the vehicle into reverse. She turned her head to the right to look out of the backlight and proceeded to back up. The driver did not check her side view or rear view mirrors prior to backing. The driver estimated that the elapsed time between entering the vehicle and the start of the backing maneuver was approximately 10 seconds. Unknown to the driver or her son, the nonmotorist had followed them out of the house and sat down in the driveway at the back right corner of the case vehicle facing east away from the vehicle and was reportedly playing in the dirt. The nonmotorist was located in the vehicle's blind zone approximately 1.1 meters (3.6 feet) behind the back right corner of the vehicle and could not be seen by the driver or her son.

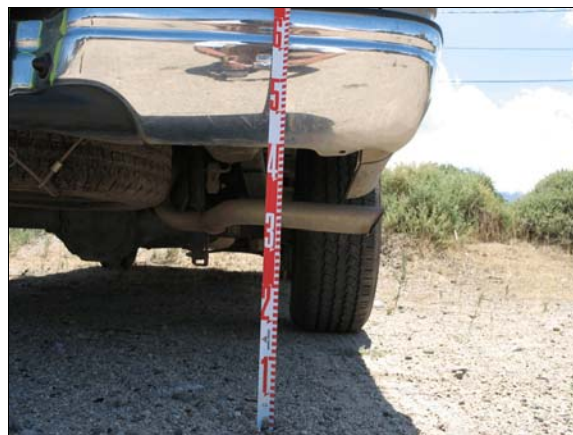
Figure 2: Back bumper, exhaust pipe and right rear tire, scale in 10th of meter

There was no evidence of nonmotorist contact to the case vehicle's back bumper, exhaust pipe or right rear tire. Based on the available information, a Collision Deformation Classification (CDC) was assigned as **06-BRLU-1 (180 degrees)** to describe the case vehicle's impact to the nonmotorist.

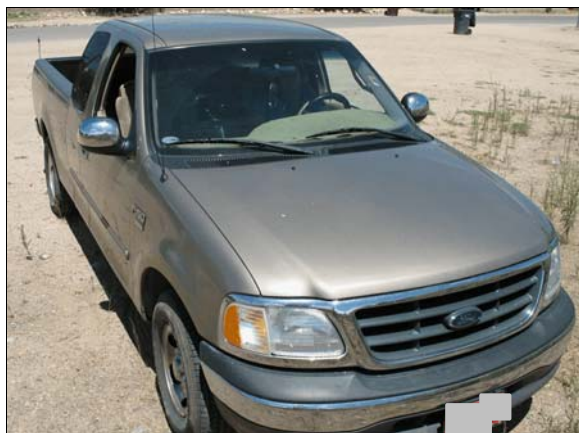
The 2002 Ford F150 Supercab (**Figures 3 and 4**) was a rear wheel drive, two-door, pickup truck (VIN: 1FTRX17W92K-----), equipped with a 4.6L, V8 engine; automatic transmission and four wheel anti-lock brakes. The case vehicle was equipped with tinted glass in the second row side windows and backlight. The case vehicle was not equipped with any after market equipment, and was not equipped with any backup/parking aid. The case vehicle's recommended tire size was P235/70R16. However, the vehicle was equipped with P255/70R16 tires. The P255/70R16 tires would raise the vehicle approximately 2.5 centimeters (1 inch) higher than the recommended tires, assuming proper tire inflation. The distance from the ground to the case vehicle's beltline was 125 centimeters (49 inches). The distance from the ground to the bottom of the back bumper was 49 centimeters (19.3 inches). The distance from the ground to the bottom of the exhaust pipe was 23 centimeters (9.1 inches). The case vehicle's wheelbase was measured as 350 centimeters (138 inches). The measured rear overhang was 120 centimeters (47 inches) and the specification overall length was 573 centimeters (225.5 inches).

Figure 3: Overview of front and right side of case vehicle

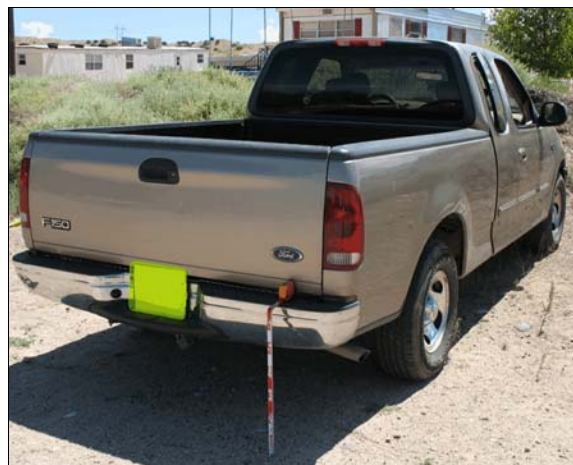
Figure 4: Overview of back and right side of case vehicle

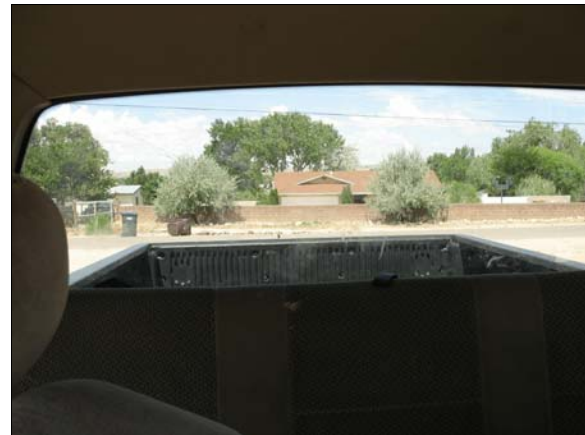
For the assessment of the blind zone behind the case vehicle, the driver was asked to look over her right shoulder out of the backlight (**Figure 5**) as she did at the time of the incident. The target was positioned behind the case vehicle and moved rearward until it came into the driver’s view. It was necessary to move the target rearward from the back of the vehicle 6.1 meters (20 feet) before the driver could see it. At this point, the target was moved to the right from the vehicle’s approximate centerline 10.3 meters (33.8 feet) where it became obstructed by the right “C”-pillar. The target was then moved an additional 4.2 meters (13.8 feet) to the right where it became visible again through the right rear window. The target was then returned to the centerline and moved to the left. The driver immediately lost view of the target because she could not turn far enough to her right to see it.

Figure 5: View out of case vehicle’s backlight from driver’s seat

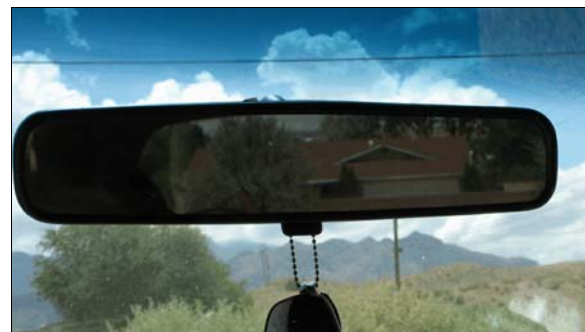
The driver was then asked to view behind the case vehicle through the rear view mirror (**Figure 6**). Again, the target was not visible to the driver until it was moved rearward from the back of the vehicle 6.1 meters (20 feet). When moved 2 meters (6.6 feet) to the right of the vehicle’s approximate centerline, the target went out of the rear view mirror’s field of view. The target was then moved 2.6 meters (8.5 feet) to the left of the centerline where it again went out of the mirror’s field of view.

Figure 6: View through rear view mirror from driver’s seat

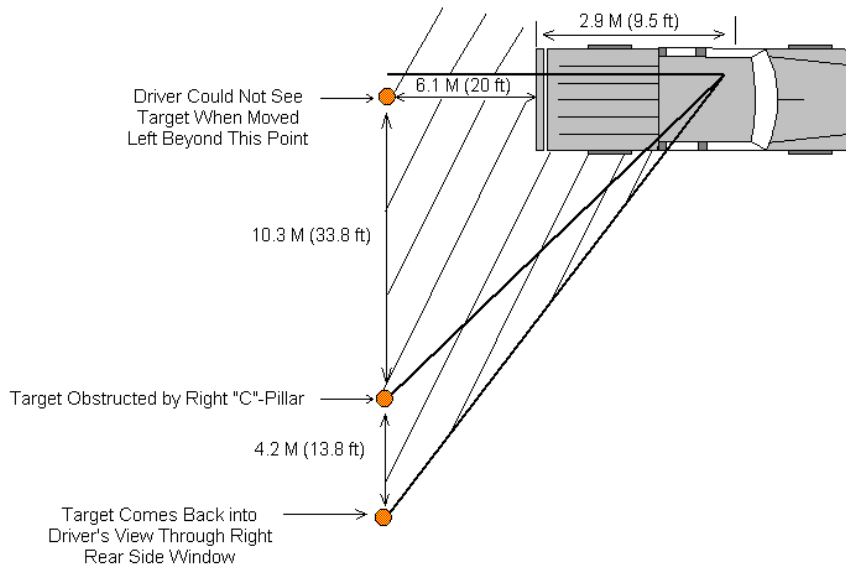
A visibility study was conducted during the case vehicle inspection in order to determine the nominal blind zone behind the case vehicle as well as the right “C”pillar blind zone. In addition, the approximate field of view of the side view and rear view mirrors were also assessed. The case vehicle driver’s eye height as she sat in the driver’s seat was measured as 150 centimeters (59 inches) above the ground. The driver had her seat adjusted to the approximate middle track position. The standard 71 centimeters (28 inches) high target was used for the visibility observations. Please refer to the Case Vehicle Nominal Visibility diagram on page 7 of this report when reading the following discussion.

1. Distance Back of Case Vehicle
To Point a 71 cm (28 in) High Reference Target
Comes Into Driver's View as She Looks Over Right Shoulder Out of Backlight

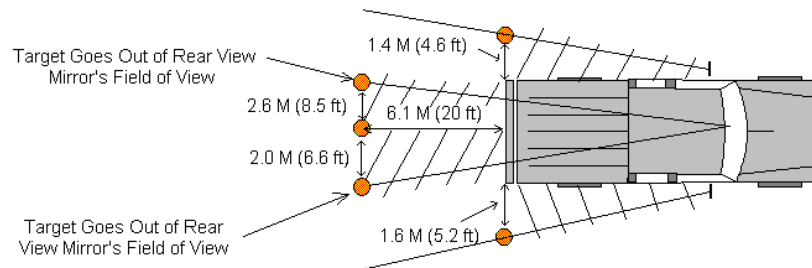
The driver had the side view mirrors adjusted such that she could see the target down each side of the vehicle through the respective side view mirror. Therefore, the target was placed at each back corner of the vehicle and moved outward until the driver could not longer see it in the mirror. For the left side view mirror, the target had to be moved outward from the back left corner 1.4 meters (4.6 feet) where it went out of the driver’s view. For the right side view

mirror, the target had to be moved outward from the back right corner 1.6 meters (5.2 feet) where it went out of the driver's view.

2. Rear View and Side View Mirrors Blind Zones
