**CALSPAN ON-SITE CHILD SAFETY SEAT CRASH INVESTIGATION**

**CASE NO: CA07-029**

**VEHICLE: 1992 CHEVROLET CAVALIER**

**CRASH DATE: SEPTEMBER 2007**

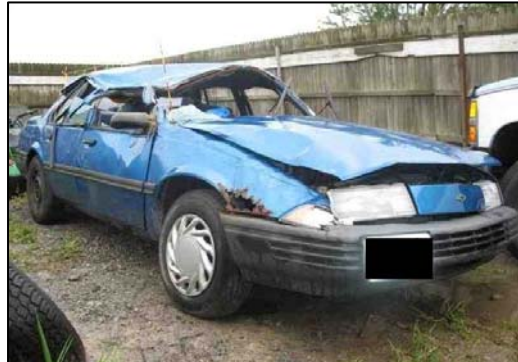
**Figure 1 – Damaged front and left side of the 1992 Chevrolet Cavalier.**

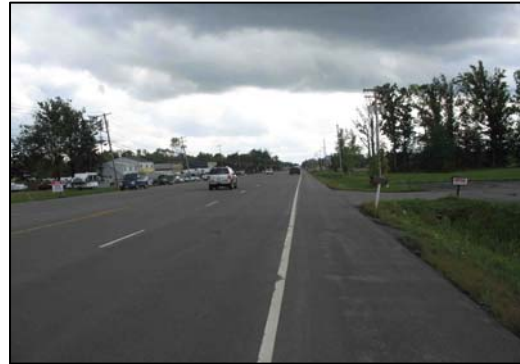
The 26-year old male driver of the Cavalier was traveling southbound on the inboard lane of the five-lane roadway and was approaching a “T” intersection (**Figure 2**). A non-contact vehicle was reportedly entering the five-lane roadway from the intersecting road and was intending to travel southbound on the Cavalier’s established lane of travel. In response to the encroachment of the non-contact vehicle, the driver of the Cavalier initiated a right steering input in an attempted avoidance maneuver. After initiating this action, the Cavalier traveled in a southwest

**Figure 2 - Southbound approach of the Cavalier.**

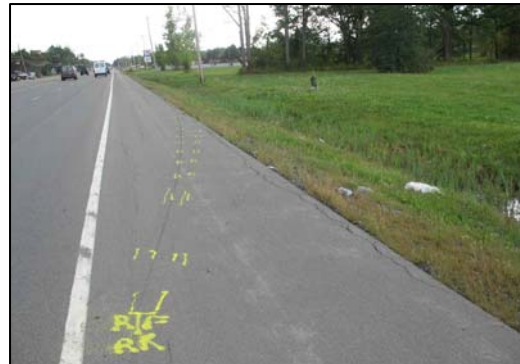
As the vehicle initially lost control off the right roadside the right side tires transferred significant amounts of yaw marks onto the asphalt roadway (**Figure 3**). The CCW tire marks attributed to the right front wheel was 39 m (128’) in length and had a radius of curvature of 159 m (522’). The CCW markings attributed to the right rear wheel were 46 m (151’) in length and had a radius of 133 m (436’). Using the average radius of curvature of the right side yaw marks and the critical speed formula, the Cavalier was estimated to be traveling at 109 km/h (68 mph). The following equation was used to determine the critical speed:

**Figure 3 – CCW yaw marks leading to the right side road departure.**

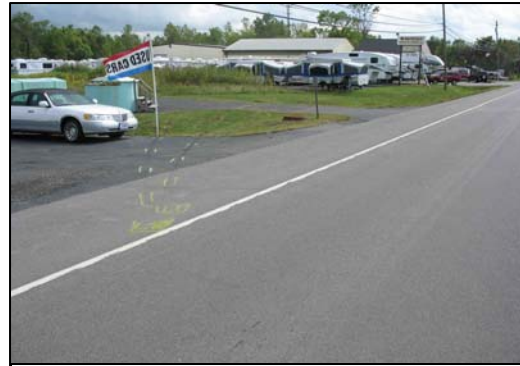
The lengths of the left front and left rear tire marks on the west shoulder were minimally curved and were 4 m (13') and 7 m (23'), respectively. Following a separation of tire marks from the west fog line, a CCW yaw mark was present that began at the outer aspect of the southbound inboard lane and terminated at the midpoint of the center turn lane. The tire mark, which was 13 m (43') in length and had a radius of curvature of 53 m (174'), resulted as the vehicle off-tracked toward the left side of the roadway. This mark was attributed to the vehicle's right rear wheel. As the vehicle departed the left roadside, the center of gravity shifted the vehicle to the left side tires, which resulted in CW yaw marks leading toward the rollover trip point (**Figure 4**). The tire mark attributed to the left front tire was 20 m (66') in length and its radius of curvature was 63 m (207'). The tire mark attributed to the left rear tire was 19 m (62') in length and had a radius of curvature of 57 m (187'). As the vehicle traversed the asphalt driveway, additional load was placed on the outboard sidewalls of left side tires. The tread rolled under the wheels and the tires de-beaded resulting in an air out of the tires. With the absence of air pressure, the left rims loaded the asphalt driveway, the soft soil and the grass at the apex of the ditch. This resulted in damage to the steel rims and deep gouges to the roadside. The damage to the left side rims as a result of contacting the asphalt driveway was circumferential along the outer aspects of the rims (**Figures 8 and 9**). The left front and left rear rims sustained 23 cm (9") and 41 cm (16") of damage, respectively. The roadside gouge marks are illustrated in **Figure 5**.

**Figure 4 - CW yaw marks leading to the left side road departure.**

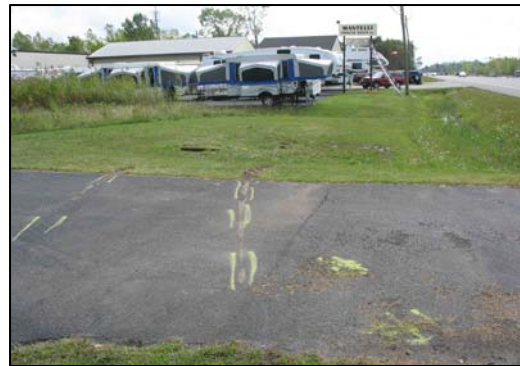
**Figure 5 - Deep gouging across asphalt driveway leading to point of impact.**

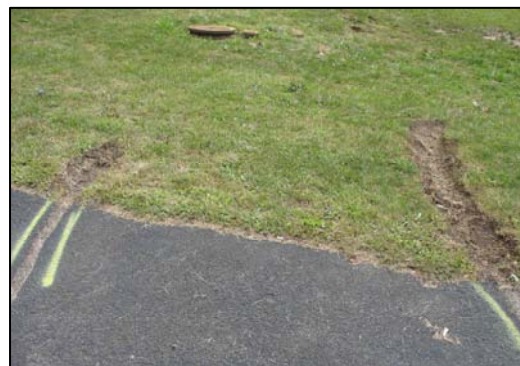
**Figure 6 - Trip points leading to overturn.**

direction. The distance between the vehicle's trip point and the final rest position was approximately 8 m (26'). **Figure 6** illustrates the vehicle's trip point, the contacted manhole cover and the area of final rest.

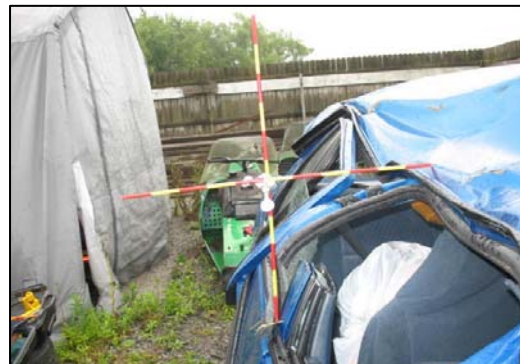
The 1992 Chevrolet Cavalier sustained moderate roof damage as a result of a five-quarter turn rollover crash. The maximum vertical and lateral crush measurements were 20 cm (8") and 17 cm (6.5"), respectively and were in the area of the right A-pillar zone. The direct contact damage on the roof side rail began at the junction of the A-pillar and extended 123 cm (48.5") rearward to the junction of the C-pillar and backlight header. An additional 58 cm (23") of direct contact damage was documented on the right A-pillar. The combined direct and

**Figure 7 - Right side gauge placement on the Cavalier.**

induced damage along the roof side rail was also 123 cm (48"). The Collision Deformation Classification (CDC) was 00-TDDO-3. **Figure 7** illustrates the maximum area of damage and the gauge placement along the right roof side rail.

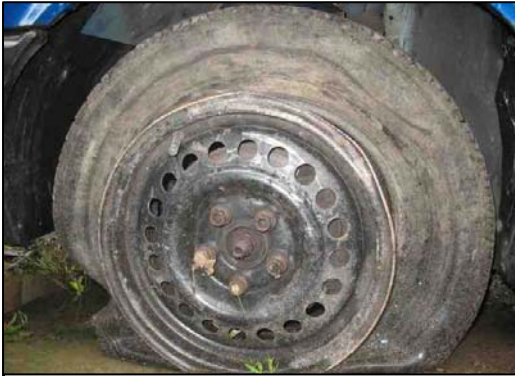
There was additional damage to the vehicle that occurred during the rollover event. All four wheels had grass and dirt debris embedded within the rim and tires. Both left side rims sustained moderate structural damage as a result of yawing across the asphalt driveway prior to overturning. The damage patterns were both circumferential around the outer aspect of the rim with the front left sustaining 23 cm (9") of deformation and the left rear wheel and 41 cm (16") of damage (**Figures 8 and 9**). In addition to the embedded debris, the right front tire had a post-crash negative camber of 5 degrees.

**Figure 8 - Left front wheel of the Cavalier.**

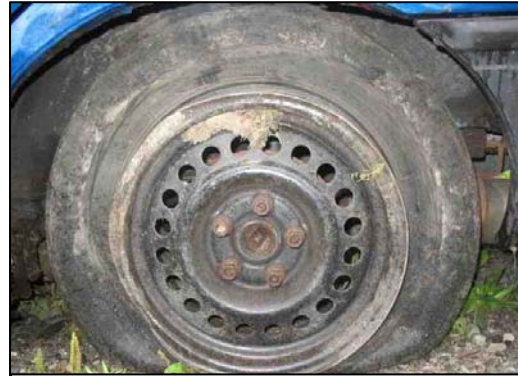
**Figure 9 - Left rear wheel of the Cavalier.**

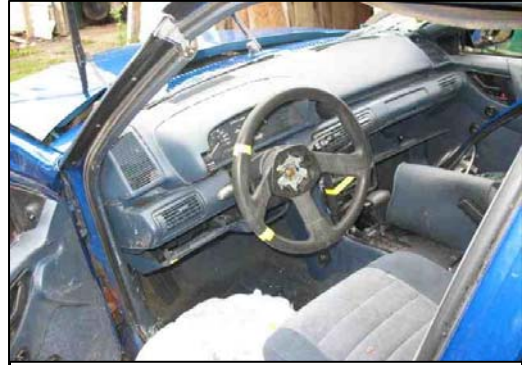
**Figure 10 - Contact pattern along the left and center instrument panel.**

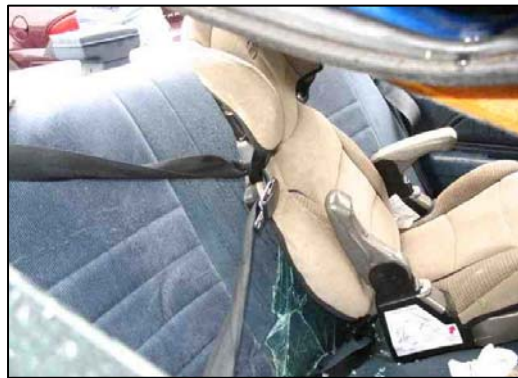
The second row consisted of manual lap and shoulder restraints for the outboard positions and an adjustable length lap belt for the middle position. The outboard restraints were configured with ELR's and locking latch plates. The second row middle position also had a locking retractor. Upon arrival at the vehicle inspection, the right rear shoulder restraint was routed through the right side shoulder belt path of the BPBSS (**Figure 11**). The webbing was twisted three revolutions, a 4 cm (1.2") abrasion was present on the shoulder webbing and a correlative abrasion was present within the BPBSS belt routing path. The abrasion on the belt was located 58 – 68 cm (23 – 27") below the uppermost aspect of the webbing. There was no further discernable loading evidence on the belt system.

**Figure 11 - Right rear belt webbing still engaged in the BPBSS belt path.**

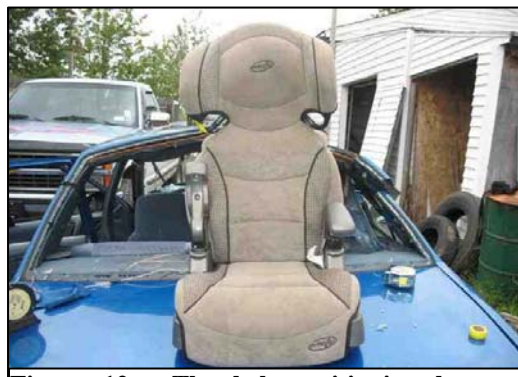
A BPBSS was installed in the second row right seating position of the 1992 Chevrolet Cavalier (**Figure 12**). The Model Number was 3371689A and the Date of Manufacture was 12/02/2006. The BPBSS had no internal hardware such as a harness or retainer clip. The BPBSS was designed with a detachable seatback. The BPBSS with the detachable high back installed was rated for children between 14 – 45 kg (30 – 100 lbs.) and between 96 – 145 cm (38 – 57"). If it was used with the high back component of the BPBSS detached, it was rated for children between 18 – 45 kg (40 – 100 lbs.) and 101 – 145 cm (40 – 57"). The child was 91 cm (36") tall and weighed 16 kg (35 lbs.). At these proportions, he was slightly undersized for the BPBSS.

**Figure 12 - The belt positioning booster safety seat.**

At the time of the SCI inspection, the shoulder restraint was routed through the right shoulder belt path of the BPBSS. The webbing was twisted three revolutions, a 4 cm (1.2”) abrasion was present on the shoulder webbing and an accompanying abrasion was present within the BPBSS belt routing path.
