ON-SITE CHILD SAFETY SEAT INVESTIGATION

CASE NUMBER - IN07033
LOCATION - ILLINOIS
VEHICLE - 1999 PONTIAC GRAND AM SE
CRASH DATE - October 2007

14. <i>Sponsoring Agency Code</i>		
15. <i>Supplementary Notes</i> On-site child safety seat investigation involving a 1999 Pontiac Grand Am SE, four-door sedan, with manual safety belts and dual front air bags, that ran-off-road and rolled over

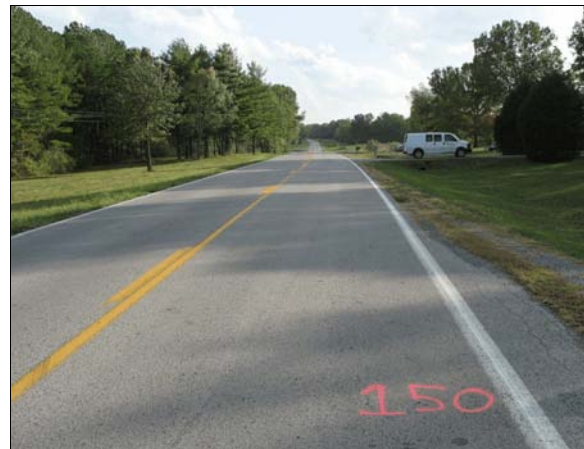
Figure 1: Pontiac's southbound travel path in slight left-hand curve; Pontiac drifted onto right shoulder before driver oversteered leftward, returning vehicle to roadway

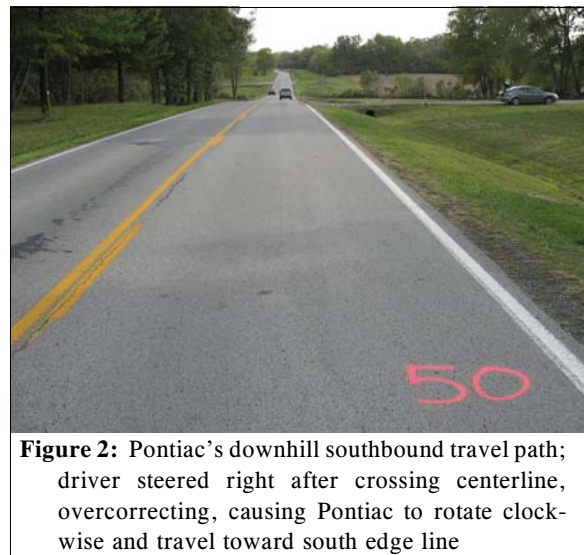
Figure 2: Pontiac's downhill southbound travel path; driver steered right after crossing centerline, overcorrecting, causing Pontiac to rotate clockwise and travel toward south edge line

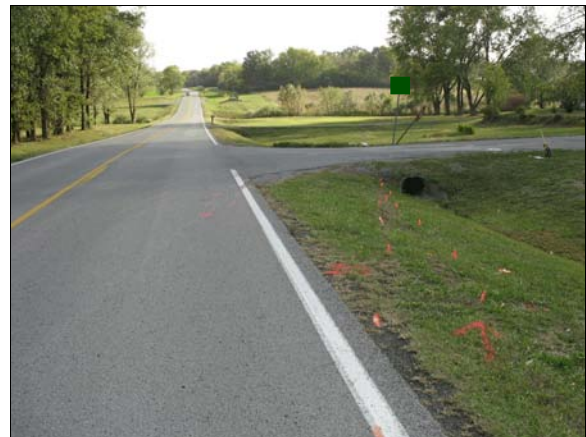
Figure 3: Pontiac’s travel path off roadway toward culvert while rotated approximately 80 degrees clockwise

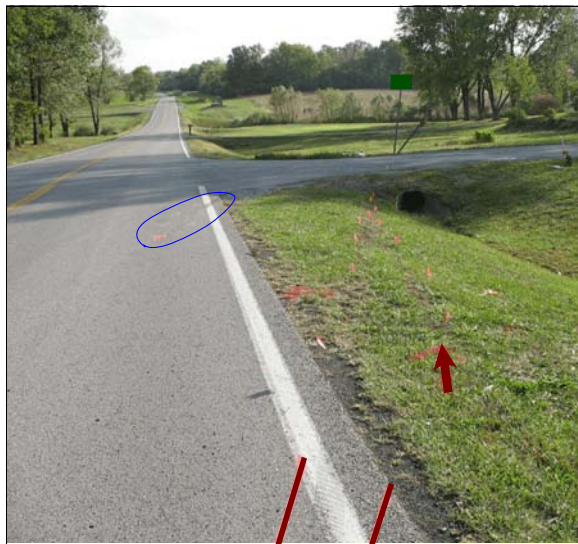
Figure 4: Pontiac’s travel path on south roadside toward culvert; scuff mark on south edge line from left front tire; arrow marks path of right front tire; highlighted area shows rear tire marks

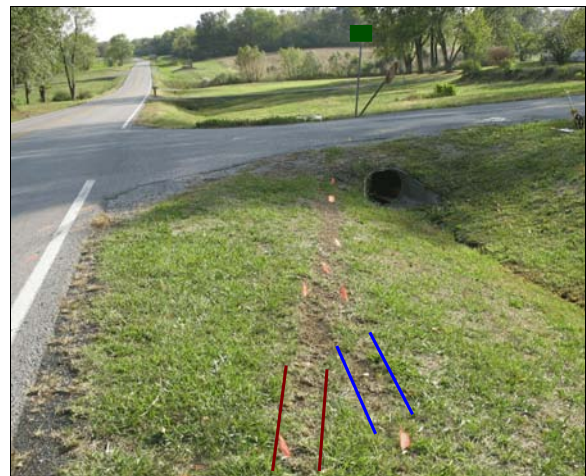
Figure 5: Convergent trajectories of Pontiac’s front tires on south roadside approaching culvert; right lines mark right front tire while left lines mark left front tire

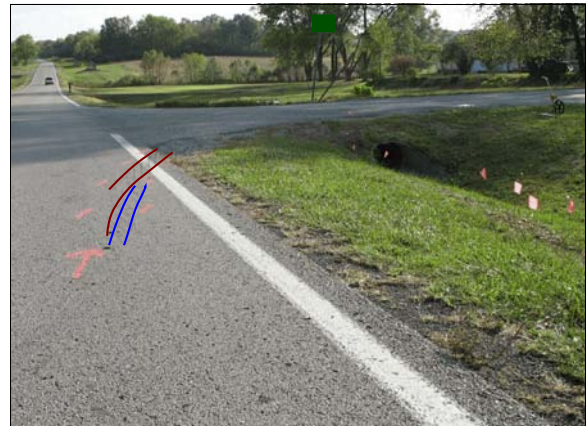
Figure 6: Convergent trajectories of Pontiac's rear tires near south edge line as it travels off road toward impact with culvert; front lines indicate right rear tire, rear lines indicate left rear tire

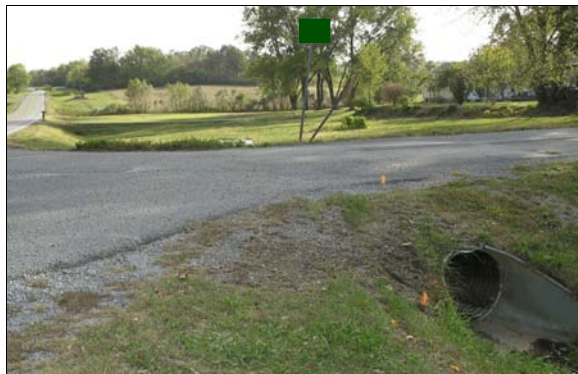
Crash: As the Pontiac rotated clockwise and departed onto the right roadside, the left front wheel impacted a culvert (**Figure 7**), shearing it off (**Figure 8**). The Pontiac traveled airborne over the

Figure 7: Pontiac's left front wheel impacts near culvert shearing wheel from vehicle and initiating vehicle's roll over

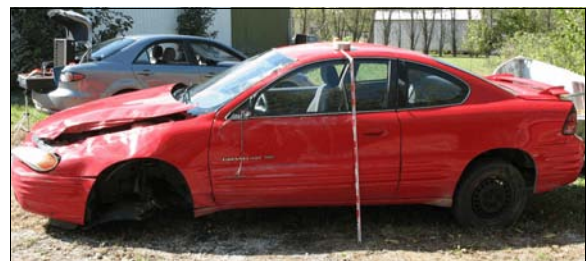
Figure 8: Pontiac's left side damage and sheared left front wheel

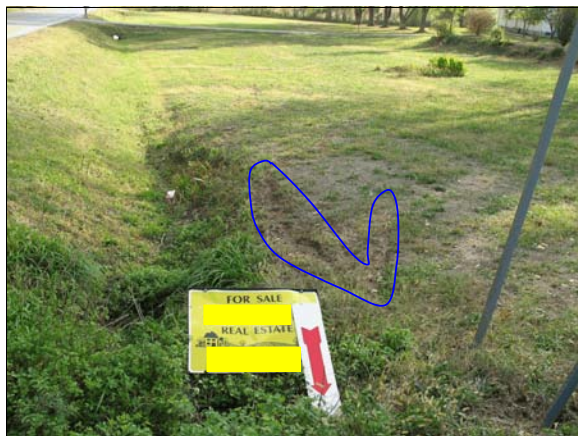
Figure 9: Pontiac's rollover touchdown location, south of intersecting roadway and west of Pontiac's roadway; left fender was initial impact point

The physical evidence indicated that the Pontiac's touchdown began approximately 4 meters (13 feet) south of the south edge of the intersecting roadway and 6 meters (20 feet) west of the main roadway (**Figure 9**). The Pontiac continued to roll about its longitudinal axis with the

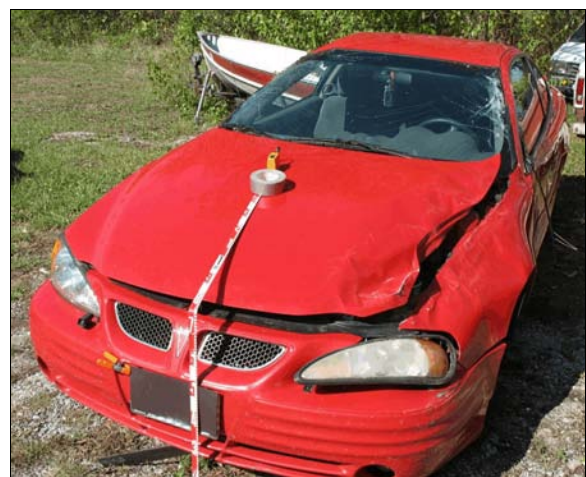
connecting county road and began to roll leftward about its longitudinal axis while simultaneously continuing to rotate clockwise. No evidence of contact from the Pontiac was found on the intersecting county road or on either the street sign or stop sign posts or signs. After clearing the connecting roadway, the Pontiac's left side impacted and damaged a realty sign. Next, the Pontiac impacted the drainage ditch (**Figure 9**), initially along the Pontiac's left fender, A-pillar, and side (**Figure 8**). The vehicle inspection showed that the Pontiac's left fender and hood were crushed inward from a lateral force along these areas (**Figure 10**).

Figure 10: Elevated view of Pontiac's rollover damage showing lateral crush to top of left fender and left side of hood

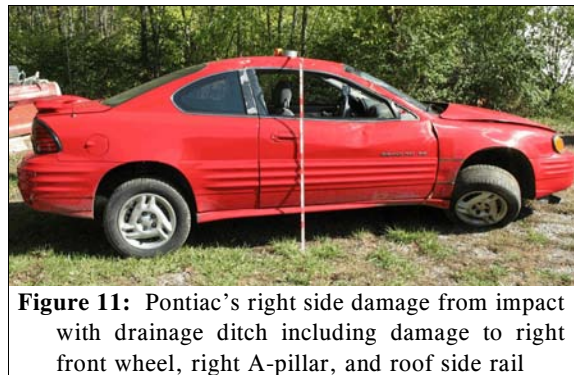
Pontiac's right front wheel, A-pillar, and roof side rail contacting the drainage area (**Figure 11**). At the same time, the Pontiac continued to rotate clockwise in its upside-down position such that the vehicle was facing in a northwesterly direction. This contractor deduced that the Pontiac rebounded (i.e., bounced) from the drainage ditch, pivoting about its back right corner, and flipped in an end-over-end fashion (rotated counterclockwise about its lateral axis) along its southward travel path. According to the investigating police officer and the Pontiac's driver, the Pontiac came to rest on its wheels along the ditch line on the west side of the roadway, heading in a southerly direction. The Pontiac rolled and flipped a total of 4 quarter turns. The distance between the trip point and the estimated final rest position was 33 meters (108 feet). There was no physical evidence supporting the exact final rest location.

Figure 11: Pontiac's right side damage from impact with drainage ditch including damage to right front wheel, right A-pillar, and roof side rail

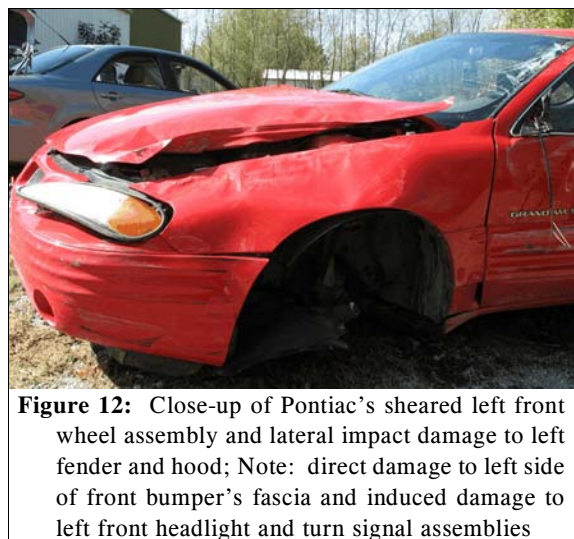
Figure 12: Close-up of Pontiac's sheared left front wheel assembly and lateral impact damage to left fender and hood; Note: direct damage to left side of front bumper's fascia and induced damage to left front headlight and turn signal assemblies

Exterior Damage: The Pontiac’s contact with the culvert involved the left front wheel which was sheared off the axle and was unavailable for inspection (**Figure 12**). The Pontiac’s damage from the rollover involved the right and left sides, as well as the hood and roof. The direct damage on the left side began at the front end of the fender (**Figure 12**) and ran longitudinally to the top of the left A-pillar and midpoint of the driver’s door (**Figure 13**). The direct damage on the right side began at the right front wheel which was positively cambered, approximately 30 degrees (**Figure 14**). The damage continued at the base of the right A-pillar and at the front of the door and ran longitudinally along the door, A-Pillar, and roof rail, ending at the back end of the roof rail (**Figure 15**). The maximum vertical and lateral crush was located 81 centimeters (32 inches) forward of the right rear axle, at the roof rail, directly over the right B-pillar (**Figure 16**). The maximum vertical crush was measured as 2 centimeters (0.8 inch), and the maximum lateral crush was measured as 5.5 centimeters (2.2 inches).

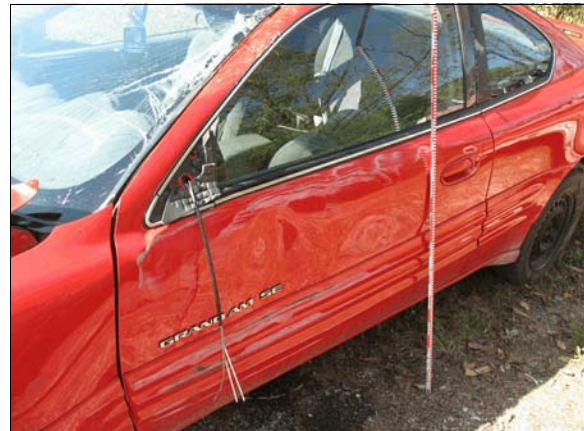
Figure 13: Direct damage to Pontiac’s left side view mirror, left A-pillar and windshield’s glazing, and contact along mid-door level

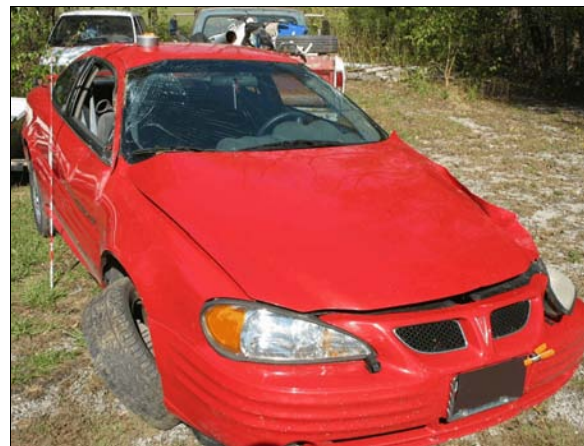
Figure 14: Direct damage to Pontiac’s right front wheel assembly during rollover

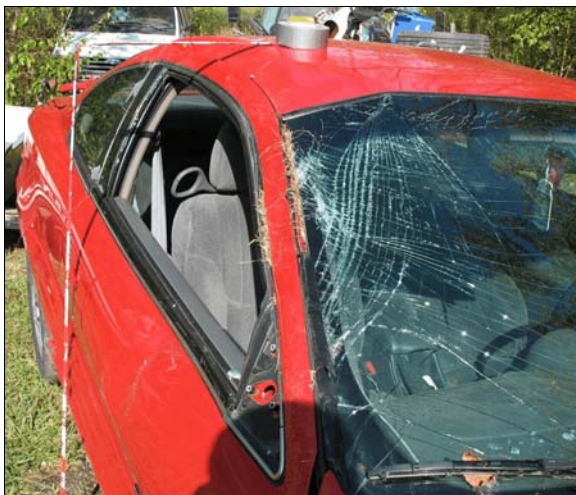
Figure 15: Direct damage to Pontiac’s right side view mirror, A-pillar, windshield’s glazing, roof, and roof side rail; Note: grass in right A-pillar

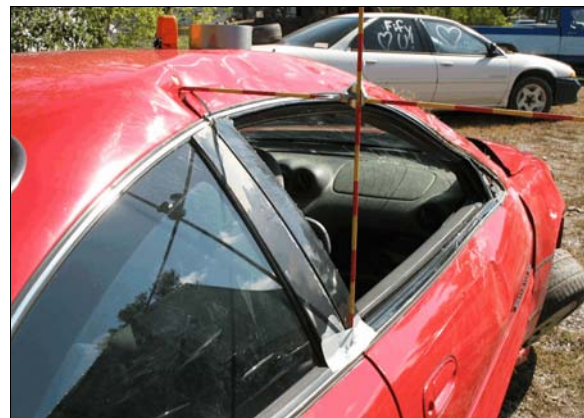
Figure 16: Pontiac’s maximum vertical and lateral crush on right roof rail just above right B-pillar

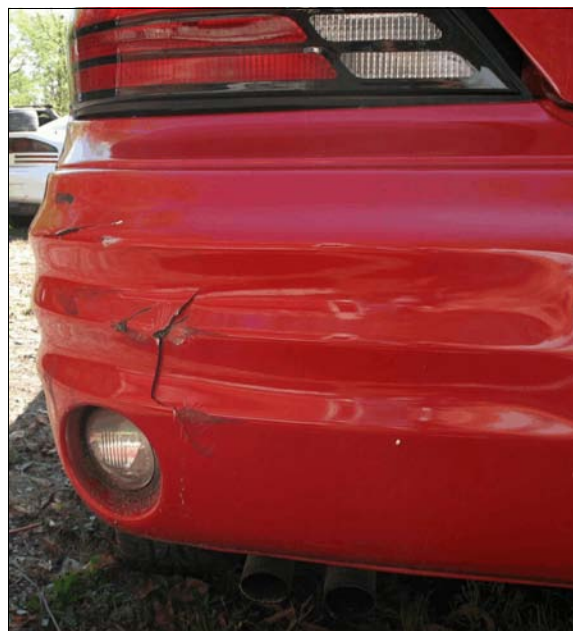
Figure 17: Induced damage to Pontiac’s back left bumper fascia, most likely from impact along left rear side

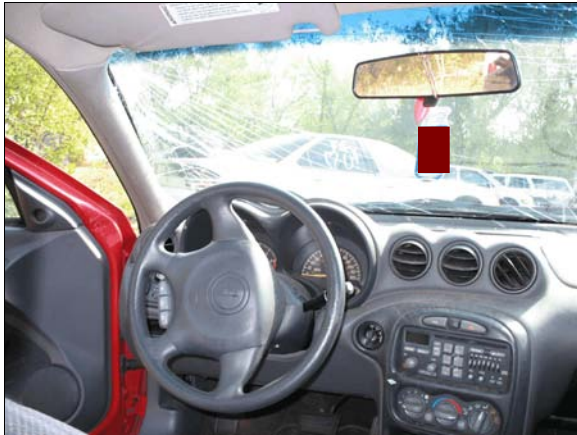
Figure 18: Pontiac's driver seating area showing no evidence of occupant contact to steering wheel, left and middle instrument panels, and greenhouse area; Note: non-deployed driver air bag

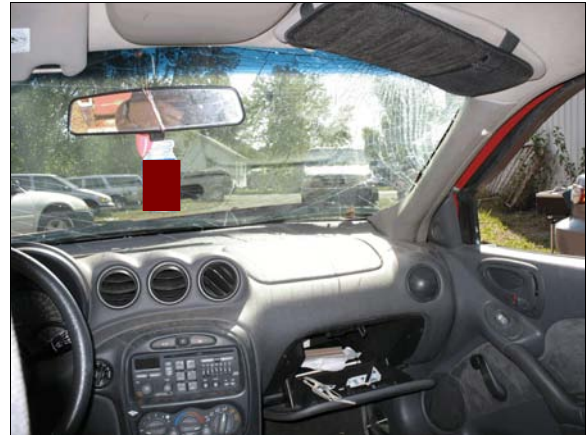
Figure 19: Pontiac's front right seating area showing no evidence of occupant contact to middle and right instrument panel areas and greenhouse area; Note: non-deployed front right air bag

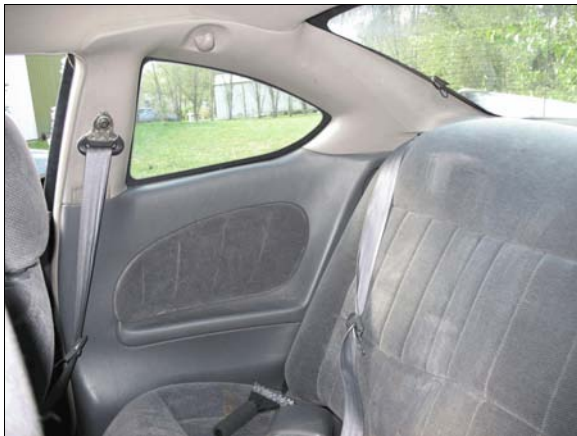
Figure 20: Pontiac's back right passenger seating area showing no evidence of occupant contact

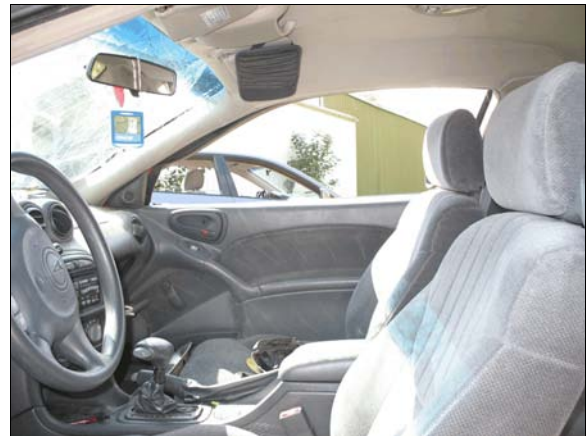
Interior Damage: Inspection of the Pontiac’s interior revealed that there was no evidence of occupant contact on the vehicle’s interior surfaces (**Figures 18, 19, and 20**). There was intrusion in the front right passenger area (**Figure 21**). Specifically, the right roof side rail intruded 3 centimeters (1.2 inches) laterally and 1 centimeter (0.4 inches) vertically. There was no evidence of compression of the energy absorbing shear capsules in the base of the steering column and no deformation of the steering wheel rim.

Figure 21: Pontiac's front seating area; intrusions were noted along right roof side rail

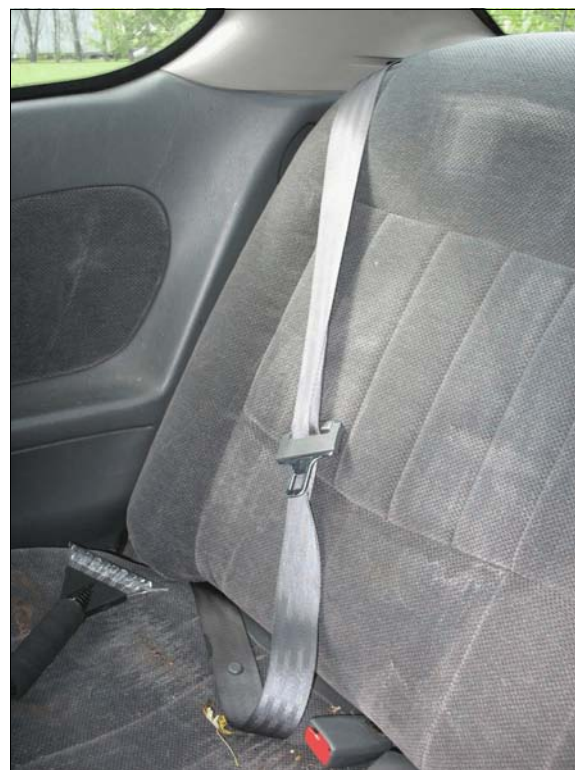
Both front and all three second row seat belts exhibited indications of historical usage. The inspection of the driver’s safety belt webbing, D-ring, shoulder belt guide, and latch plate showed no evidence of loading. The inspection of the second row right passenger’s safety belt webbing, shoulder belt guide, and latch plate showed the webbing was pinched in the latch plate, but there were no scuffs or burn marks on the webbing, only slight webbing deformation (**Figure 22**).

Figure 22: Pontiac’s second row right safety belt showing slight pinching in latch plate but no clear evidence of stress or loading on webbing; Note: wear pattern on seat’s cushion from child seat’s presence

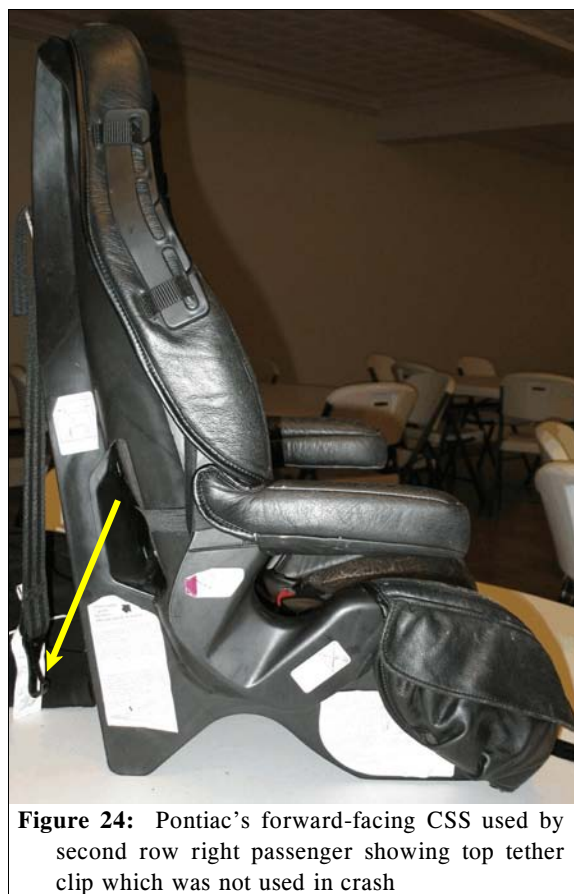
Figure 24: Pontiac's forward-facing CSS used by second row right passenger showing top tether clip which was not used in crash

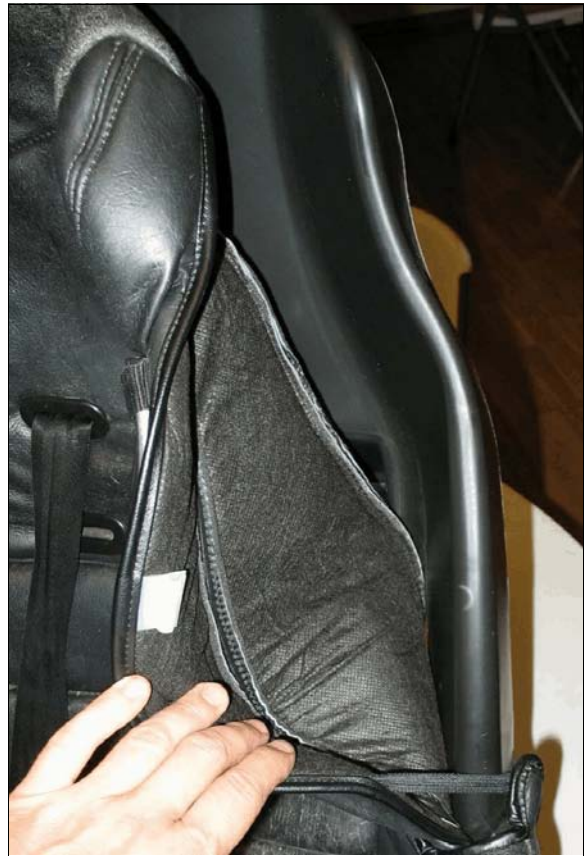
An inspection of the CSS revealed no apparent fractures to the seat's shell, but there were semicircular stress marks (possibly indicating buckling of the plastic) on the seat's left side (**Figure 25**) about shoulder level and at the top of the CSS (**Figure 26**). In addition, no damage or fractures were noted along the seat's belt path (**Figure 24**). The inspection of the CSS's harness revealed no evidence of loading.

Figure 25: Semicircular stress mark on left side/in-board side of CSS used by Pontiac's second row right passenger

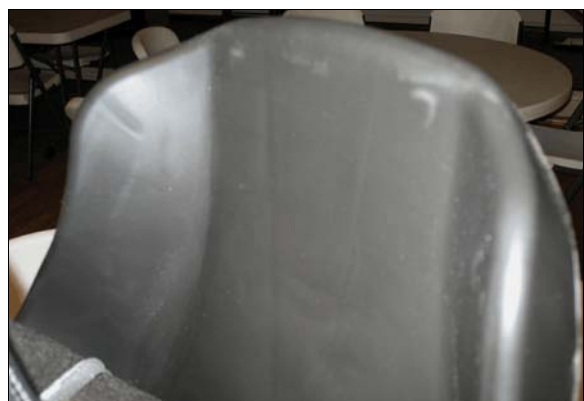
Figure 26: Semicircular stress marks across top of CSS used by Pontiac's second row right passenger

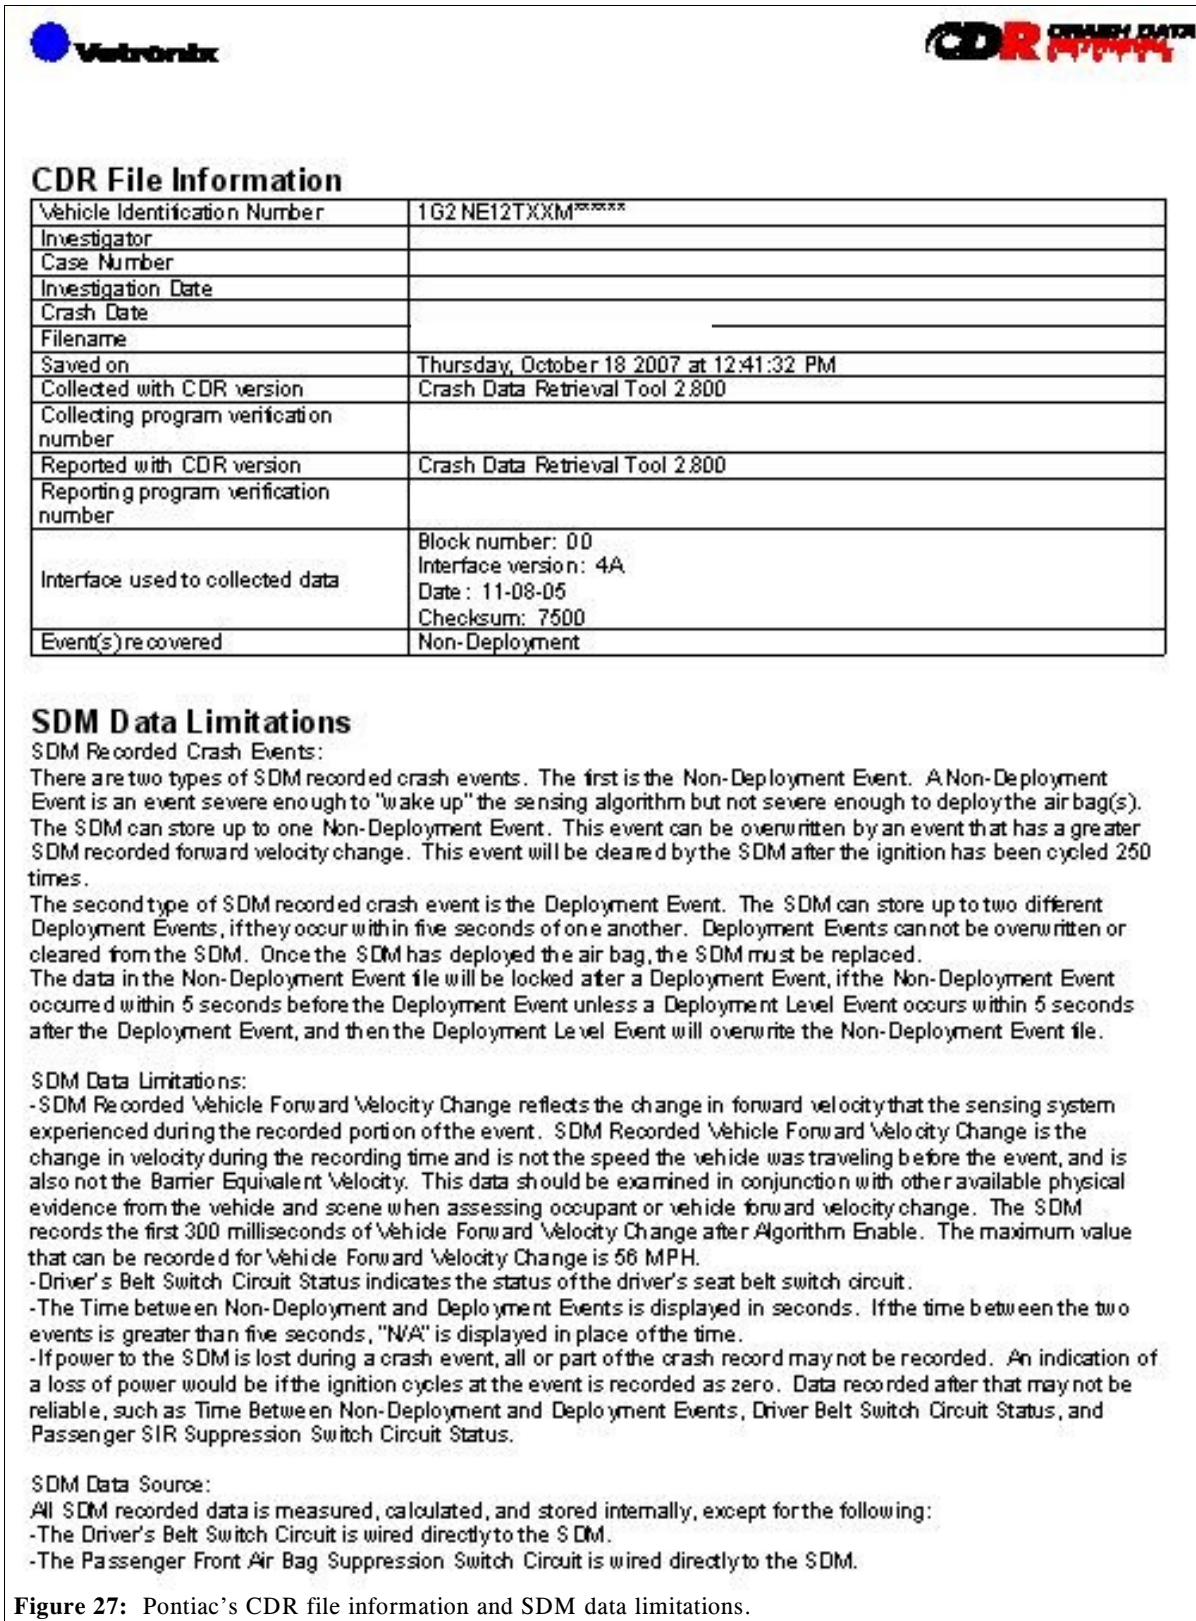
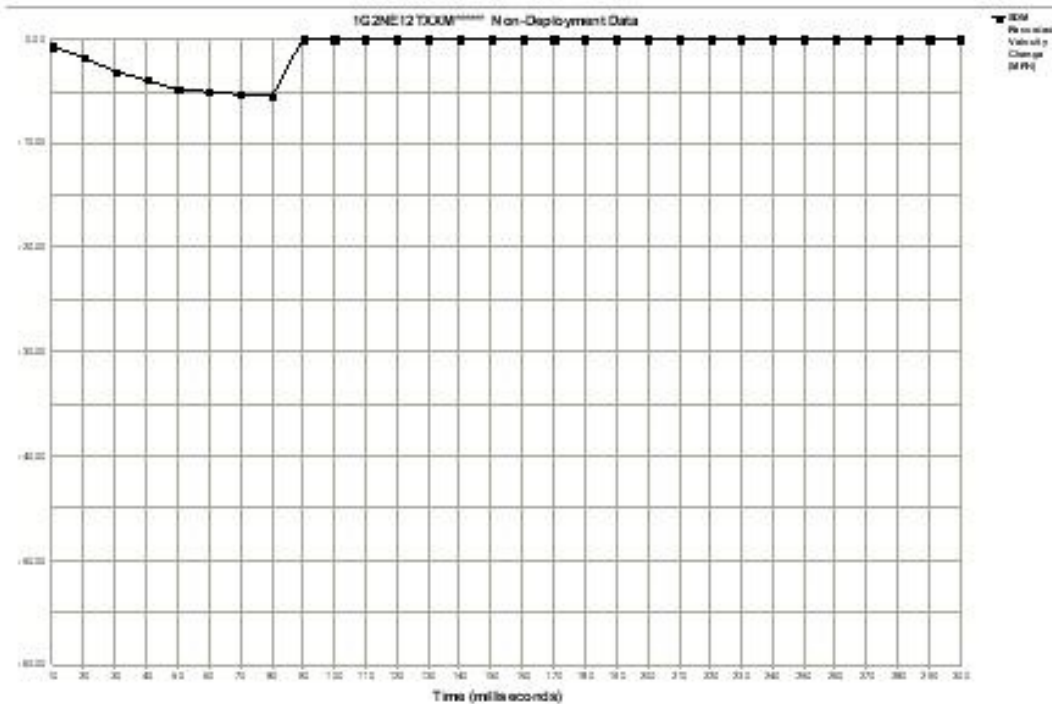
SIR Warning Lamp Status	OFF
Driver's Belt Switch Circuit Status	UNBUCKLED
Passenger Front Air Bag Suppression Switch Circuit Status	Air Bag Not Suppressed
Ignition Cycles At Non-Deployment	18819
Ignition Cycles At Investigation	18820
Algorithm Enable to Maximum SDM Recorded Velocity Change (in sec)	71.25
Maximum SDM Recorded Velocity Change (MPH)	-5.49
A Deployment was Commanded Prior to this Event	No

Figure 28: Pontiac's System Status At Non-Deployment report. The Pontiac sustained an SDM recorded velocity change of approximately -8.8 km/h (-5.5 mph) during the first 80 milliseconds after the algorithm was enabled; maximum velocity change was recorded as -8.84 km/h (-5.49 mph) at 71.25 milliseconds.
