Remote Not In Traffic Surveillance Back Over Investigation  
Dynamic Science, Inc. / Case Number: DS07034  
2007 Dodge Durango  
California  
April 2007

1. Report No. DS07034	2. Government Accession No.		3. Recipient Catalog No.	
4. Title and Subtitle Remote Not In Traffic Surveillance Back Over Investigation			5. Report Date August 10, 2008

**Dynamic Science, Inc.  
Crash Investigation  
Case Number: DS07034**

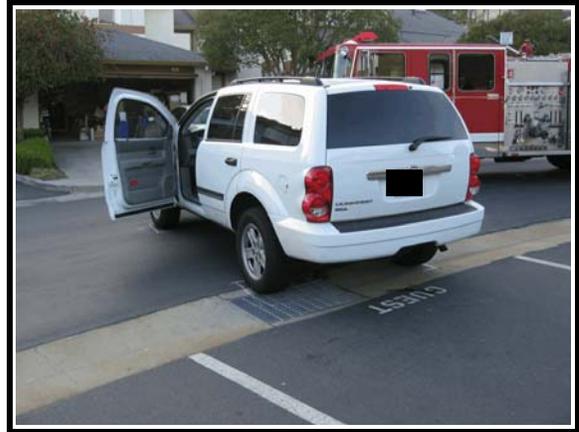
**Figure 1.** Subject vehicle, 2007 Dodge Durango

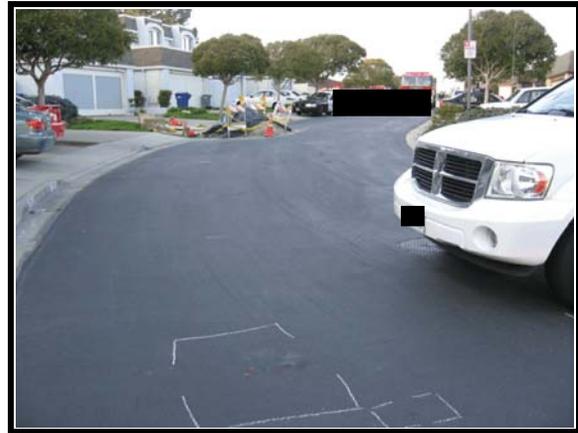
**Figure 2.** Overview of crash scene (looking north)

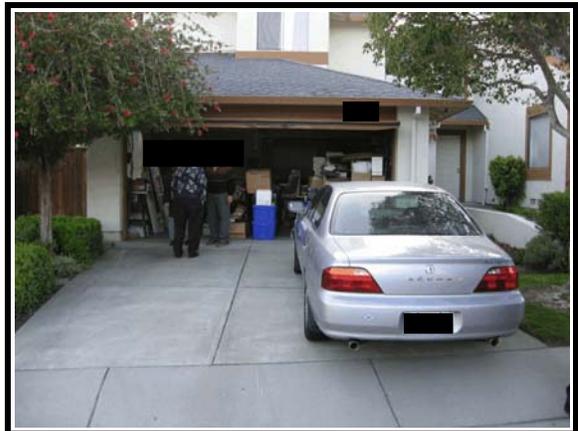
**Figure 3.** Back view of vehicle path from driveway (west)

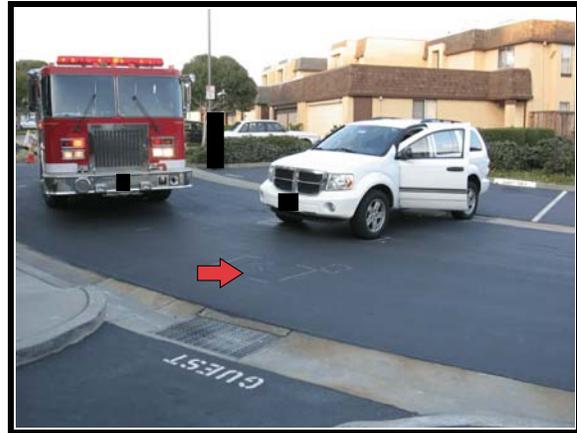
**Figure 4.** Area of final rest. Arrow marks area of impact.

The driver stated that he felt the vehicle “jump up” as he was backing out of the driveway but thought the vehicle was going over a curb so he continued backing. It is probable that the child was knocked down by the left rear bumper of the case vehicle and then run over by the left rear tire (**Figure 4**). It is possible that the child may also have been run over by the left front tire. The area of impact was approximately 2.3 m (7.5 ft) east of the west curb line.

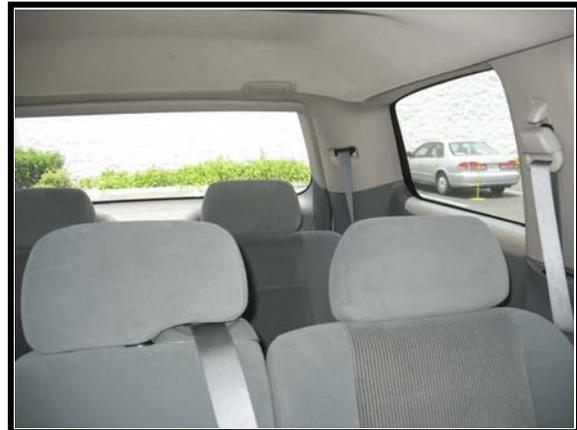
The initial set of measurements were taken as if the driver were looking over his right shoulder through the backlight. The target was moved rearward from the rear bumper along the vehicle's centerline until it became visible to the investigator. The point at which the target became visible to the investigator measured 7.92 m (26.0 ft) rearward of the rear bumper. This measurement was used as the point of origin for two sets of lateral measurements which were then taken. Measurements taken laterally to the left and right resulted in a visibility zone that could be viewed through the backlight. The lateral measurements were taken from the vehicle's center line to the left and right sides of the backlight until the target was out of view due to the presence of the head restraints or the D-pillars. The second row head restraints partially blocked the investigator's rearward vision through the backlight (**Figure 5**). Two visibility zones were observed through the backlight: one on the left and one on the right. At 7.92 m (26.0 ft) rearward of the rear bumper, the left lateral visibility zone fell between the left rear head restraint and the left D-pillar and measured 43 cm (1.4 ft) in width. The right lateral visibility zone fell between the left rear head restraint and the right rear head restraint and measured 2.06 m (6.8 ft) in width. The blind zone created by the left rear head restraint was 1.16 m (3.8 ft) in width. The blind zone created by the right rear head restraint was of similar width and overlapped the blind zone created by the right D-pillar. The roadway surface became visible to the at 14.63 m (48.0 ft) rearward of the rear bumper.

**Figure 5.** View through backlight, exemplar vehicle

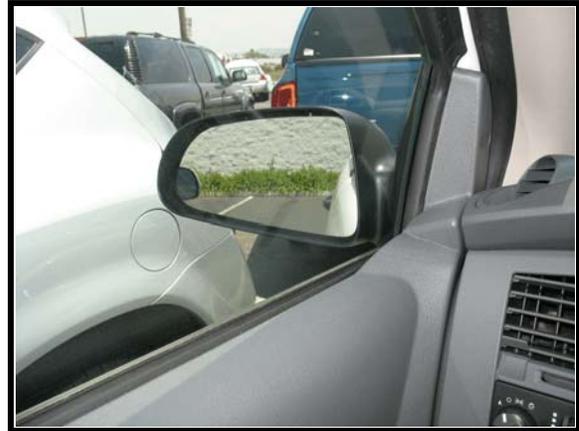
From a seated posture, the side views were examined (**Figure 6**). Since the SCI investigator was using an exemplar vehicle, he adjusted the side mirrors appropriately for the driver's seated eye height. The target was placed at the left rear bumper. The target was moved laterally to the left until the target became visible through the left side view mirror. The target was then moved laterally to the left until the target was no longer visible. These measurements resulted in a visibility zone which could be viewed through the side view mirror. This process was repeated on the right side of the vehicle. The visibility zone lateral to the left bumper measured 85 cm (2.8 ft) in width. The visibility zone lateral to the right bumper measured 1.22 m (4.0 ft) in width. The area between the left and right visibility zones resulted in a blind zone which measured 1.99 m (6.5 ft) in width.

**Figure 6.** View through left side mirror, exemplar vehicle

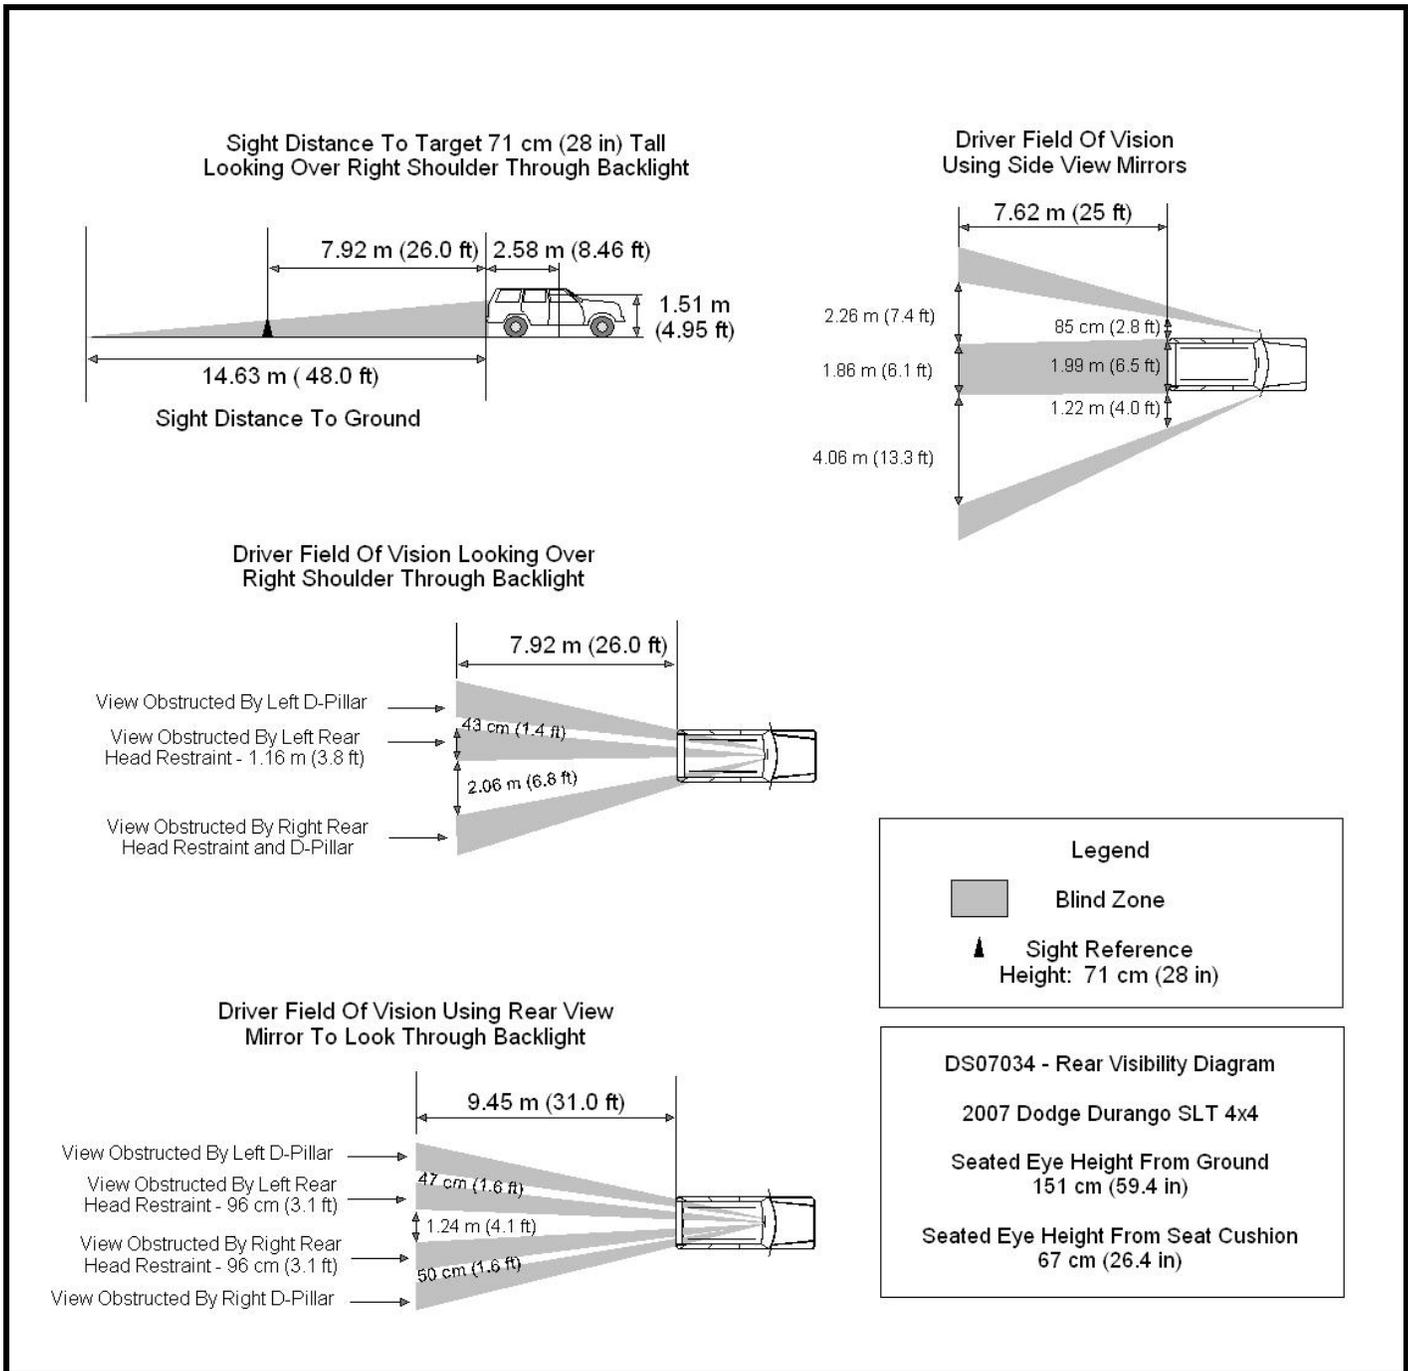
The target was then placed at 7.62 m (25.0 ft) rearward of the rear bumper. Lateral measurements were taken to the left and right at the points at which the investigator could view the target through the side view mirrors. The area between the left and right visibility zones resulted in a blind zone. At 7.62 m (25.0 ft) rearward of the rear bumper, the left and right lateral visibility zones measured 2.26 m (7.4 ft) and 4.06 m (13.3 ft), respectively. The blind zone measured 1.86 m (6.1 ft) in width. The width of the nominal blind zone when using the side view mirrors diminished approximately 13 cm (5.1 in) at a distance of 7.62 (25.0 ft) rearward of the rear bumper versus at the rear bumper.

It is this investigator's opinion that the non-motorist could not have been seen by the driver prior to the incident.

Figure 7. Nominal visibility diagram

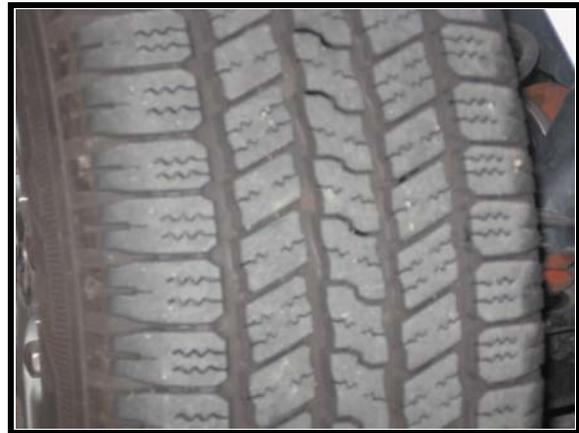
There was no exterior damage to the vehicle. There was blood found on the tread of the left rear tire (**Figure 8**).

**Figure 8.** Blood in left rear tire tread
