Remote SCI/NASS Combination Side Air Bag Investigation
Dynamic Science, Inc. (DSI), Case Number 2008-74-083K
2002 Dodge Neon
Nebraska
April 2008

Dynamic Science, Inc.
Crash Investigation
Case Number: 2008-74-083K

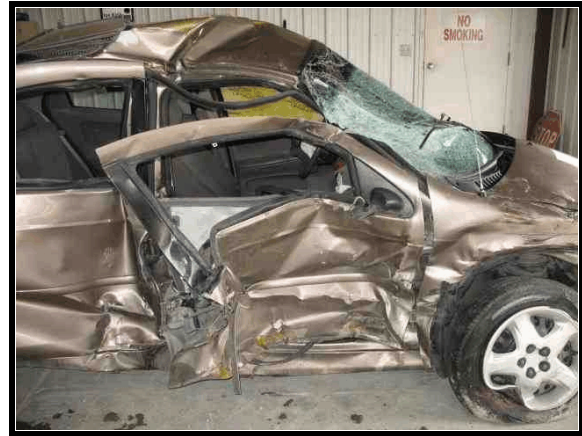
Figure 1. Right side damage to 2002 Dodge Neon

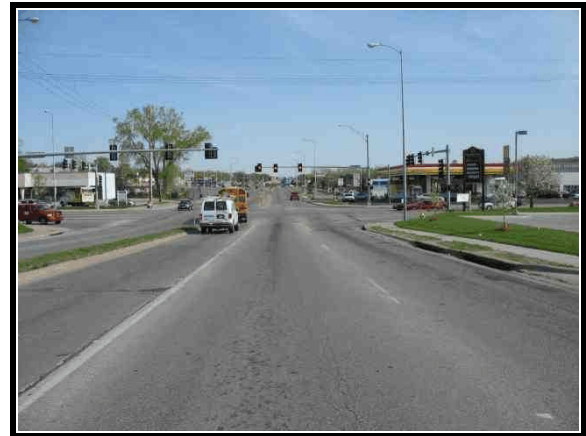
The subject vehicle was traveling northbound (**Figure 2**) and the other vehicle was traveling westbound (**Figure 3**). The vehicles entered the intersection at the same time. According to the police report, the Ford entered the intersection against a red light.

Figure 2. Northbound approach

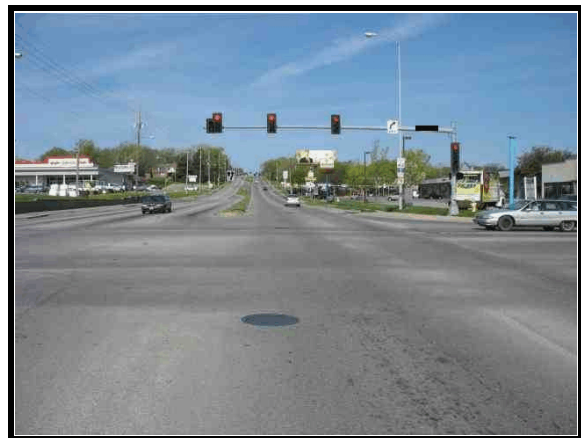
Figure 3. Westbound approach

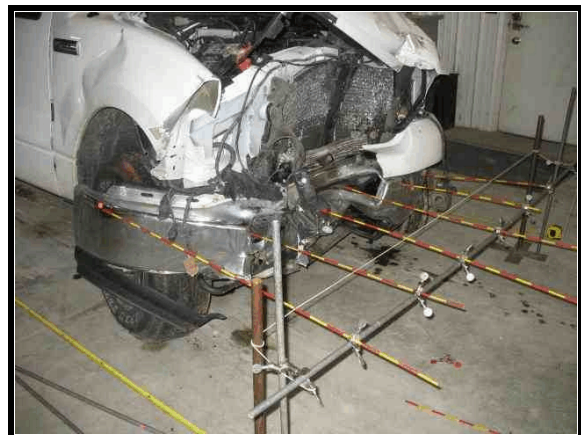
The front end of the Ford (**Figure 4**) impacted the right side of the Dodge in the passenger compartment area. The impact resulted in the deployment of the Dodge's frontal air bags and the right seat mounted side air bag. During the impact, the hood of the Ford contacted the deployed seat mounted side air bag and the first row right occupant of the Dodge. The Damage algorithm of the WinSmash program computed a total delta V of 69 km/h (42.8 mph), based on the Dodge's right side crush profile. The longitudinal and lateral components were -24 km/h (-14.9 mph) and -65 km/h (-40.4 mph), respectively. The Dodge was redirected into a clockwise rotation and traveled in a northwest direction. The Dodge crossed the curb at the northwest corner of the intersection, departed the roadway, struck a fire hydrant with its back end, and came to rest facing southeast. The Damage algorithm of the WinSmash program computed a total delta V of 11 km/h (6.8 mph), based on the Dodge's back end crush profile. The Ford was redirected in a clockwise direction across the intersection, and came to rest in the intersection facing southeast.

Figure 4. Frontal damage to 2005 Ford F150 pickup

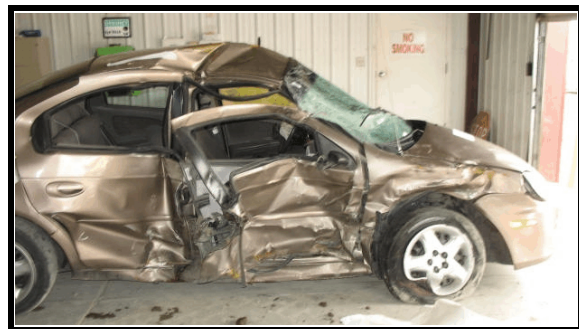
The Dodge sustained severe right side damage from the impact with the Ford (**Figure 5**). The direct damage began at the right front bumper corner and extended 250 cm (98.4 in) rearward along the right side plane. The induced damage began at the right front bumper corner and extended 272 cm (107 in) rearward along the right side plane. Six crush measurements were documented at the sill level as follows: C1 = 6 cm (2.4 in), C2 = 38 cm (14.9 in), C3 = 34 cm (13.3 in), C4 = 27 cm (10.6 in), C5 = 9 cm (3.5 in), C6 = 0 cm. The maximum lateral crush was located at C2. The Collision Deformation Classification (CDC) for the impact with the Ford was 02RYAW3.

Figure 5. Right side damage

The impact was to the passenger area and measurements were taken to determine the vehicle's sill height, maximum crush height, and the resultant Door Sill Differential (DSD). The sill height measured 22 cm (8.7 in). The maximum crush height measured 30 cm (11.8 in). Based on vehicle photographs, the DSD was determined to be approximately 5 cm (2 in).

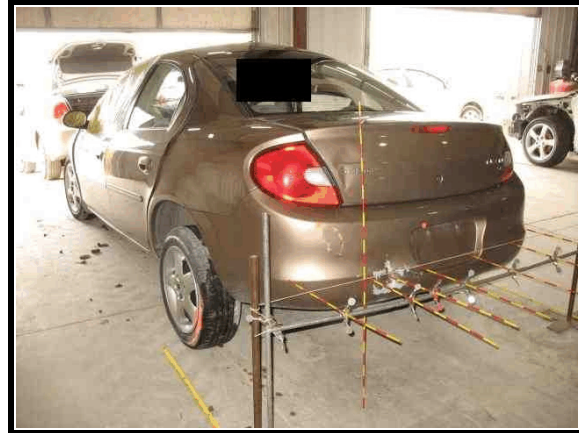
The Dodge sustained minor back end damage from the impact with the fire hydrant (**Figure 6**). The direct damage began 12 cm (4.7 in) from C1 and extended 48 cm (18.9 in) laterally to the right along the rear bumper. The field L was distributed from bumper corner to bumper corner and measured 141 cm (55.5in). Six crush measurements were documented at the bumper level as follows: C1 = 1 cm (0.4 in), C2 = 0 cm, C3 = 0 cm, C4 = 0 cm, C5 = 0 cm, C6 = 0 cm. The CDC for the impact with the fire hydrant was 06BYEW1.

Figure 6. Rear end damage from fire hydrant

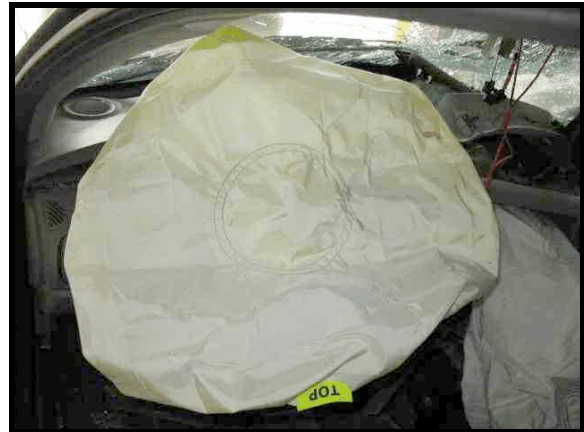
The driver’s air bag was housed in the center of the steering wheel with a single cover flap design (**Figure 7**). No contact evidence was documented to either the module cover or the bag surface. The air bag was vented by two ports located at the 11 and 1 o’clock sectors on the rear aspect of the air bag. The air bag was tethered, evidenced by the circular stitching on the center of the air bag. The front right passenger air bag deployed from the right mid instrument panel area with a single cover flap design hinged at the top aspect (**Figure 8**). No contact evidence was documented to either the module cover or the bag surface.

Figure 7. Driver’s air bag

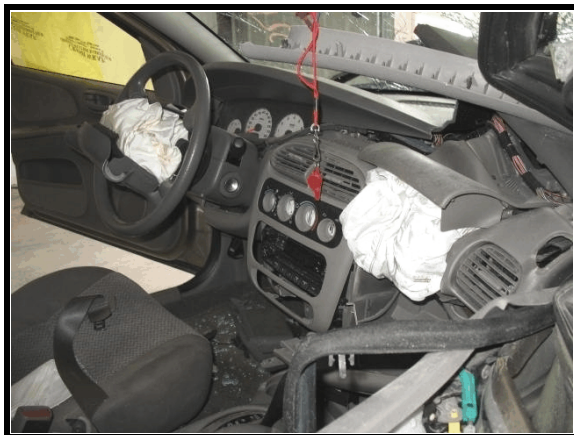
Figure 8. Overview of driver and front right passenger air bags

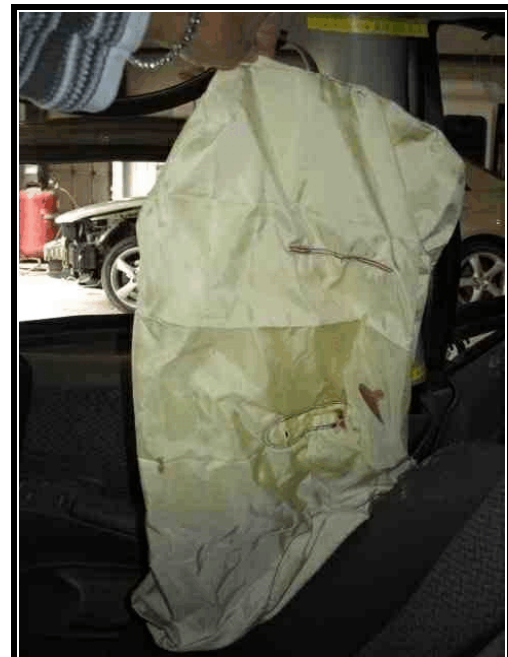
The right seat mounted side air bag deployed from the outer aspect of the right front seat back (**Figure 9**). The side air bag was designed to protect the head and torso. The air bag was tethered, as evidenced by the horizontal stitching one-third of the way from the top of the bag. The air bag was vented by two ports one-third of the way from the bottom of the air bag. The ports were located on both the inboard and outboard aspects of the air bag. There was an unidentified brownish stain located above and below the inner facing vent ports. Just aft of the vent ports was a stain which was probably blood.

Figure 9. Front right seat mounted side air bag

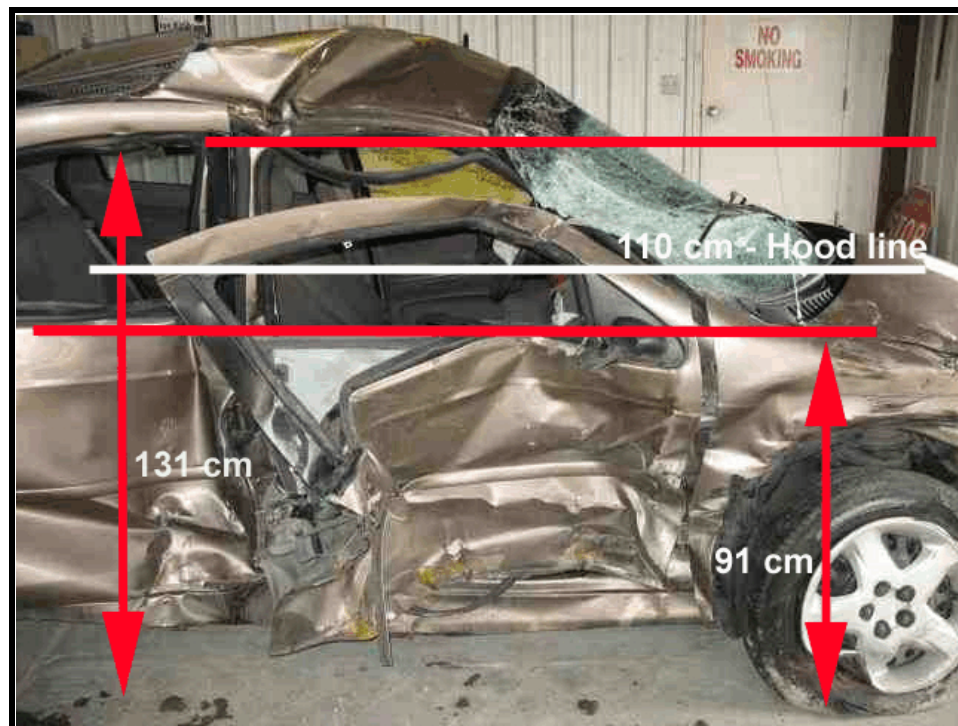
Figure 10. Comparison of Ford hood line and Neon's lower side window frame
