On-Site Child Safety Seat Investigation  
Dynamic Science, Inc. (DSI), Case Number DS08002  
1989 GMC Jimmy S-15  
California  
December 2007

**Dynamic Science, Inc.  
Crash Investigation  
Case Number: DS08002**

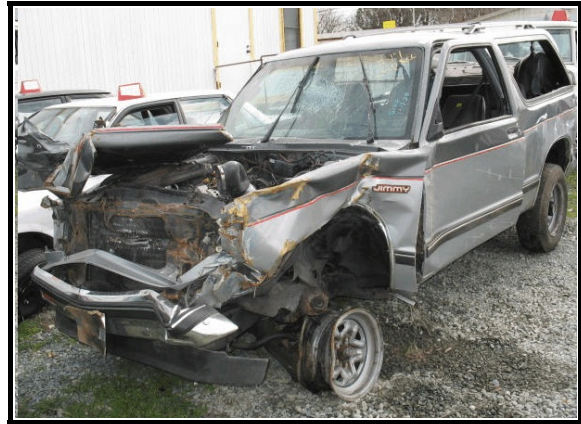
**Figure 3.** Subject vehicle, 1989 GMC Jimmy S-15

The GMC sustained direct damage to the left and the right planes; induced damage was sustained by all planes. The front grille was detached from the vehicle. The hood was buckled and displaced to the right. The left side view mirror was missing. The drive shaft was detached and was found inside the vehicle. The left front tire was missing and the rim flange was bent.

The crash consisted of three events: two impacts with the Utility trailer and one impact with the roadside shrubbery. The direct damage from Event 1 began at the front left bumper corner, extended 123 cm (48.4 in) down the left side, and ended 53 cm (20.9 in) aft of the left front axle (**Figure 3**).

Six crush measurements were taken at the mid-door level as follows: C1 = 0 cm, C2 = 20 cm (7.9 cm), C3 = 15 cm (5.9 in), C4 = 29 cm (11.4 in), C5 = 21 cm (8.3 in), C6 = 13 cm (5.1 in). The maximum lateral crush measured 29 cm (11.4 in) and was located at C4. The Collision Deformation Classification (CDC) for the first impact was 08LFEW3.

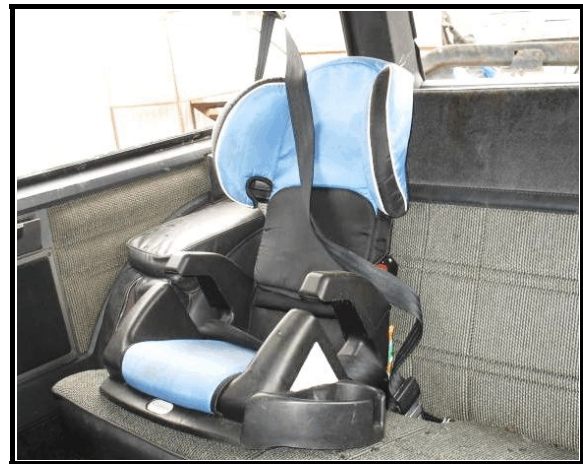
**Figure 4.** Cosco Protek BSS as found in vehicle during inspection

At the time of the vehicle inspection, the BSS was found upright on the second row right seat cushion. The vehicle's manual lap belt was not routed through belt positioning slots and the shoulder belt was hanging across the headrest (**Figure 4**). The safety belt was equipped with an ELR retractor and the safety belt was in the buckled position. There was slack in the belt webbing. The retractor mechanism would not stop the belt from unspooling, even when the webbing was given a strong jerk by the DSI investigator. The retractor would retract to some degree but the recoil mechanism was weak. The safety belt was examined and displayed no evidence of occupant loading. The BSS was examined and exhibited no evidence of occupant contact, damage or loading from the safety belt.

The 20-month-old occupant's mother estimated the child to be 61 cm (24 in) in height, and 13.6 kg (30 lb) in weight at the time of the crash. The child did not meet the height and age requirements of a BSS, and this contributed to the ejection. The child was too small to be properly secured by a

lap and shoulder safety belt. It was therefore determined that the improper restraint usage directly resulted in the ejection of the child from the BSS and from the vehicle.

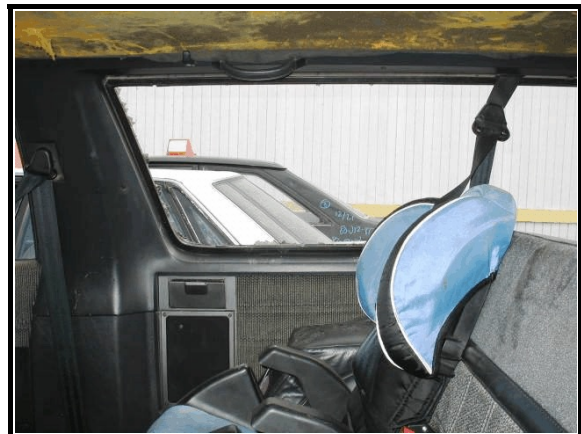
**Figure 5.** Area of Occupant 3 ejection, right rear window

During the impacts with the trailer, the child was displaced to the left in response to the directions of force. The child loaded the safety belt and remained in the CSS. After the side slap impact, the GMC initiated a clockwise rotation and was displaced to the right. Due to the rotational dynamics of the vehicle, the child was displaced to the right and displaced from the BSS and contacted the right side glass. The occupant's contact with the side glass disintegrated the glazing and the child exited the vehicle through the window (**Figure 5**). The contact of the child's head and face with the side glass resulted in minor lacerations to the left and right scalp and the right eyebrow.

After the occupant was ejected he landed in the shrubbery and then contacted the ground with his head. He sustained a minor laceration to the posterior scalp as a result of contact with the ground, and he came to final rest at 3.3 m (10.8 ft) from the back end of the GMC's final rest location. The occupant was ground transported to a local hospital, treated, then released later that day.
