## ON-SITE CHILD SAFETY SEAT INVESTIGATION

CASE NUMBER - IN08005

VEHICLE - 2000 PLYMOUTH NEON LX

CRASH DATE - December 2007

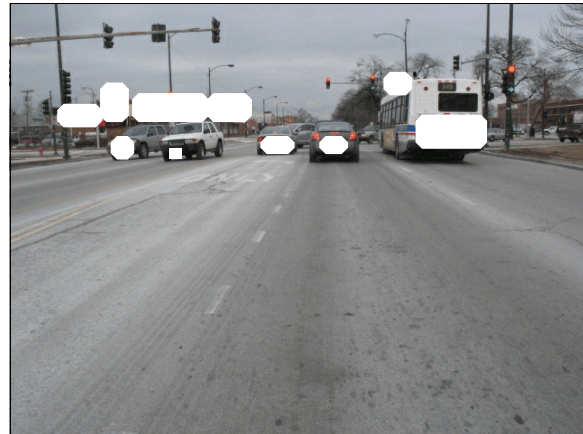
**Figure 3:** Ford's approach to intersection in inside northbound lane

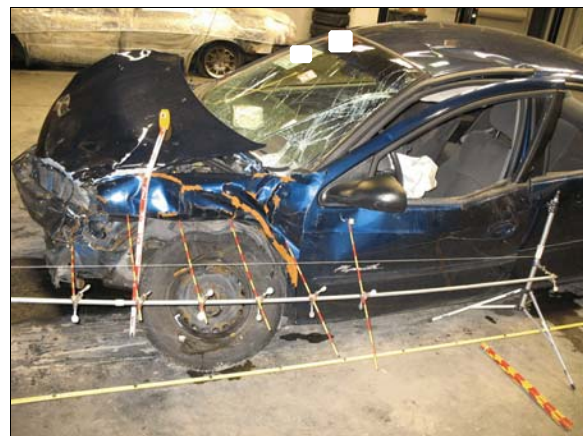
**Crash:** The front of the Ford impacted the left front of the Plymouth (**Figure 4**, event 1). The direction of principal force was within the 11 o'clock sector on the Plymouth and the impact force was sufficient to deploy the driver's and front right passenger's frontal air bags. The police crash report indicated that the Ford's driver and front right passenger frontal air bags also deployed. The impact caused the Ford to rotate counterclockwise and the Plymouth to rotate clockwise. The scene inspection revealed no evidence of the final rest positions of either vehicle and the police crash schematic did not depict their final rest positions. Based on the damage to the Plymouth and experience with similar crashes, both vehicle's probably came to final rest within the intersection heading northwest.

**Figure 4:** Left side damage to Plymouth; vertical scale in tenths of meter; each increment on measurement rods is 5 cm (2 in); each black mark on tape measure is 0.3 meter (1 foot)

**Exterior Damage:** The Plymouth's impact with the Ford involved the left side plane. The left fender, left headlamp/turn signal assembly, hood, left front wheel, left portion of the front bumper, and the front portion of the left front door were directly damaged (**Figure 4**). The direct damage began 210 centimeters (82.7 inches) forward of the left rear axle and extended 107 centimeters (42.1 inches) forward along the left side. The crush measurements were taken along the upper door level and the residual maximum crush was measured as 43 centimeters (16.9 inches) occurring at C<sub>6</sub>. The table below shows the vehicle's left side crush profile.

The left side wheelbase was reduced 9 centimeters (3.5 inches) while the right side wheelbase was extended 1 centimeter (0.4 inch). The induced damage involved the left A-pillar, left front and rear doors, hood, right fender, right headlamp/turn signal assembly, and the roof.

**Damage Classification:** The Plymouth's Collision Deformation Classification (CDC) was **11-LYEW-3 (320 degrees)** for the impact with the front of the Ford (event 1). The Missing Vehicle algorithm of the WinSMASH program calculated the Plymouth's total Delta V as 25 km/h (15.5 mph). The longitudinal and lateral velocity changes were -19.2 km/h (-11.9 mph) and 16.1 km/h (10.0 mph), respectively. The results were based only on the Plymouth's crush profile and should be considered a borderline reconstruction.

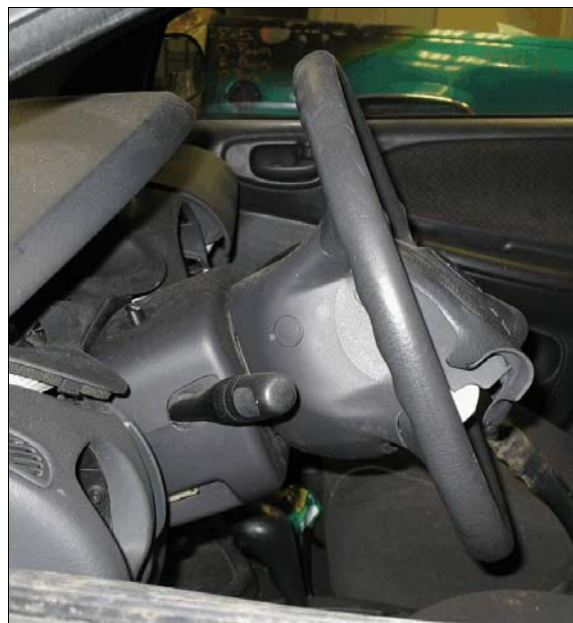
**Figure 5:** Left side view of the Plymouth's steering wheel showing lack of deformation of the steering wheel rim

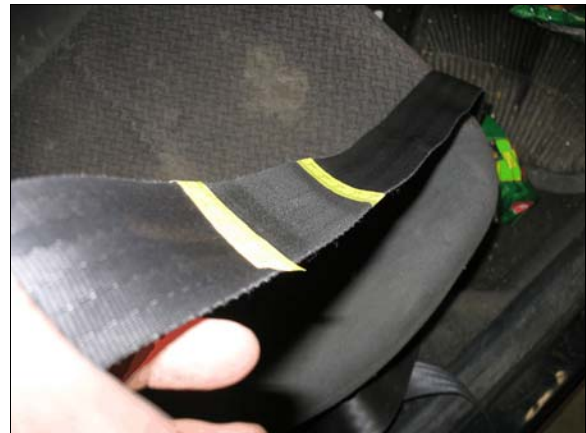
The inspection of the front right passenger's seat belt assembly revealed a load mark on the webbing (**Figure 6**), which also had a slight stretched appearance to it. The evidence indicated that the front right passenger was restrained by the lap-and-shoulder belt.

**Figure 6:** Load mark (between yellow tape) on Plymouth's front right passenger's seat belt

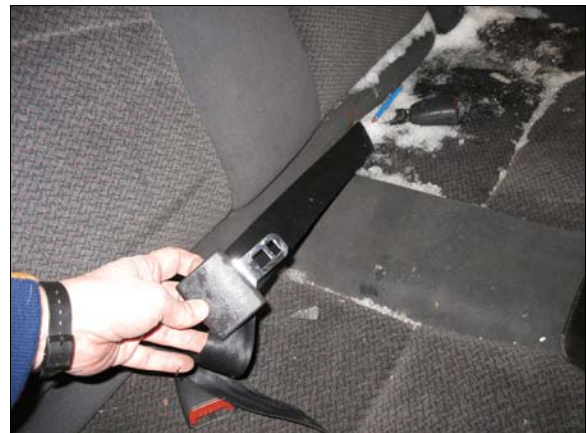
**Figure 7:** Plymouth's second row center lap belt, which was used to secure the CSS

The inspection of the second row center lap belt (**Figure 7**) revealed no evidence of loading. This belt was used to secure the CSS. The driver stated during the interview that she routed the lap belt through the belt paths on the back of the CSS and pulled the belt tight to secure it in the vehicle.

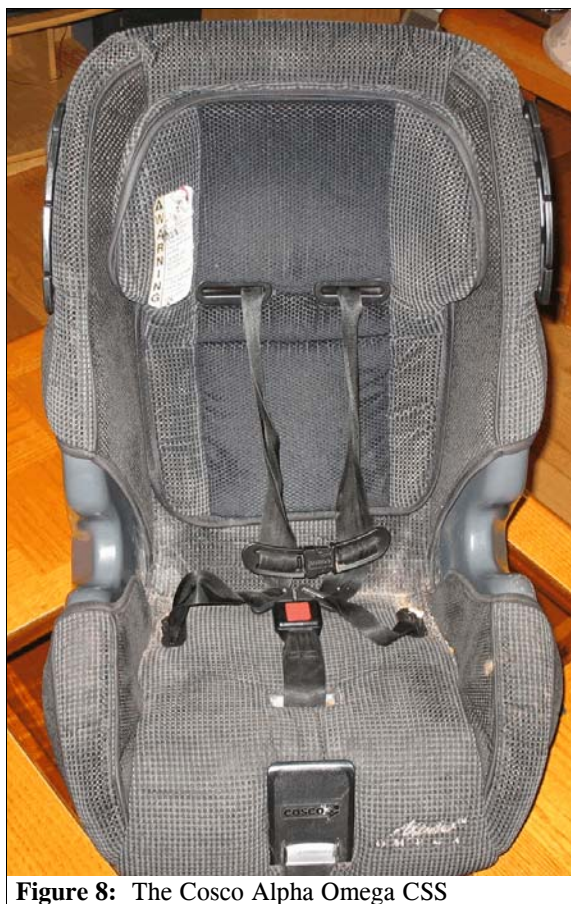
**Figure 8:** The Cosco Alpha Omega CSS

The CSS was constructed of a one piece plastic shell and was fitted with a cloth covered foam pad. Inspection of the CSS revealed three minor stress marks in the plastic, one at the lower right portion of the shell and two on the left side. Otherwise, the CSS was intact and unremarkable.
