ON-SITE SIDE IMPACT INFLATABLE OCCUPANT PROTECTION INVESTIGATION

CASE NUMBER - IN08012
LOCATION - TEXAS
VEHICLE - 2006 HONDA CIVIC LX
CRASH DATE - January 2008
Submitted:

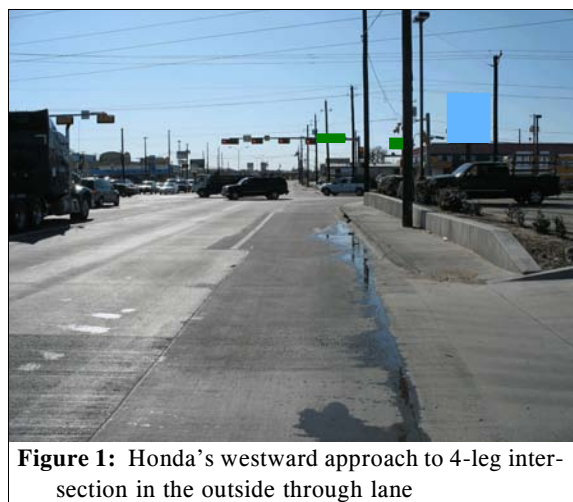
Figure 1: Honda's westward approach to 4-leg intersection in the outside through lane

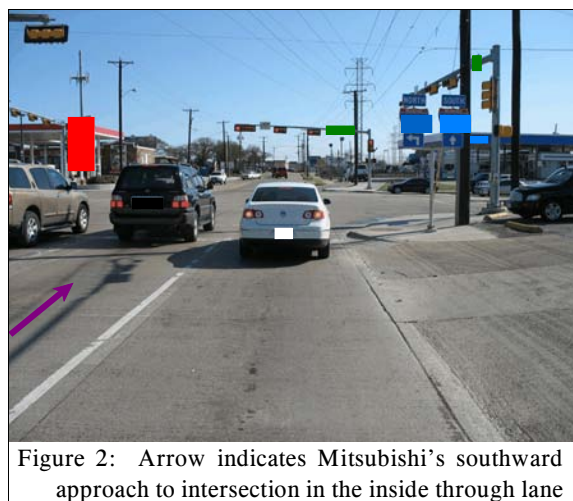
Figure 2: Arrow indicates Mitsubishi's southward approach to intersection in the inside through lane

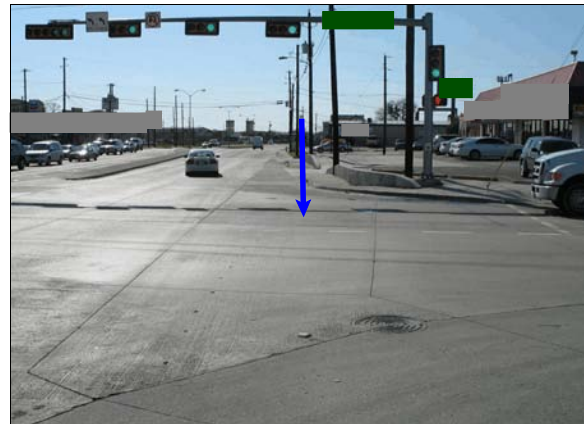
Figure 3: Honda's travel path into intersection and arrow indicates likely point of impact with Mitsubishi; traffic signal pole with traffic controls on northwest quadrant of intersection

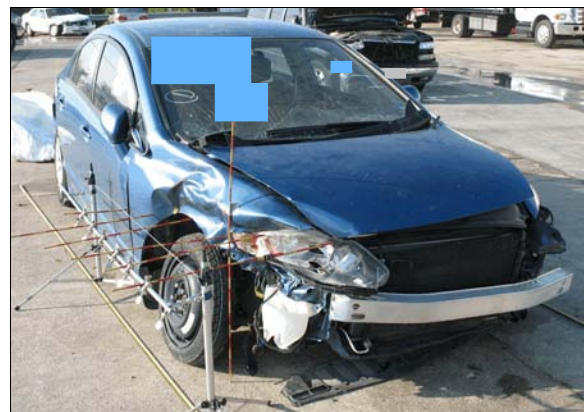
Figure 4: Honda's right front damage from frontal impact (event 1) by Mitsubishi

Exterior Damage: The Honda's initial impact (event 1) with the Mitsubishi involved the right side with the damage distributed on the right fender (Figures 4 and 7). Direct damage began 252 centimeters (99.2 inches) forward of the rear axle and extended 103 centimeters (40.6 inches) along the fender to the right front bumper corner. Induced damage began 221 centimeters (87.0 inches) forward of the right rear axle. Residual maximum crush was measured as 37 centimeters (14.6 inches) at C₆ (Figure 8). The Honda's right fender, right front wheel assembly, right corner of front bumper, front bumper fascia, hood, and right headlight and turn signal assemblies were directly damaged and crushed inward. There was induced damage to the hood, front bumper fascia, grille, left fender, and left headlight and turn signal assemblies as well as the windshield's glazing.

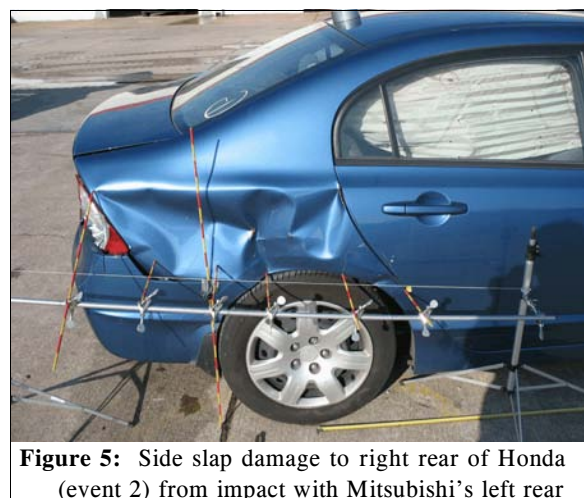
Figure 5: Side slap damage to right rear of Honda (event 2) from impact with Mitsubishi's left rear

The Honda's side slap impact (event 2) with the Mitsubishi involved the right side with damage distributed on the right quarter panel (Figures 5 and 7). Direct damage began 31 centimeters (12.2 inches) forward of the right rear axle and extended 106 centimeters (41.7 inches) rearward to the rear bumper corner. Residual maximum crush was measured as 12 centimeters (4.7 inches) occurring at C₄ (Figure 9). The direct damage is greater than Field L because C₁ is located at the top of the right quarter panel while the rear end of the direct

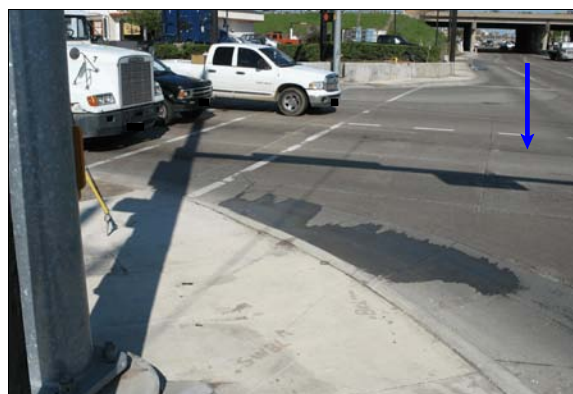
Figure 6: Eastward view from northwest quadrant of intersection with arrow indicating likely point of initial impact (event 1); Mitsubishi impacted and came to rest against signal pole (event 3)

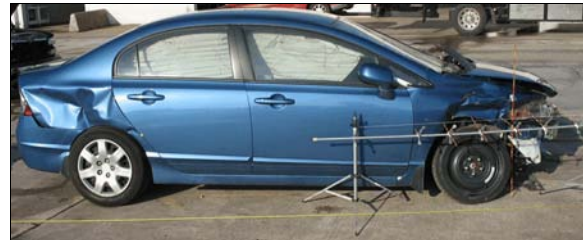
Figure 7: Honda's right side damage from impacts with Mitsubishi—initial impact (event 1) to front, side slap impact (event 2) to rear

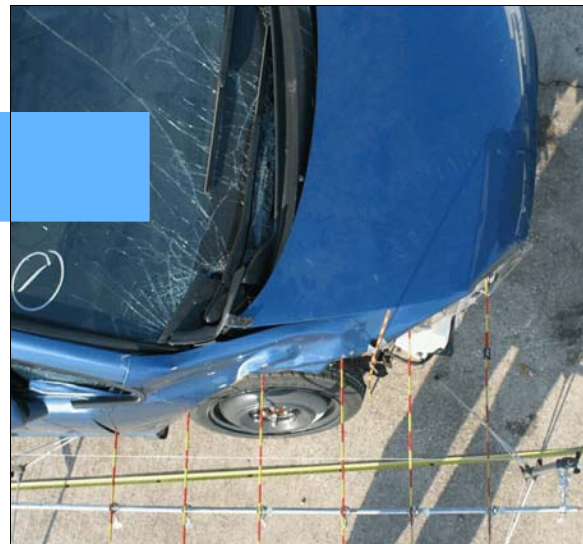
Figure 8: Overhead view of crush profile to Honda's right front (event 1)

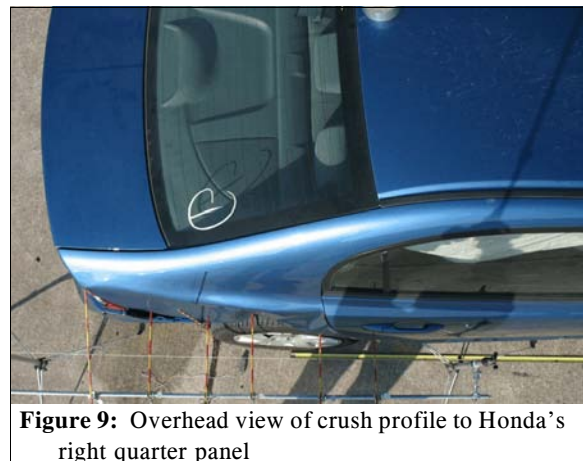
Figure 9: Overhead view of crush profile to Honda's right quarter panel

damage is located at the bumper corner, further out than C₁. The vehicle’s right quarter panel, right rear wheel assembly, right side of the rear bumper fascia, and right brakelight and turn signal assemblies were directly damaged and crushed inward. In addition, the rear portion of the right rear door was damaged. There was induced damage to the right rear door and truck lid. Remote buckling was also found on the left rear wheel assembly which was tilted outward at the top and displaced from its original position. The table below shows the Honda’s crush profiles.

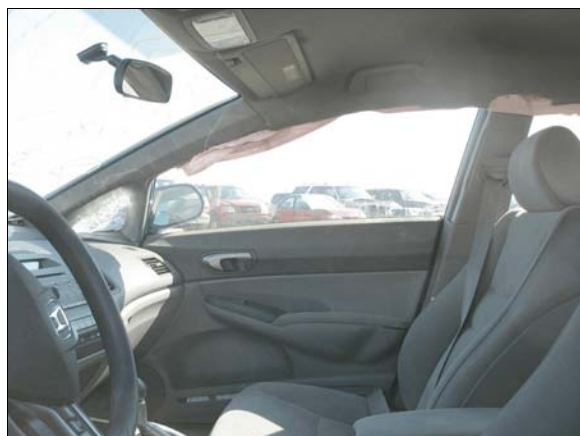
Interior Damage: Inspection of the Honda’s interior (**Figure 10**) revealed occupant contact evidence on the right front door armrest (**Figure 11**), which was dented. Friction burns were observed on the front right passenger’s shoulder belt and D-ring, and the buckle-mounted pretensioner had actuated. No other occupant contact evidence was found and no intrusion of the

Figure 10: Honda's front seating areas viewed from driver's door

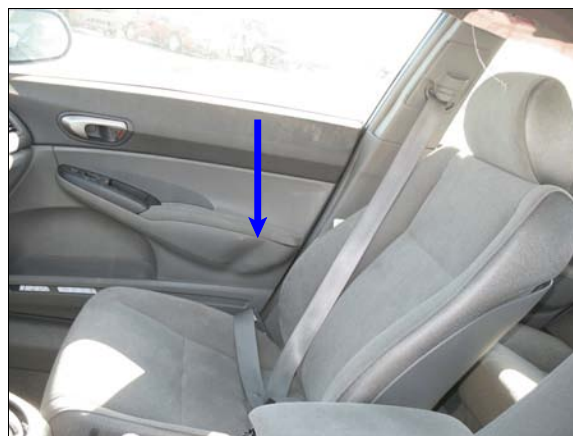
Figure 11: Arrow shows occupant contact dent in armrest of Honda's right front door

the front right passenger moved further to the right with his right hip contacting and riding down the deflating side impact air bag. Furthermore, he loaded and deformed his right arm rest (**Figure 11**). After the secondary impact, he likewise rebounded back toward his original lateral position and remained leaning forward as the vehicle came to rest. The front right passenger remained in his seating position throughout the crash.

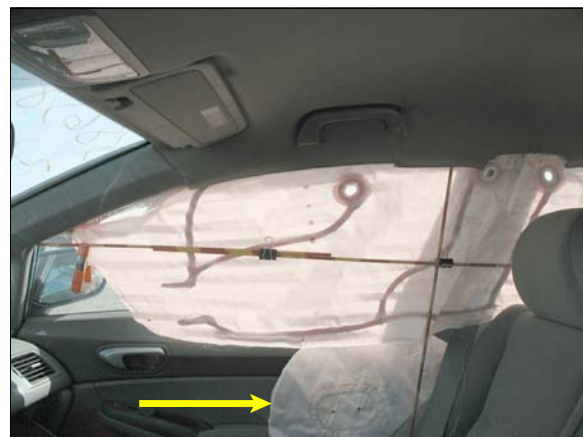
The Honda’s right side inflatable curtain air bag and front right side impact air bag deployed during the Honda’s initial (event 1) right side impact with the front of the Mitsubishi. The Honda’s right side curtain air bag was located along the right roof side rail (**Figure 12** and **13**), inside the head liner and extended along the side rail from the middle of the right A-pillar, across the front right and back right seat positions and right C-pillar. The right side curtain air bag was approximately 192 centimeters (75.6 inches) in length and 35 centimeters (13.8 inches) in height. It was constructed with inflation chambers adjacent to the front right and back right seat position. In addition, there was an inflation

Figure 12: Honda’s deployed right side curtain air bag (front portion); arrow shows deployed front right seat back-mounted side impact air bag

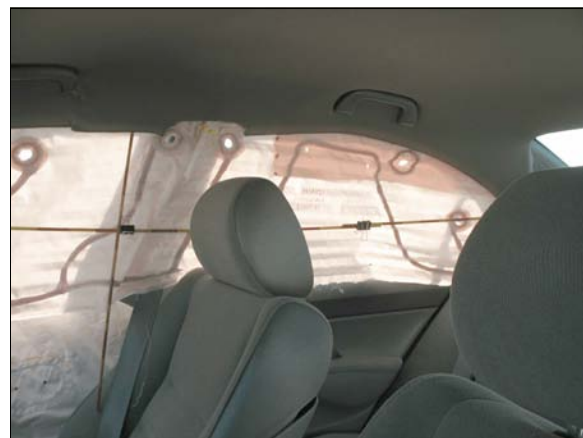
Figure 13: Center and rear portions of Honda’s deployed right side curtain air bag

chamber over the right B-pillar. There were no obvious vent ports in the air bag. Inspection of the air bag revealed no evidence of occupant contacts, and there was no damage to the air bag due to deployment.

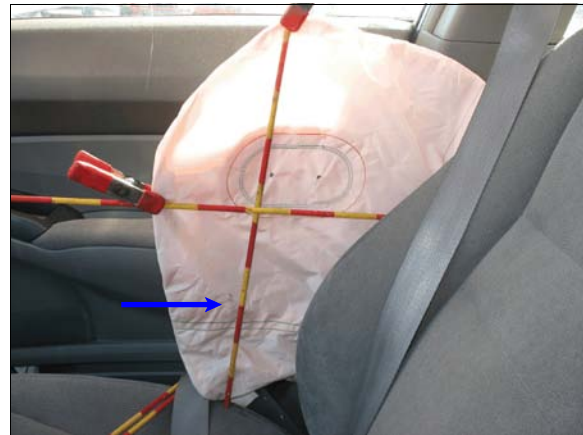
The Honda's front right seat back-mounted side impact air bag was located in the right side of the seat back. The air bag deployed through a tear-seam in the side of the seat back. The deployed air bag (**Figure 14**) was approximately oval in shape, and measured approximately 50 centimeters (19.7 inches) in height and 30 centimeters (11.8 inches) in width. It was designed without tethers and had a oval shaped area of stitching in the approximate middle of the air bag, which appeared to control the width of the air bag during deployment and have a tether-like effect on the bag's shape (i.e., there was no tether per se within the bag). What appeared to be a single vent port was located on the front edge of the air bag. There was no evidence of damage to the air bag. A small dark scuff was observed on the inboard surface of the air bag approximately 15 centimeters (5.9 inches) above the bottom of the air bag. There was no other evidence of possible occupant contact on the inboard surface of the air bag.

Figure 14: Inboard surface of Honda's front right seat back-mounted air bag; arrow shows location of small dark scuff
