ON-SITE SIDE IMPACT INFLATABLE OCCUPANT PROTECTION INVESTIGATION

CASE NUMBER - IN08015

VEHICLE - 2004 CADILLAC CTS

CRASH DATE - February 2008

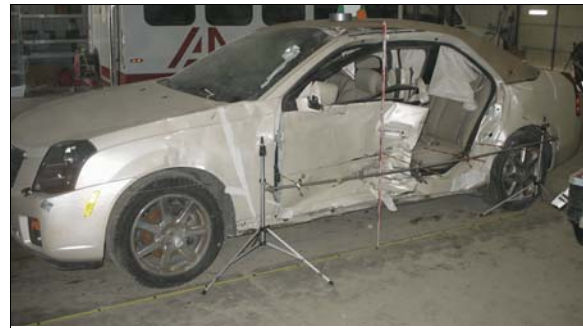
Figure 1: The damaged 2004 Cadillac CTS

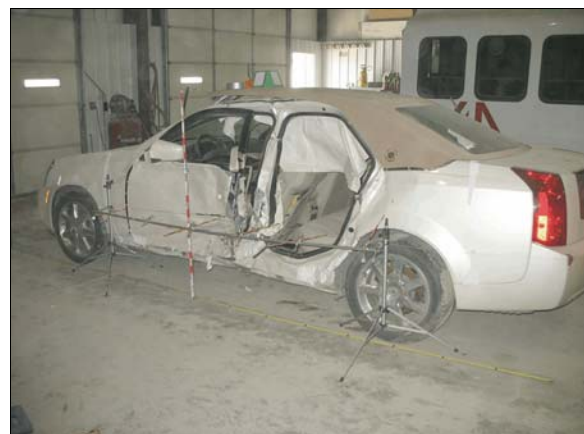
Figure 4: Damage to left side of Cadillac from impact with the Jeep

Exterior Damage: The Cadillac’s impact with the Jeep involved the left side plane. The left front and left rear doors and the left quarter panel all sustained direct damage. The direct damage began 69 cm (27 in) rear of the left front axle and extended 213 cm (83.9 in) along the left side of the vehicle. The crush measurements were taken at the mid-door level and the maximum residual crush was 29 cm (11.4 in) occurring at C₄. The vehicle’s sill height was 36 cm (14.8 in) and the height of the maximum door crush was 50 cm (19.7 in). The door sill differential was 21 cm (8.3 in). The crush measurements at C₂ and C₃ (Figure 5) were estimated based on the appearance of the crush on the front door and crush at the lower portion of the B-pillar (Figure 6) because the left rear door had been removed by rescue personnel. The crush values at C₄ and C₅ were also adjusted to account for the displacement of the left front door when it was forced open during the rescue operations. The table below shows the vehicle’s front crush profile.

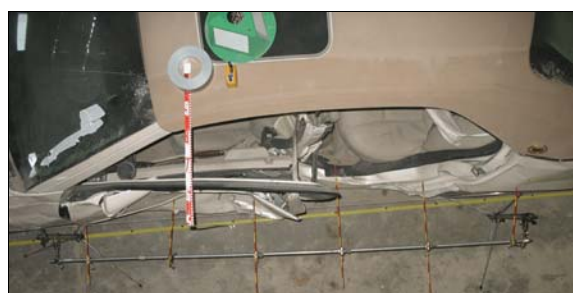
Figure 5: Top view of crush to left side of Cadillac

Damage Classification The Cadillac’s Collision Deformation Classification was **10-LZEW-3 (290 degrees)** for the impact with the Jeep. The Missing Vehicle algorithm of the WinSMASH program calculated the Cadillac's total Delta V 21 km/h (13.1 mph). The longitudinal and lateral velocity changes were -7.2 km/h (-4.5 mph) and 19.7 km/h (12.2 mph), respectively. The results are considered borderline because they are based only on the damage to the Cadillac. The vehicle’s EDR recorded a maximum longitudinal velocity change of 10.17 km/h (-6.32 mph).

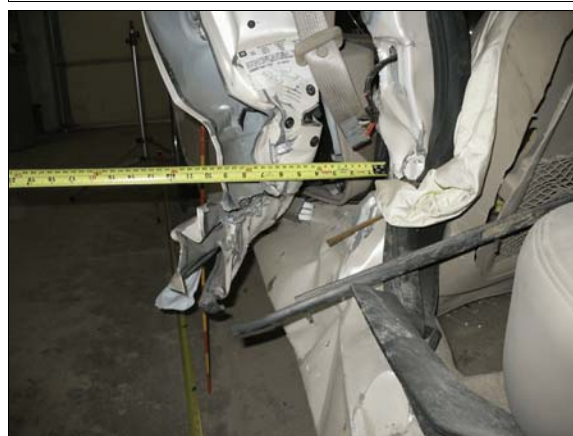
Figure 6: Back to front view of crush to lower portion of the left “B”-pillar

The passenger compartment sustained intrusions of the left front door, left rear door, left B-pillar, sill, and the left roof side rail. The left B-pillar and left front door intruded laterally 15

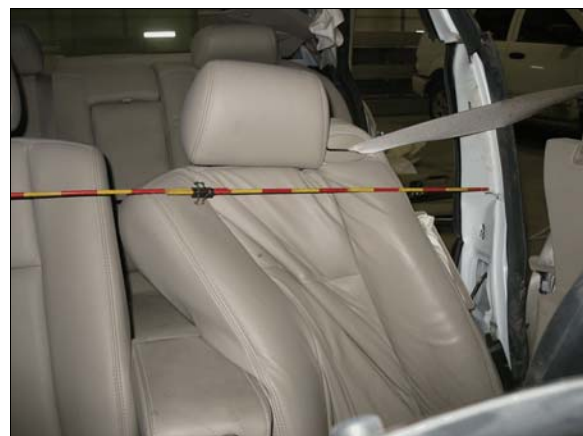
Figure 7: Intruded driver’s seat back

cm (6 in) into the front left sector while the sill intruded 6 cm (2.4 in), and the left roof side rail was estimated to have intruded between 3 and 8 cm (1.2 and 3.1 in). The driver's seat back (**Figure 7**) was also displaced to the right and intruded laterally 22 cm (8.6 in) into the front center sector. Due to the displacement of the left front door and upper B-pillar/roof side rail during the rescue operations, the door and side rail intrusions were estimated.

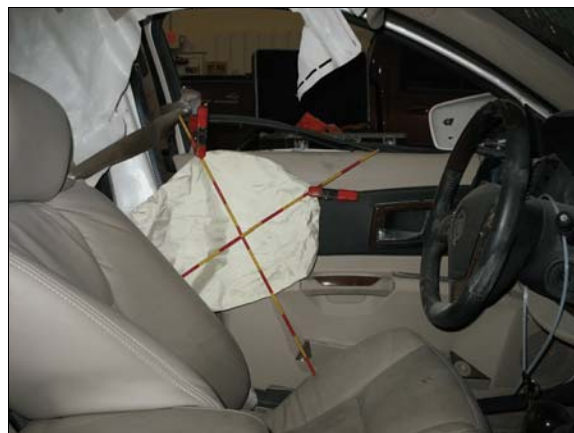
The left front seat back-mounted side impact air bag was located in the left side of the driver's seat back and deployed through a rectangular-shaped module cover flap that was 24 cm (9.4 in) in length. The deployed air bag was approximately oval in shape (**Figure 8**) and was 36 cm (14 in) in width and 32 cm (13 in) in height. A few deployment scuffs and grease/dirt smears were noted on the inboard and outboard sides of the air bag, but no discernable occupant contacts or damage were observed.

Figure 8: Driver's seat back-mounted side impact air bag

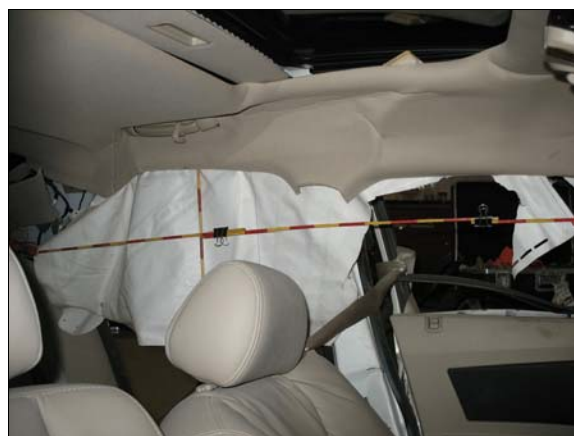
The left side impact curtain air bag (**Figure 9**) was located along the left roof side rail, inside the head liner and extended from the A-pillar to the C-pillar. The side curtain air bag was 127 cm (50 in) in length and 40 cm (16 in) in height. The front portion of the air bag had been cut away.

Figure 9: Left side curtain air bag; front portion of air bag cut out by fire department
