On-Site Rollover Investigation
Dynamic Science, Inc. (DSI), Case Number DS08018
2006 Honda Civic LX Coupe
Washington
May 2008

**Dynamic Science, Inc.
Crash Investigation
Case Number: DS08018**

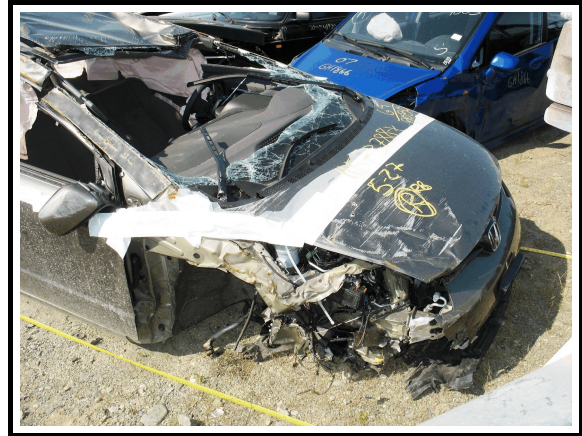
The Honda sustained moderate front end and right side damage as a result of the frontal impact with the traffic barrier. A section of the front right bumper, right front rim/tire, and right front fender were displaced from the vehicle during the crash (**Figure 3**). Those components could not be located and

therefore were not inspected. As the Honda engaged the impact attenuator, the vehicle rotated clockwise approximately 90 degrees and the contact damage was distributed across the front end. Direct damage for the frontal impact began at the front left bumper corner and extended 144 cm (56.7 in) to the right. An estimated 12 cm (4.7 in) of additional direct damage would have extended to the front right bumper corner that was torn from the vehicle.

Figure 3. Front end and right side damage

Six crush measurements were taken at bumper level to the existing bumper fascia and to the backing bar where the fascia was missing. The crush measurements were as follows: C1 = 0 cm, C2 = 0 cm, C3 = 0 cm, C4 = 0 cm, C5 = 5 cm (2.8 in), C6 = 10 cm (3.9 in). The maximum crush was located at C6. The Collision Deformation Classification (CDC) for the Event 1 was 12FDEW1. The damage to the right front rim and axle was not included in the CDC due to National Automotive Sampling System (NASS) coding conventions.

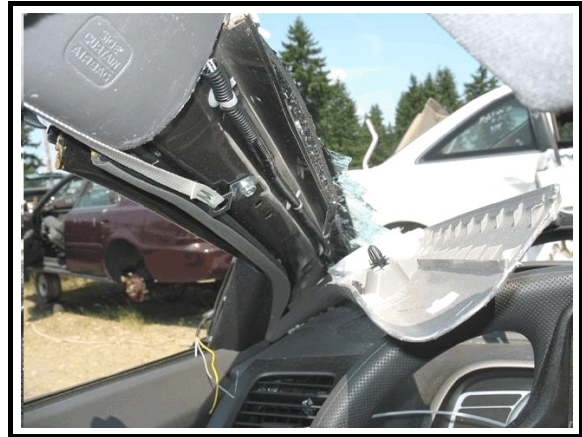
The Honda sustained interior damage as a result of the rollover. The windshield was out of place and holed, probably as a result of extrication activity. The interior A-pillar cover was displaced beginning at its upper aspect and extending down to the left instrument panel (**Figure 4**). The glazing was disintegrated at the left front and rear, right front, and backlight windows. Three of the five head restraints were missing from the seat backs, probably as a result of extrication activity.

Figure 4. Interior damage, left A-pillar

The passenger compartment intrusions were confined primarily to the front row left area, in close proximity to the driver. The intruded components included the left A-pillar, left roof, left and center windshield header, and left roof side rail.

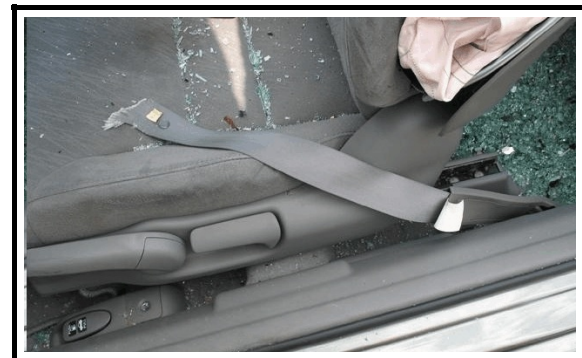
Figure 5. Driver's safety belt webbing was cut during extrication efforts.

The driver's safety belt webbing was cut through in two places: at the lap portion of the belt webbing near the stop button (**Figure 5**) and near the D-ring. The safety belt webbing was cut by emergency personnel during extrication activity. A section of webbing that was cut away was missing and therefore was not examined. The latch plate was found by the DSI investigator in the buckled position (**Figure 6**). Neither the latch plate, the safety belt webbing nor the D-ring evidenced occupant loading. However, based on the extrication damage to the safety belt webbing and the driver's kinematics, it was determined that the driver's safety belt was used during the crash. The driver's safety belt buckle stalk was examined and measured. The

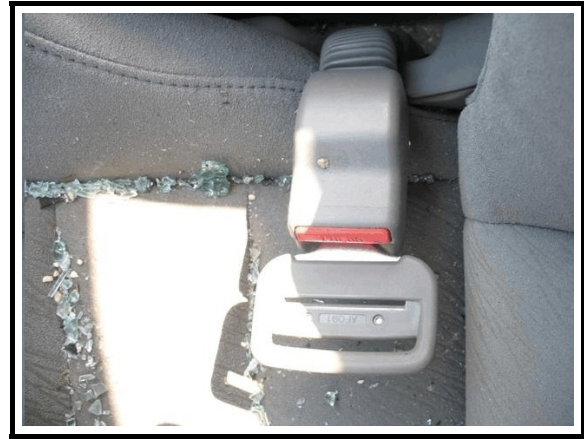
flexible section of stalk measured 6 cm (2.4 in). The right side buckle stalk measured the same length. Later, the buckles of an exemplar vehicle were measured and yielded identical results. It was determined the driver's buckle pretensioner did not actuate, based on these measurements. The shoulder portion of the driver's safety belt webbing was found retracted into the B-pillar. The safety belt was configured with an ELR retractor and a retractor pretensioner, and the retractor was not locked in place due to pretensioner actuation. Based on the functional retractor, it was determined that the retractor pretensioner did not actuate during the crash.

Figure 6. Driver's safety belt latch plate was found in buckled position

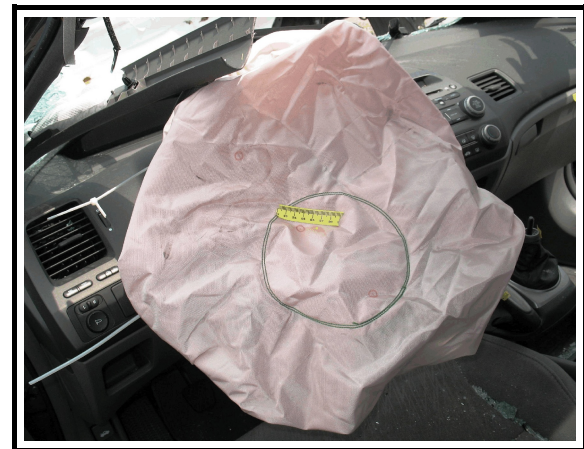
Figure 7. Driver's frontal air bag

The vehicle's advanced dual-stage frontal air bags were designed to deploy according to impact severity. Front seat sensors determined whether the air bags should inflate; the appropriate power of inflation was based on occupant weight. The driver's frontal air bag deployed during Event 1 due to sufficient longitudinal deceleration at impact with the impact attenuator.

The driver's frontal air bag deployed from the steering wheel hub through one upper and two lower

cover flaps (**Figure 7**). It was configured with two circular vent ports and two internal tethers. The air bag was circular in shape and measured 47 cm (18.5 in) in diameter in its deflated state. The front center of the bag was configured with a circular stitching pattern that measured 16 cm (6.3 in) in diameter. Within the stitched circle was a yellow-colored fabric transfer which covered an area 5 x 2 cm (2.0 x 0.8 in). This transfer mark was a result of driver contact with the air bag.

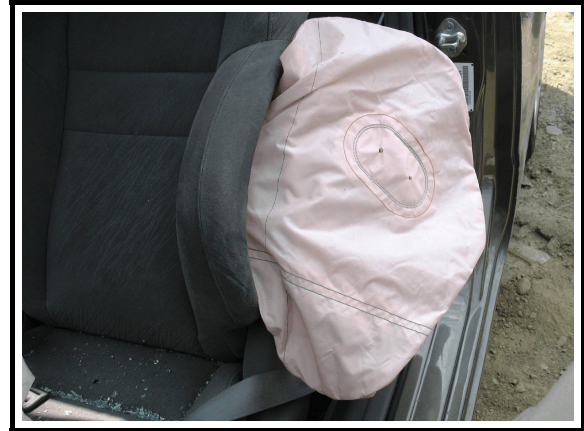
The driver's seat-mounted side air bag deployed during the rollover event (**Figure 8**) from a module in the outboard aspect of the driver's seat back. The air bag measured 52 cm (20.5 in) in height and 40 cm (15.8 in) in width in its deflated state. The air bag was configured with a single vent port and no tethers. Faint transfers were present on the outboard aspect of the air bag as a result of contact to the interior door panel during the deployment. There was no evidence of occupant contact or damage on the air bag.

Figure 8. Left seat-mounted side air bag

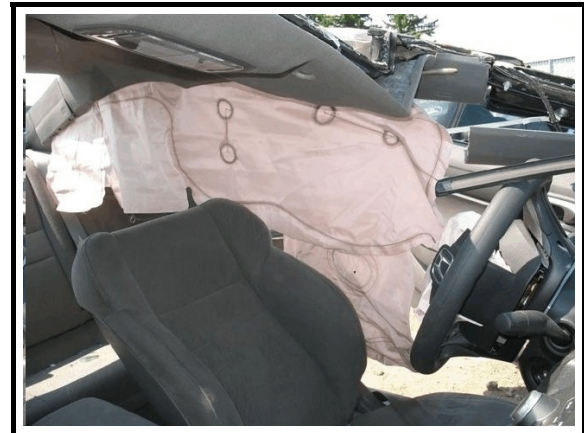
The side curtain air bags were monitored by side impact sensors, and deployed during the rollover event. They provided head protection coverage for the first and second row outboard seating positions (**Figures 9-10**). The side curtain air bags deployed from a configuration of three in-line flaps from the left and right roof rails and measured 140 cm (55.1 in) in length and 35 cm (13.8 in) in height. Each was configured with a single external tether at its forward aspect.

Figure 9. Left side curtain air bag and seat-mounted side air bag

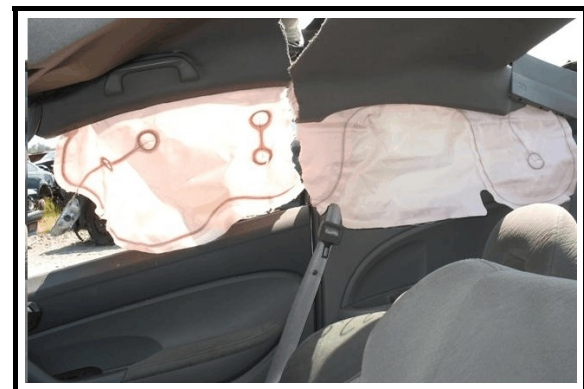
During extrication activity, the right side curtain air bag was cut from bottom to top near the B-pillar at 65 cm (25.6 in) aft of the forward aspect. The tether strap was cut or torn into two pieces; a section of tether remained attached to the bag and another was attached to the roof rail.

Figure 10. Right side curtain air bag was cut near B-pillar

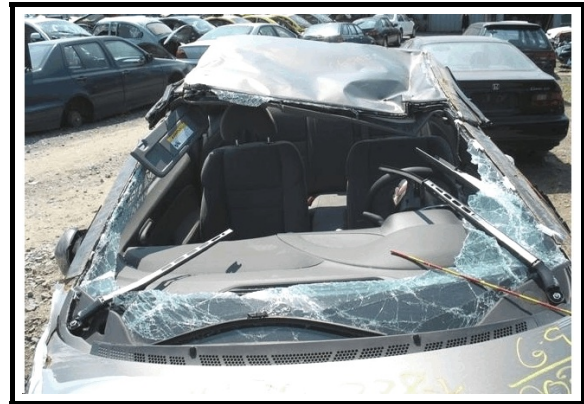
The maximum lateral crush sustained in the rollover event was located at the top left A-pillar, lateral to the top of the windshield, and measured 6 cm (2.4 in). The maximum vertical crush sustained in the rollover was located at the left roof, 25 cm (9.8 in) right of the left roof side rail, and measured

12 cm (4.7 in). The CDC for Event 3 was 00TYDO3.

Figure 11. Frontal view showing roof crush sustained during rollover

The vehicle's pre-crash speed and stability were not known. Following the impact with the impact attenuator, the vehicle rotated clockwise 220 degrees, initiated a right side leading turn over, and rolled three quarter-turns (**Figure 11**). It is not known what effect driver input had on the rollover; however, steering and braking forces were mitigated due to the vehicle's rotational forces and the displacement of the right front rim and tire. The vehicle rolled three quarter turns and came to final rest on its left side. The roll distance was not known.
