On-Site Rollover Investigation
Dynamic Science, Inc. (DSI), Case Number DS08019
2007 Ford F150
Oregon
June 2008

1. Report No. DS08019	2. Government Accession No.		3. Recipient Catalog No.	
4. Title and Subtitle Rollover Investigation		5. Report Date December 16, 2008

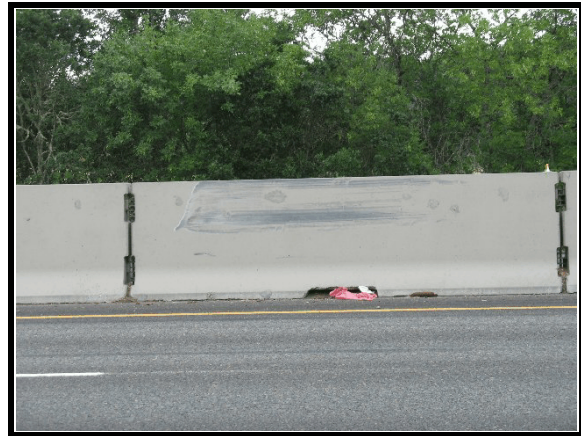
Figure 3. Evidence of trailer contact with center divider

The driver steered back and forth but was unable to regain control of the Northwood trailer. The trailer contacted the center divider with its left side, depositing a 2.7 m (9 ft) mark (**Figure 3**). The trailer then rotated clockwise and separated from the Ford. The Ford began a clockwise rotation,

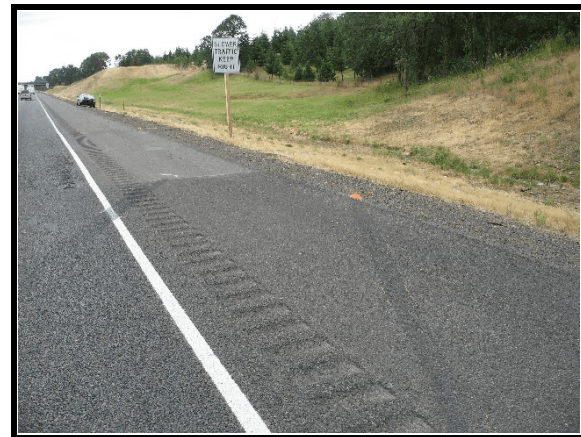
Figure 4. Path of Ford to rollover and impact with post

traveled across the adjacent travel lane, and onto the eastern shoulder. Near the edge of the shoulder, the vehicle tripped and began a left side leading rollover (**Figure 4**). After rolling four quarter turns, the left side of the Ford struck and sheared a wooden pole supporting a traffic sign. The Ford rolled one additional quarter turn and came to rest on its left side facing southeast (**Figure 5**). After contacting the barrier, the trailer crossed the adjacent travel lane, departed the roadway to east and overturned onto its left side, north of the Ford and approximately 61 m (200 ft) north of the barrier contact point.

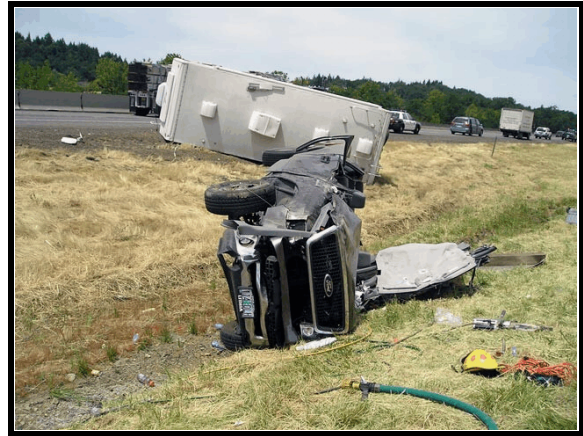
Figure 5. Subject vehicle, 2007 Ford F150, at final rest

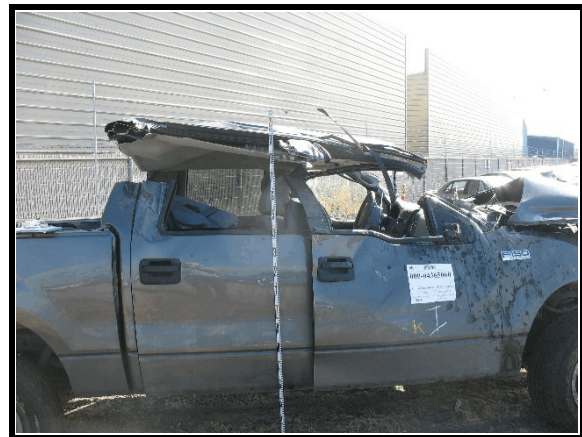
Figure 6. Right side damage, 2007 Ford F150

There was damage to the top and sides from the rollover event (**Figure 6**). There was 535 cm (210.6 in) of direct contact along the left side that extended along the top of the bed, into the C-pillar and left rear door, along the top of the driver's door into the A-pillar and along the top of the left front fender. There were vertical striations/scratches present in the left front and left rear sideglass. The direct damage on the right side began 71 cm (27.9 in) forward of the rear axle and extended 352 cm (138.5 in) forward along the right side plane. There was damage to the fender,

upper right front door, and above the right rear door. There was lateral crush to the right B-pillar/sideglass frame that extended 34 cm (13.4 in) to the left. The right bumper corner was deformed laterally 32 cm (12.6 in) to the left. There was damage to the roof that extended from the backlight header forward 349 cm (137.4 in). The damage on the right side, at the rail, was 58 cm (22.8 in) wide. The damage on the left side, at the rail, was 15 cm (5.9 in) wide. The maximum vertical crush was located at the right B-pillar, but the damage was masked by extrication efforts. The CDC for the rollover event was 00TDDO3.

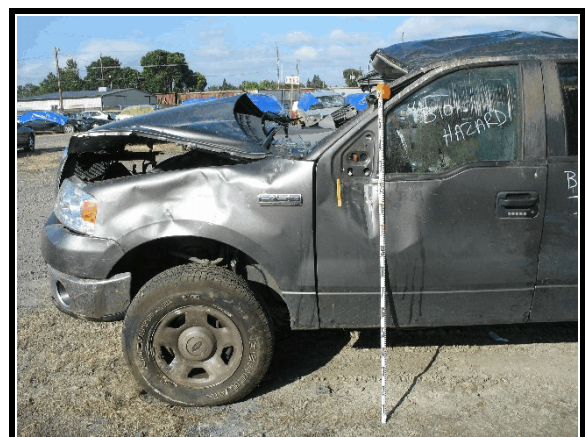
Figure 7. Left side damage from post impact

There was minor damage to the F150 from the impact with the wooden pole (**Figure 7**). The damage was located 67 cm (26.4 in) rear of the front axle and measured 14 cm (5.5 in) in width. The height along the door was 30 cm (11.8 in). The field L measured 21 cm (8.3 in). The side view mirror was knocked off by this impact. Six crush measurements were taken near the beltline level as follows: C1 = 0 cm, C2 = 2 cm (0.8 in), C3 = 3 cm (1.2 in), C4 = 2 cm (0.8 in), C5 = 1 cm (0.4 in), C6 = 0 cm. The maximum crush was located at C3. The CDC for the pole impact was 09LPHN2.

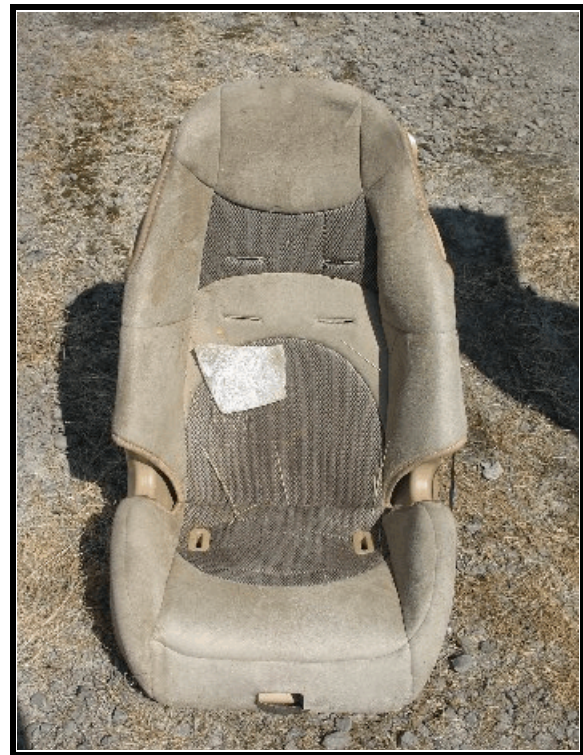
Figure 8. Dorel High Back Booster Car Seat

The 3-year-old male second row left occupant was seated in a Dorel High Back Booster Car Seat (**Figure 8**). The model number was 22-209 RDO and the date of manufacture was June 13, 2006. The seat was designed to be used as a forward facing child seat or a belt-positioning booster seat. The 5-point internal harness had been removed and the seat was being used as a belt-positioning booster seat. When used as a booster, the manufacturer recommended the seat be used for children greater than 1 year of age, whose weight was between 18-36 kg (40-80 lbs), and whose height was between 109-132 cm (43-52 in). The 3-year-old using the seat weighed 16 kg (36 lbs) and was 104 cm (41 in)

tall. He did not fall within the manufacturer recommendations. The child had gotten into the seat on his own and had put on his own seat belt. According to the interviewee, the lap and shoulder belt was being worn properly with the shoulder belt webbing routed through the upper guide. There was 9 cm (3.5 in) of scuffed plastic located at and below the left lower belt guide (**Figure 9**). The damage likely occurred during the rollover sequence as the left side of the seat came into contact with the left rear door.

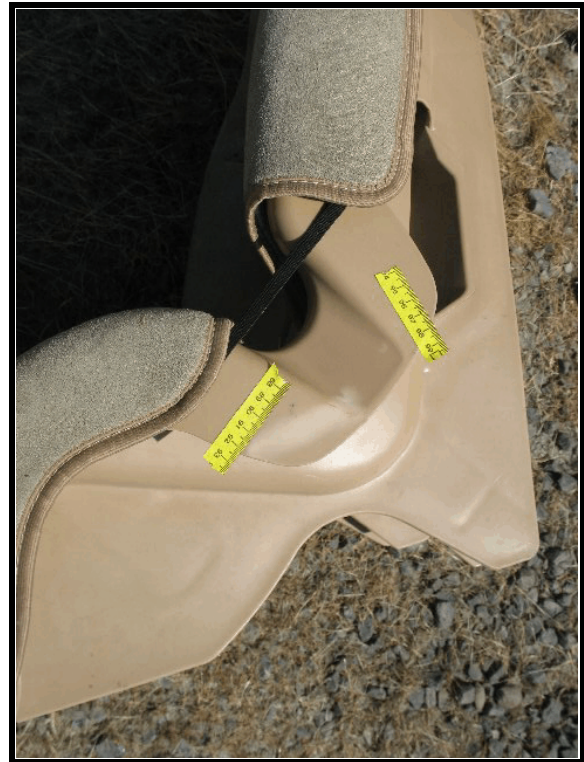
Figure 9. Scuffed plastic loading mark to left lower belt guide

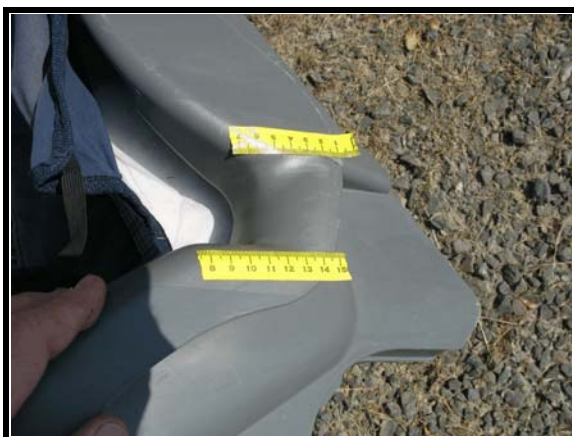
The 5-year-old male second row right occupant was seated in an Evenflo Sightseer booster seat (**Figure 10**). The model number was 2692198P2 and the date of manufacture was October 12, 2001. The manufacturer recommended the seat be used for children who are between 94-137 cm (37-54 in) in height, who weigh 9-36 kg (20-80 lbs), and whose ears are below the top of the restraint back. The 5-year-old child weighed 21 kg (46 lbs) was 107 cm (42 in) tall. He was within the manufacturer's weight and height recommendations. The child had gotten into the seat on his own and had put on his own seat belt. According to the interviewee, the lap and shoulder belt was being worn properly with the shoulder belt webbing routed through the upper shoulder belt guide. There were indications of seat belt loading along the left lower seat belt guide (**Figure 11**).

Figure 11. Loading to left lower seat belt guide

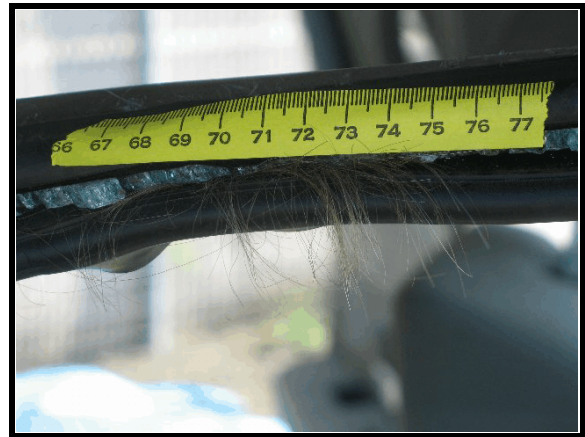
The 51-year-old female passenger was seated in the front right position. She was restrained by the 3-point manual lap and shoulder belt. As the Ford rotated, she was displaced slightly to the left. As the vehicle began to roll, she was held in place by the lap and shoulder belt. Between the second and third quarter turns, the right side roof rail contacted the ground. The right side of this occupant's head came into contact with the roof rail/window frame area. She sustained a right side skull fracture, a large right side scalp laceration, a cervical spine injury, and had internal bleeding. She was transported to a local hospital and then transferred to an area trauma center where she was hospitalized for 14 days.

Figure 12. Window frame contact

<u>Injury</u>	<u>AIS Code</u>	<u>Injury Mechanism</u>	<u>Confidence Level</u>
Right side skull fracture	150400.2,1	Window frame	Certain
Right scalp laceration	190600.1,1	Window frame	Certain
Cervical spinal injury. Coded as cervical strain without fracture or dislocation	640278.1,6	Window frame	Probable
