TRANSPORTATION RESEARCH CENTER

ON-SITE CHILD SAFETY SEAT INVESTIGATION

CASE NUMBER - IN08020
LOCATION - TEXAS
VEHICLE - 2004 GMC ENVOY
CRASH DATE - March 2008

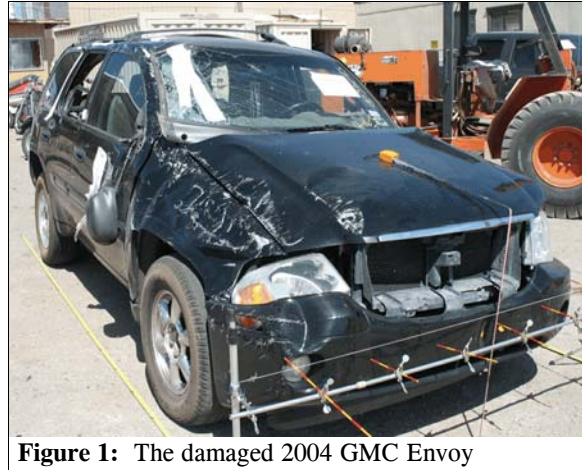
Figure 1: The damaged 2004 GMC Envoy

Exterior Damage: The damage from the rollover (Figures 1, 5 and 6) involved the top plane, both side planes, and portions of the front and back bumpers. The direct damage on the left side plane began on the left fender and extended rearward to the back bumper. The direct damage on the right side began at the front bumper corner and extended rearward along the fender and roof side rail to the D-pillar. The right side of the back bumper fascia was also scratched. The direct damage to the top plane began at the front right bumper corner and extended to the back of the vehicle. Scratches along both roof side rails and across the rear hatch also involved the full width of the roof, which was 123 cm (48.4 in). The maximum vertical crush was 8 cm (3.1 in) and occurred on the roof at the second row right seat position. The maximum lateral crush was 5 cm (2 in) and occurred on the right A-pillar.

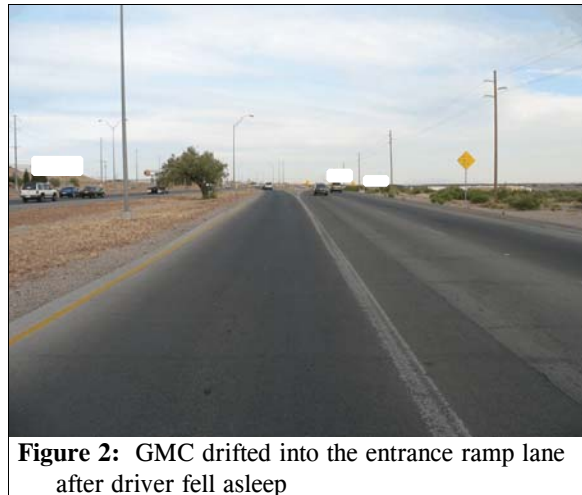
Figure 2: GMC drifted into the entrance ramp lane after driver fell asleep

enter the interstate. She fell asleep and the vehicle drifted to the left into the entrance ramp lane (Figure 2). The driver was awakened and initiated a right steering maneuver. The vehicle traveled through the gore and reentered the roadway (Figure 3). The driver steered left and the vehicle departed the north side of the roadway (Figure 4). As the GMC entered the gravel on the north roadside, the driver initiated a right steering maneuver and the vehicle began to rotate clockwise.

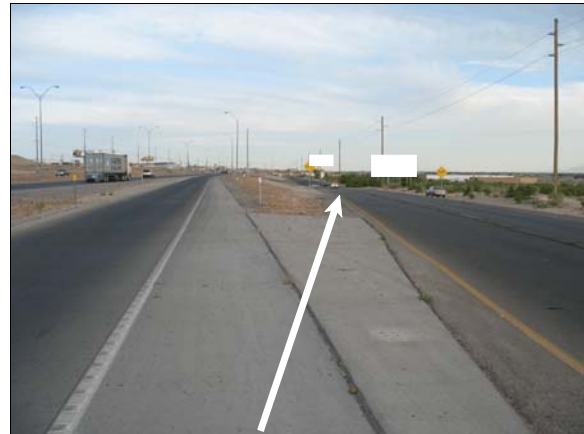
Figure 3: Driver steered right and the GMC traveled through the gore and reentered the roadway

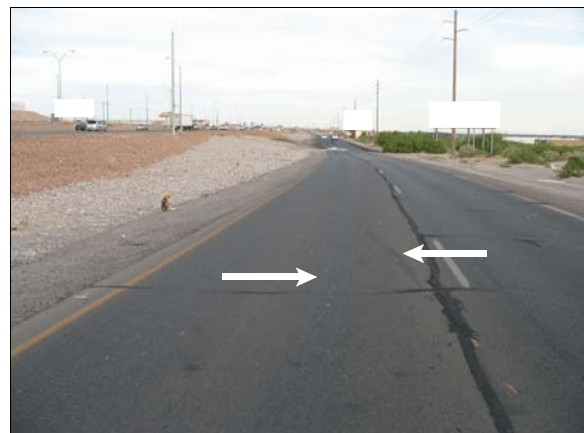
Figure 4: Driver steered left (arrow on left shows right front yaw mark; arrow on right shows right rear yaw mark) and GMC departed north side of roadway

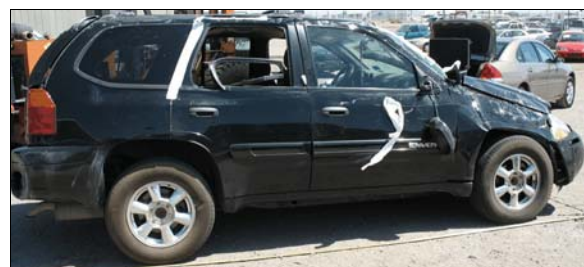
Crash: As the rotation increased, the vehicle tripped and rolled over (Figures 5 and 6), left side leading, an unknown number of quarter turns. The vehicle came to final rest on its left side partially on the shoulder and the left lane heading west. The right rear window glazing disintegrated during the rollover and the second row left and right passengers were fully ejected through the right rear window opening (Figure 5). Both occupants came to final rest on the roadway, but their location relative to the vehicle is not known.

Figure 5: Damage from the rollover on the right side of the GMC; second row left and right passengers ejected through right rear window opening

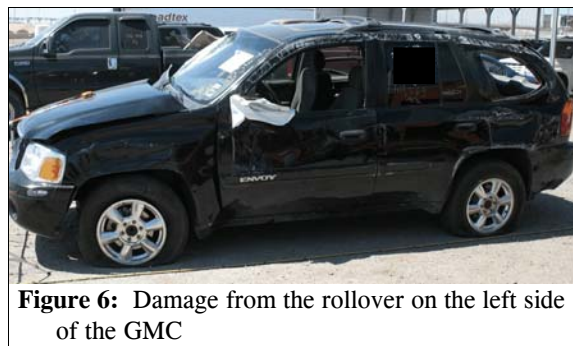
Figure 6: Damage from the rollover on the left side of the GMC

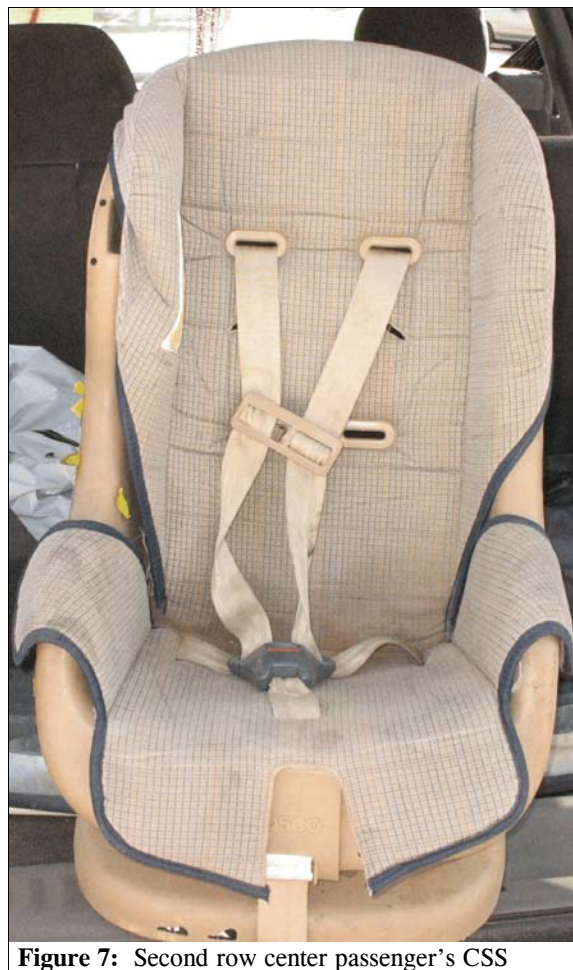
The GMC's back center passenger [2-year-old, male; 86 cm and 12 kg (34 in, 27 lbs)] was seated in a convertible CSS (**Figure 7**). The CSS was a Cosco brand manufactured by the Dorel Juvenile Group. The CSS model, model number, date of manufacturer, and weight and height limitations could not be determined because the manufacturer's labels had been removed or worn.

Figure 7: Second row center passenger's CSS

The CSS was constructed of a one piece plastic shell and the seat back and seat cushion were fitted with a cloth pad. Inspection of the CSS revealed a few light discolorations in the plastic on the left and right sides; otherwise, the CSS was undamaged and unremarkable.
