On-Site Hybrid Vehicle Investigation
Dynamic Science, Inc. (DSI), Case Number DS08020
2005 Toyota Prius
Washington
June 2008

1. Report No. DS08020		2. Government Accession No.		3. Recipient Catalog No.	
4. Title and Subtitle Hybrid Vehicle Investigation			5. Report Date August 3, 2009

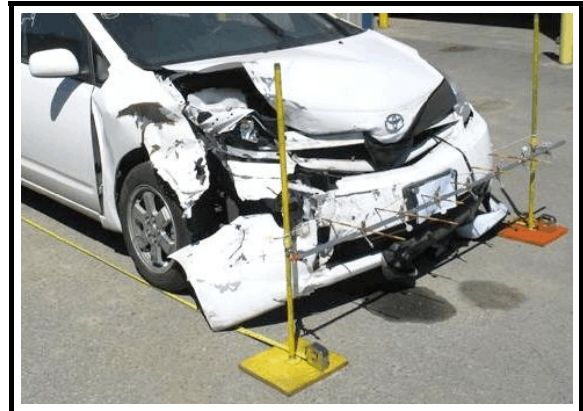
The Toyota sustained minor front end and right side damage as a result of the frontal impacts with the Hyundai and Ford (**Figure 3**). Direct damage to the front bumper began at the front right bumper corner and extended 65 cm (25.6 in) to the left. The bumper fascia and foam backer were torn from the vehicle at the right end of the backing bar at 12 cm (4.7 in) to the left of the bumper corner. The Field L began at the front right bumper corner and extended 114 cm (44.8 in) to the left.

Figure 3. Subject vehicle showing front end crush measurement

Six crush measurements were taken at mid-bumper level as follows: C1 = 3 cm (1.2 in), C2 = 2 cm (0.8 in), C3 = 2 cm (0.8 in), C4 = 4 cm (1.6 in), C5 = 3 cm (1.2 in), C6 = 4 cm (1.6 in). Maximum crush was located at C5.

Direct damage resulted in crush to the vehicle's grille and hood. In accordance with National Automotive Sampling System (NASS) coding conventions for above-bumper crush, a second set of measurements was taken at the upper radiator support as follows: C1 = 2 cm (0.8 in), C2 = 1 cm (0.4 in), C3 = 1 cm (0.4 in), C4 = 5 cm (2.0 in), C5 = 20 cm (7.9 in), C6 = 42 cm (16.5 in). Maximum crush was located at C6. Based on the two sets crush measurements, the average crush measurements were as follows: C1 = 3 cm (1.2 in), C2 = 2 cm (0.8 in), C3 = 2 cm (0.8 in), C4 = 4 cm (1.6 in), C5 = 12 cm (4.7 in), C6 = 23 cm (9.1 in). Maximum crush was located at C6 and measured 42 cm (16.5 in) as it was not averaged. The frontal damage resulting from the two impacts could not be separated and a single Collision Deformation Classification (CDC) of 01FZEW3 was generated to describe the final appearance of the damage.

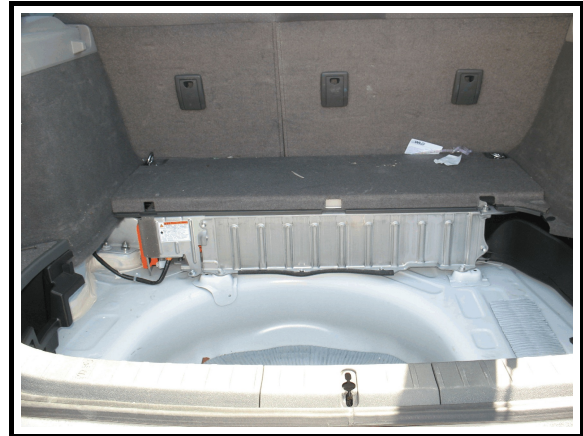
Figure 4. Battery module, located beneath second row seats

1. There were no indications of electrolyte spillage from the propulsion battery either outside or inside the passenger compartment (**Figure 4**).
2. There was no movement of the propulsion battery or other system components including the service plug (**Figure 5**).

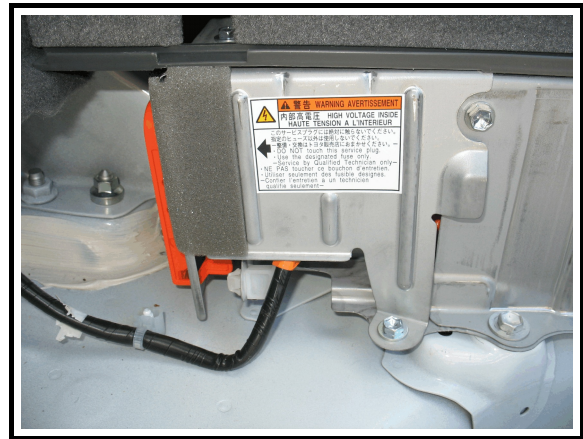
Figure 5. Service plug remained in place

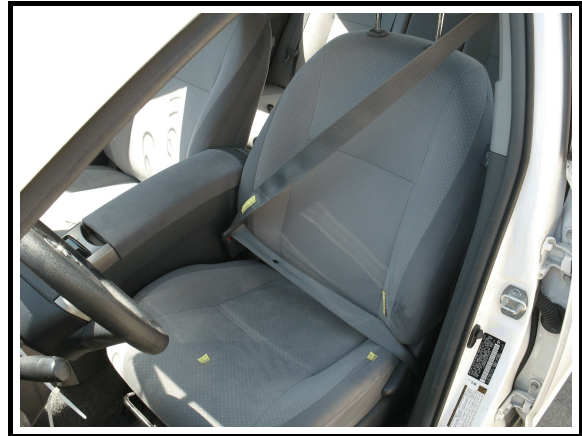
Figure 6. Driver's seat and safety belt restraint

The lap portion of the driver's safety belt webbing exhibited slight fraying along the upper edge where the belt was routed through the latch plate with the belt in the buckled position, indicating historical usage (**Figure 6**). The safety belt, latch plate and D-ring showed no evidence of occupant loading. It was determined the safety belt was used by the driver during the crash based on evidence of historical usage, the absence of occupant contacts relating to the frontal impacts, and the fact that the occupant sustained no injuries.

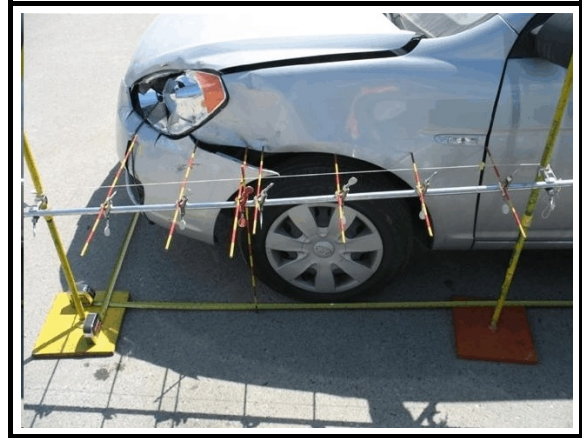
The Field L began at the front left bumper corner, extended rearward 110 cm (43.3 in), and ended 47 cm rearward of the front axle at the A-pillar (**Figure 7**). The front bumper fascia was fractured and displaced from the vehicle and the front left headlamp was fractured.

Figure 7. 2007 Hyundai Accent, showing left side crush measurement

Six crush measurements were taken at the mid-door level on the left side as follows: C1 = 0 cm, C2 = 0 cm, C3 = 2 cm (0.8 in), C4 = 8 cm (3.2 in), C5 = 7 cm (2.8 in), C6 = 10 cm (3.9 in). Maximum crush was located at C6 and measured 10 cm (3.9 in). The CDC for the left side impact was 10LFEW1.

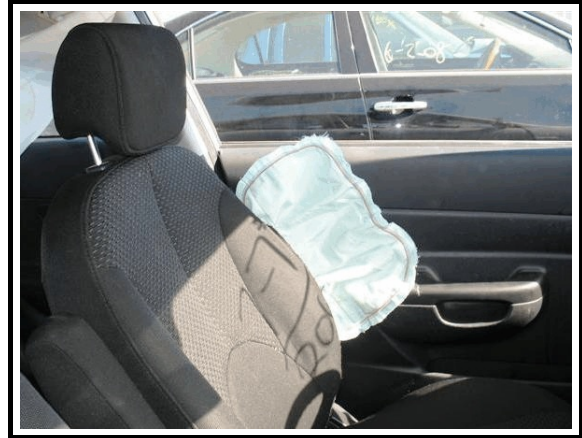
Figure 8. Driver's seat-mounted side air bag

During the crash the Hyundai deployed the driver's seat-mounted side air bag (**Figure 8**). The air bag was rectangular in shape, measured 45 cm (17.7 in) in height, 25 cm (9.8 in) in width. It displayed evidence of contacts on both the inboard and outboard aspects. A dark-colored L-shaped transfer was present on the bottom edge of the inboard panel measured 5 x 9 cm (2.0 x 3.5 in) and was determined to be an occupant contact. The contact was a fabric transfer and was probably deposited at impact when the driver's left hip contacted the air bag in response to the 10 o'clock direction of force.

The outboard panel had several patches of dark-colored transfers which were deposited during deployment when the air bag contacted the left door panel. Correlating evidence of these transfers was present on the interior door panel in the form of white residue and light abrasions.

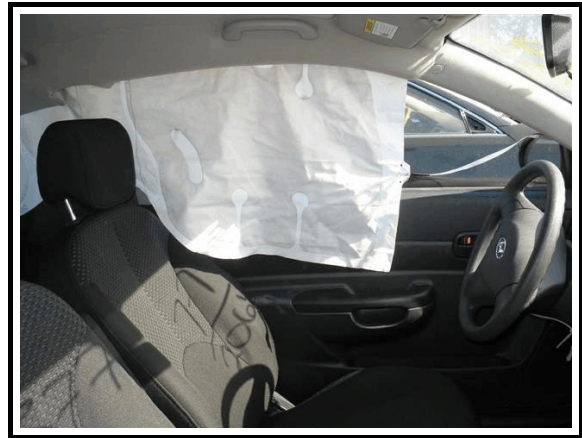
Figure 9. Driver's side curtain air bag

The left side curtain air bag deployed from a module located in the roof side rail (**Figure 9**). The air bag measured 134 cm (52.8 in) in length, and 47 cm (18.5 in) at its forward aspect. The middle and rear aspects measured 28 cm (11.0 in) and 27 cm (10.6 in), respectively. The air bag was configured with a single tether at the forward aspect which measured 40 cm (15.8 in). The side curtain air bag was undamaged and was otherwise unremarkable.
