**CALSPAN ON-SITE CERTIFIED ADVANCED 208-COMPLIANT VEHICLE**

**CRASH INVESTIGATION**

**SCI CASE NO.: CA08021**

**VEHICLE: 2008 NISSAN SENTRA**

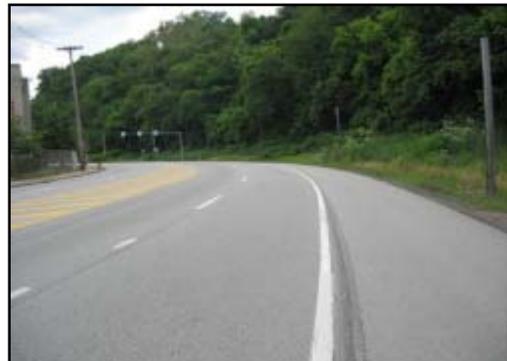
The 25-year old female driver of the Nissan was traveling in an easterly direction on the outboard lane negotiating the left curve (**Figure 2**). The driver stated that while she was negotiating the left curve, she reached for her cellular phone that had fallen onto the floor. While reaching for the phone, the vehicle continued on a straight path within the left curve and departed the right travel lane. The vehicle traversed the 3.6 meter (11.8 feet) wide asphalt shoulder and entered the roadside.

**Figure 2. Nissan's pre-crash approach.**

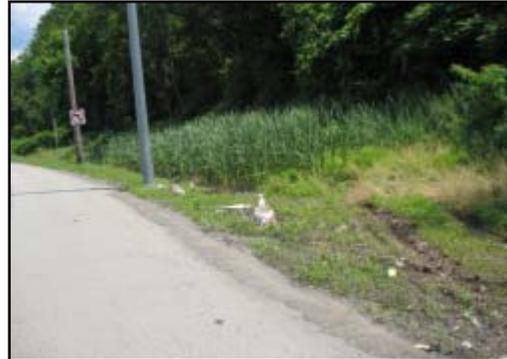
The front right aspect of the vehicle impacted and sheared a metal overhead sign pole (**Figure 3**) that was located 0.3 meters (1 foot) outboard of the shoulder. The replacement pole was mounted to a concrete base that extended above the ground approximately 5 cm (2"). Additionally, a sheared wooden utility was located near the crash site. This pole was not contacted by the Nissan. The direction of force was 12 o'clock for this fixed object impact. The barrier equivalent algorithm of the WINSMASH program was used to calculate a delta-V for this impact. The calculated Barrier Equivalent Speed (BES) was 48 km/h (30 mph). The impact actuated the front retractor mounted safety belt pretensioners and deployed the driver's frontal air bag, the right seat back mounted air bag, and the right curtain air bag.

**Figure 3. Area of impact with the utility pole.**

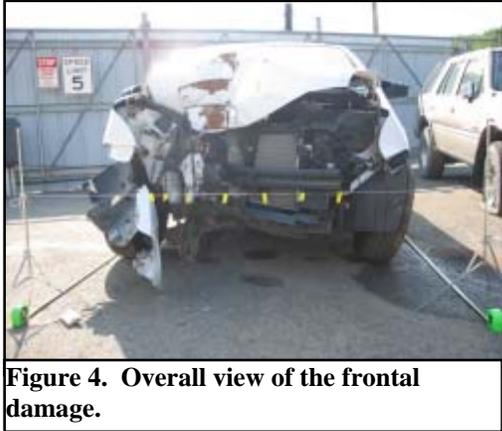
The 2008 Nissan Sentra sustained severe damage to the front plane as a result of the impact with the pole (**Figures 4 and 5**). The damaged components included, but were not limited to, the bumper fascia, bumper beam, hood, right fender, and the right front suspension components. The impact occurred inboard of the front right frame rail. The direct contact damage was measured on the hood which began 16 cm (6.3") right of the vehicle's centerline and extended 32 cm (12.4") to the right. The total length of direct contact damage was 32 cm (12.4").

The maximum crush measured 68 cm (26.7") and was located 36 cm (14.2") right of the centerline. A crush profile was documented along the bumper beam which was as follows: C1 = 0 cm, C2 = 10 cm (3.9"), C3 = 27 cm (10.6"), C4 = 44 cm (17.3"), C5 = 64 cm (25.2"), C6 = 55 cm (21.7").

The front right impact reduced the right wheelbase by 8 cm (3.1”) and elongated the left wheelbase by 5 cm (2”). The Collision Deformation Classification (CDC) for the pole impact was 12-FZEN-3

**Figure 4. Overall view of the frontal damage.**

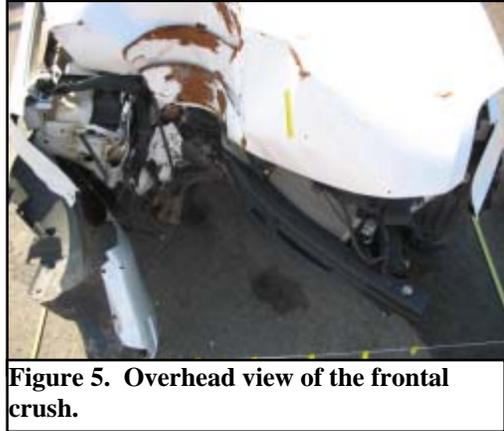
**Figure 5. Overhead view of the frontal crush.**

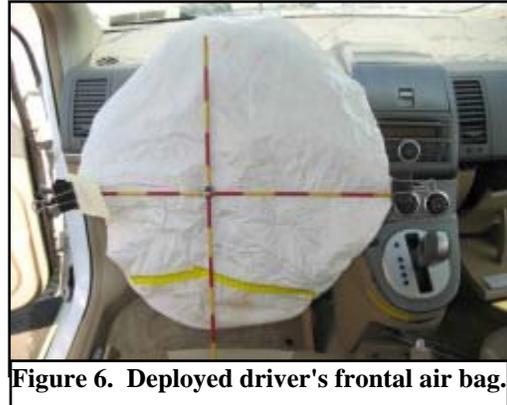
The driver's air bag (**Figure 6**) was concealed in the center hub of the three-spoke steering wheel by asymmetrical cover flaps. The top flap was 14 cm (5.5") in width at the horizontal tear seam and 9 cm (3.5") in height. The two lower flaps measured 8 cm (3.1") in width and 6 cm (2.4") in height. The air bag membrane was 59 cm (23.2") in diameter in its deflated state. The air bag was vented by two vent ports located at the 11 and 1 o'clock positions.

The driver's face contacted the deployed air bag membrane which was evidenced by make-up transfers. These contacts consisted of two black colored mascara (eye make-up) transfers and a large beige colored (make-up) transfer. The transfers from the left and right eye were located 11 cm (4.3") 13 cm (5.1") from the top seam, respectively. Inboard from the left seam, the left and right eye transfers were located from 1-3 cm (0.4-1.2") and 7-9 cm (2.8-3.5"), respectively.

**Figure 6. Deployed driver's frontal air bag.**

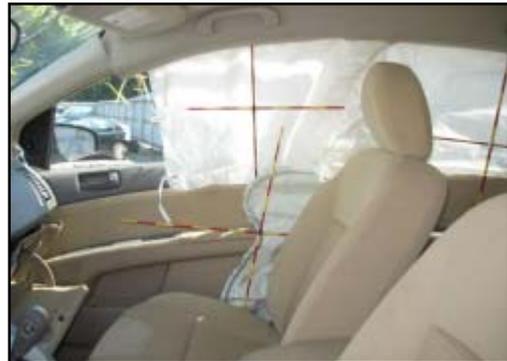
The right curtain air bag deployed from the roof side rail. The air bag membrane measured 153 cm (60.2”) in length. The air bag was tethered to the A- and C-pillars. The A-pillar tether was cut post-crash; however, it measured 53 cm (20.9”) in length. The C-pillar tether measured 7 cm (2.8”) and was also cut post-crash. At the front seating position, the membrane measured 45 cm (17.7”) in height, extending to 10 cm (3.9”) below the top of the door panel. The curtain air bag overlapped the seat back mounted air bag by 11 cm (4.3”) in its deflated state. As designed, the curtain air bag left a triangular shaped void at the front position which measured 37 cm (14.6”) in height and 46 in (18.1”) length. The height of the curtain air bag membrane at the right rear position was 44 cm (17.3”) and extended 12 cm (4.7”) below the top of the door panel. Vertically, the air bag membrane provided coverage to the belt line; however, due to the void near the A-pillar, complete longitudinal coverage across the front glazing was not available.

**Figure 7. Front right curtain air bag and the seat back mounted side impact air bag.**

The right curtain air bag did not contain occupant loading evidence. Post-crash damage was present to the outboard aspect of the air bag membrane. This damage consisted of two diagonally oriented cuts to the membrane at the right rear position that measured approximately 15 cm (6.0”). **Figure 7** depicts the front right curtain air bag and the seat back mounted side impact air bag.

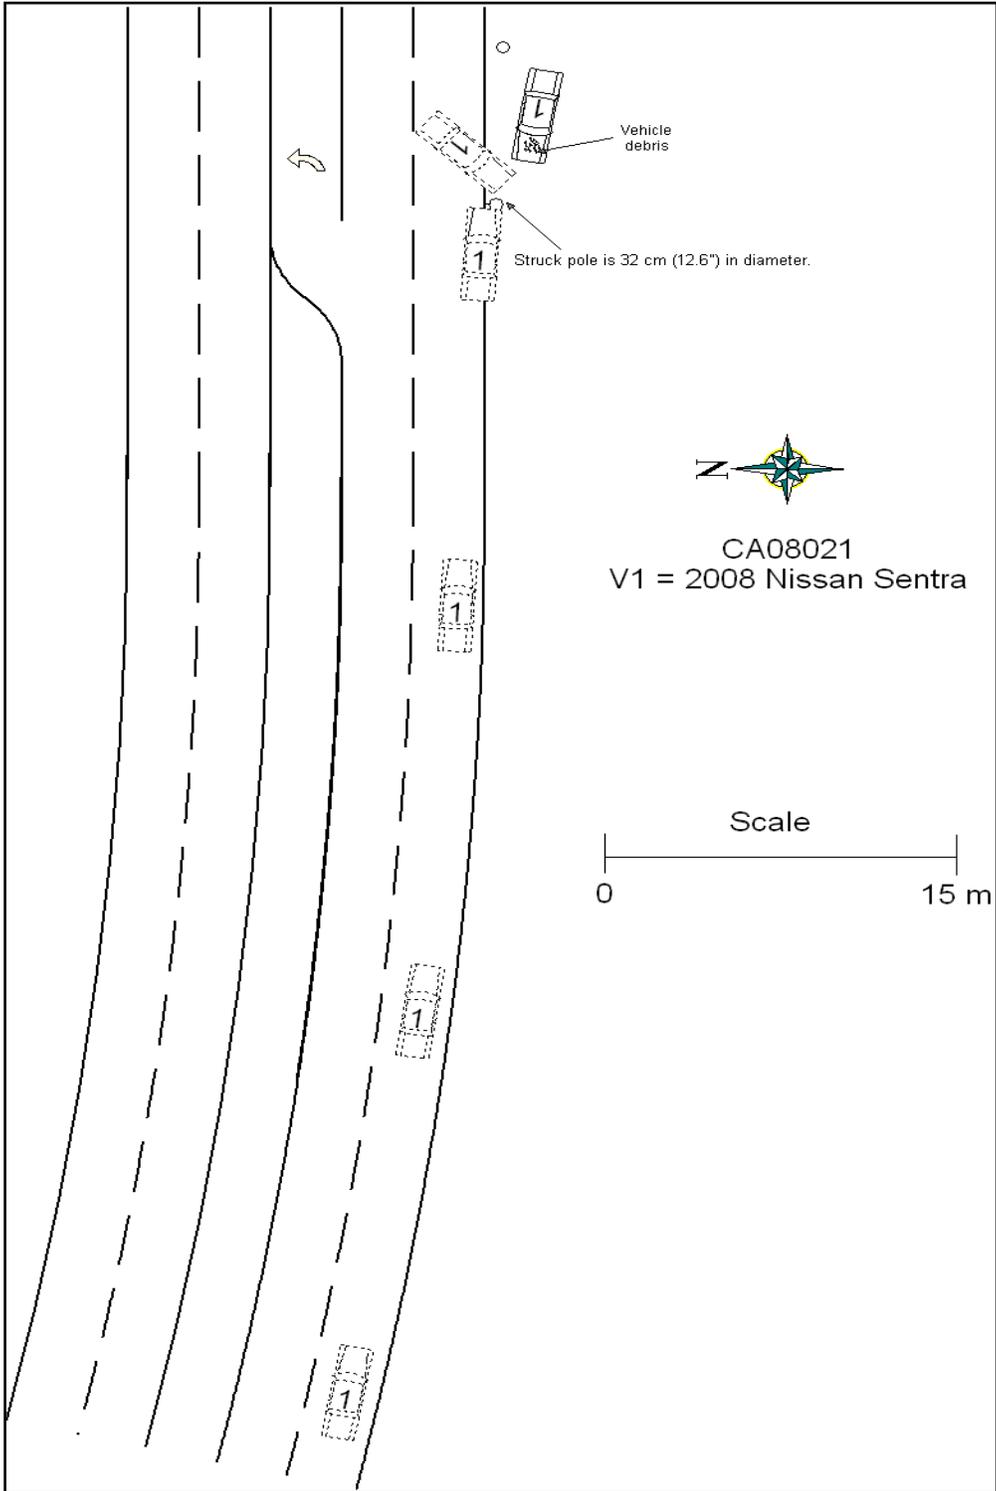
**Figure 8: Scene Schematic**

near the crash site. A paved shoulder was adjacent to the eastbound travel lanes and a concrete curb bordered the west road edge. Utility poles, a grass embankment, and a tree line extended beyond the east shoulder. The stuck pole was a metal overhead sign pole that was mounted to a concrete base. The diameter of the struck pole was 32 cm (12.6”) and was located 0.3 meters (1 foot) south of shoulder. The posted speed limit was 40 km/h (25 mph). At the time of the crash, the weather conditions were clear, dark, and dry. The Scene Schematic is included as **Figure 8** of this report.
