## ON-SITE ROLLOVER INVESTIGATION

CASE NUMBER - IN08021

LOCATION - TEXAS

VEHICLE - 2006 MAZDA TRIBUTE DX

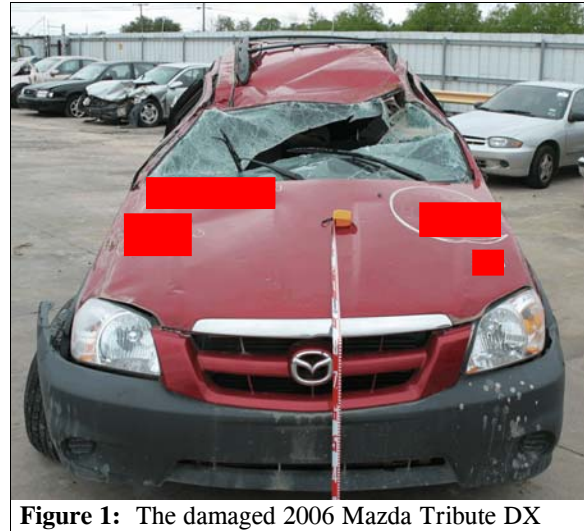
**Figure 1:** The damaged 2006 Mazda Tribute DX

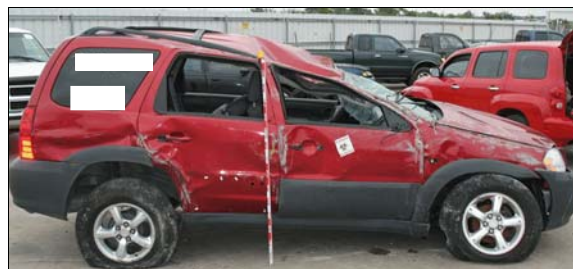
Figure 3: Damage to right side and top of the Mazda from the rollover; vertical scale in tenths of meter

**Crash:** The Mazda rolled over (Figures 3 and 4) with the left side leading (rollover initiation type: trip-over). During the rollover, the front right passenger's right arm was ejected through the disintegrated right front window and her right hand was rolled upon by the vehicle. There was insufficient evidence to determine the distance traversed during the rollover and the number of quarter turns. The Mazda came to final rest on its top on the inside lane heading south.

**Exterior Damage:** The rollover damage involved the Mazda’s top plane and both side planes. The hood, roof, windshield, both fenders, the entire right side, left front door, left A-pillar and quarter panel were directly damaged (Figures 3, 4, and 5). The width of the direct damage on the top plane was 124 cm (48.8 in). The maximum lateral and vertical crush occurred at the right roof side rail midway between the A-pillar and B-pillar (Figure 6). Based on the vehicle inspection and measurements from an exemplar vehicle, the maximum vertical crush was 23 cm (9.1 in) and the maximum lateral crush was 12 cm (4.7 in). The Mazda’s wheelbase was unchanged. The induced damage involved the front bumper and roof.

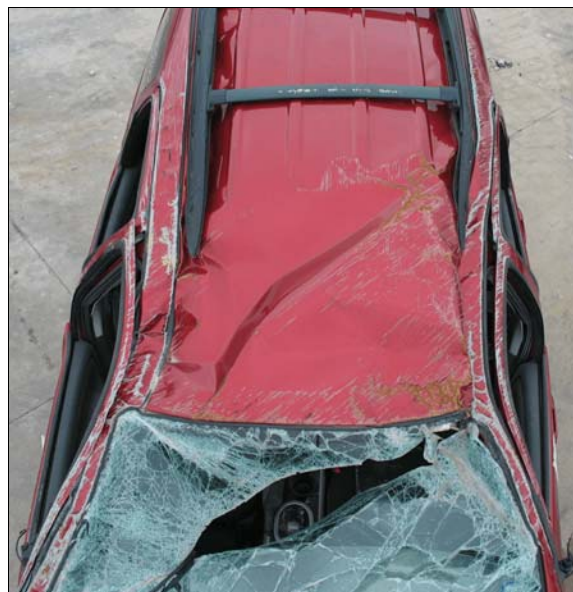
Figure 4: Damage to the top of the Mazda from the rollover, pavement scratches formed in three directions

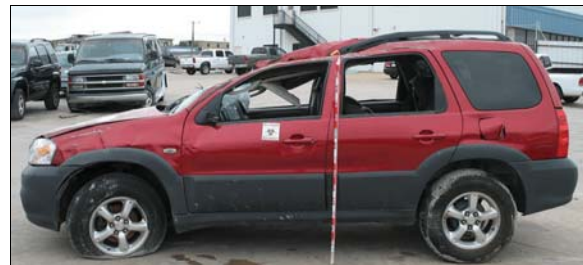
Figure 5: Left side view of damage to the Mazda

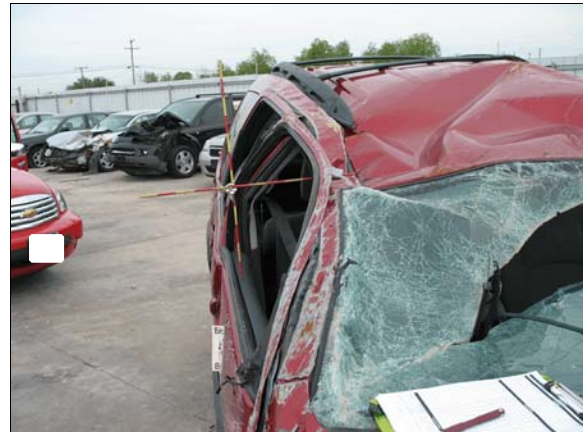
Figure 6: Scale shows the maximum vertical and lateral crush of right roof side rail, each increment in 5 cm (2 in)

**Damage Classification:** The Mazda’s Collision Deformation Classification was **00-TDDO-3**. The WinSMASH reconstruction program could not be used to determine the vehicle’s Delta V because rollovers are out of scope for the program. The severity of the rollover damage was moderate based on the extent of crush to the top.

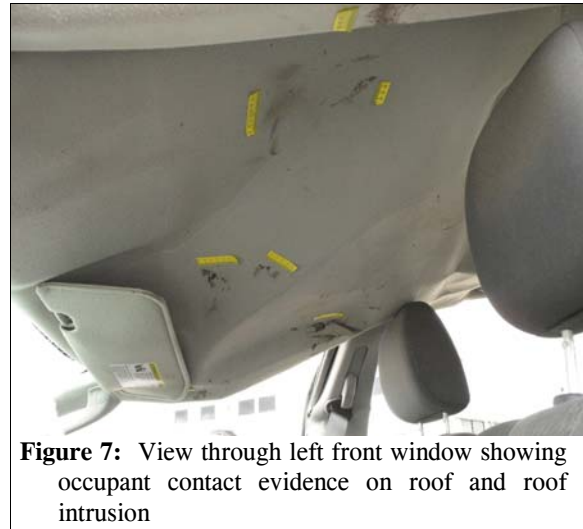
**Vehicle Interior:** Inspection of the Mazda’s interior revealed blood smears and hair transfers on the roof and roof side rails in the front row (Figure 7). The blood smears were intermittent across the full width of the roof. They were probably related to the driver and front right passenger’s movements following the crash. No other occupant contact evidence was found. The left front,

The Mazda sustained numerous passenger compartment intrusions during the rollover. The most severe intrusions involved the right A-pillar, windshield header, roof, and roof side rail (**Figure 7**), all of which intruded vertically 24 centimeters (9.4 inches) into the front right sector. There was no evidence of steering rim deformation or compression of the energy absorbing steering column.

**Figure 7:** View through left front window showing occupant contact evidence on roof and roof intrusion

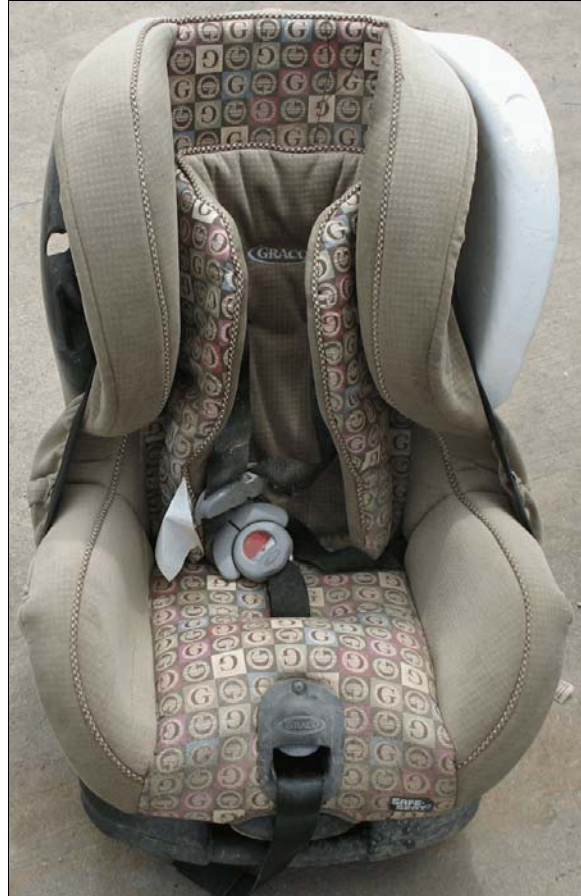
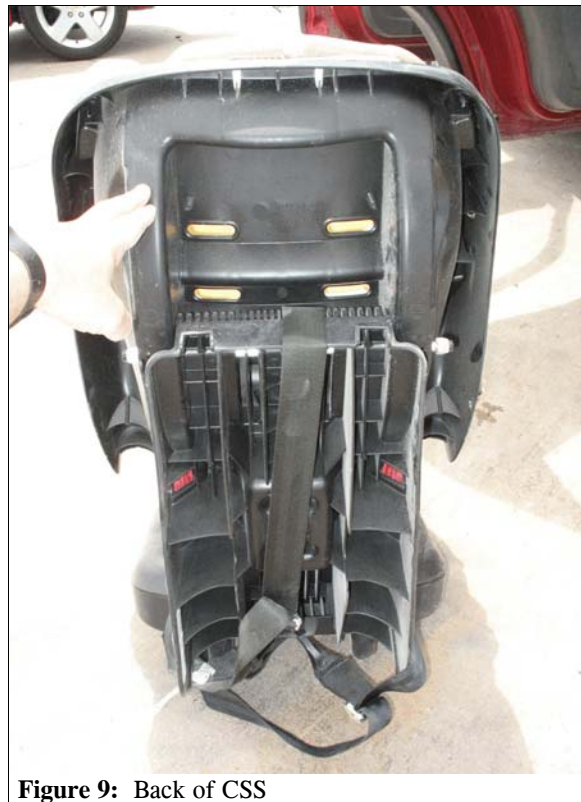
The Mazda's back right passenger [2-year-old, female; 84 cm and 11 kg (33 in and 25 lbs)] was seated in a forward facing CSS (**Figures 8 and 9**). The CSS was designed for children who weigh between 9 to 18 kg (20 to 40 lbs) and whose height is 109 cm (43 in) or less. The CSS was manufactured by Graco Children's Products in August 20, 2007. The model was SafeSeat-Step 2 and the model number was 8B05GLR2. The CSS was designed with a LATCH system, 5-point harness and three sets of harness strap adjustment slots. The harness straps were threaded through the bottom set of slots and a harness retainer clip was attached to the harness straps. The driver stated during the interview that the harness retainer clip was positioned above the child's armpit level, and the vehicle's lap-and-shoulder belt was used to secure the CSS in the vehicle. The seat belt was routed through the CSS's forward facing belt paths, but the driver did not pull the seat belt out of the retractor to switch it to the automatic locking function.

**Figure 8:** Second row right passenger's CSS, a Graco SafeSeat-Step 2

**Figure 9:** Back of CSS

The CSS was constructed of a one piece plastic shell and was attached to a non-removable plastic base. The shell was fitted with a padded cushion and the seat back was fitted with a styrofoam pad. There was no crash related damage to the CSS. The left harness strap was partially cut and was twisted in the harness retainer clip (**Figure 10**). The harness strap was probably cut during rescue activities. The driver stated that the harness strap was not cut prior to the crash.

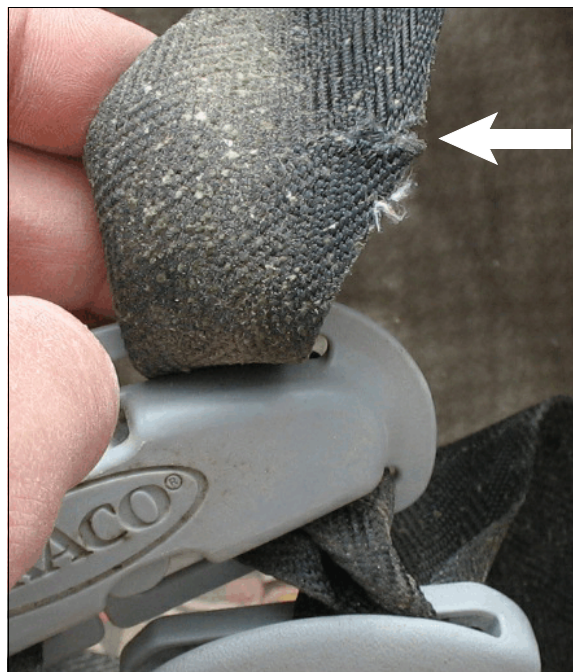
**Figure 10:** Arrow shows cut in left harness strap
