Side Curtain Air Bag Investigation  
Dynamic Science, Inc. (DSI), Case Number DS08022  
2006 Subaru B9 Tribeca  
Nebraska  
May 2008

**Dynamic Science, Inc.**  
**Crash Investigation**  
**Case Number: DS08022**

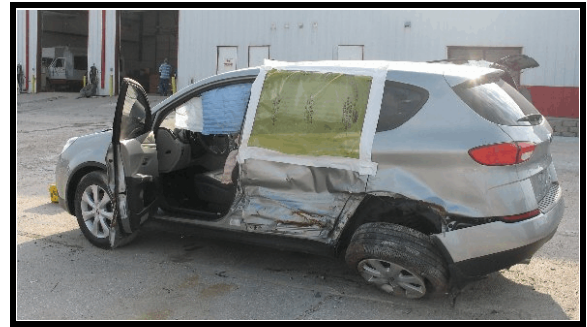
This on-site investigation focused on the deployment of the side curtain and seat mounted side air bags in a 2006 Subaru Tribeca that was involved in a three vehicle crash (**Figure 1**). The Tribeca was being driven by a restrained 27-year-old female. The front right seat was occupied by a 28-year-old female. The Tribeca was struck on the left side by a 2003 Chevrolet Tahoe sport utility vehicle. The impact resulted in sufficient lateral deceleration of the Subaru to command the deployment of the left side curtain air bag and left seat mounted side air bag. After the initial impact, the Subaru was deflected laterally to the right across the intersection and contacted a 1999 Mercedes-Benz E430 four-door sedan. There were no reported injuries. The Subaru was towed from the scene due to damage and was later declared to be a total loss by the insurance company. The Chevrolet was towed from the scene and was not available for an inspection. The Mercedes was driven from the scene.

**Figure 1.** Damaged 2006 Subaru Tribeca

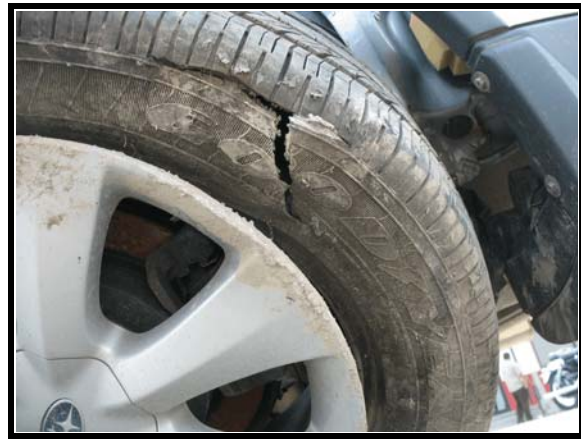
The left rear tire was torn during the crash (**Figure 5**). There was a T-shaped tear that began in the sidewall and extended to the outboard portion of the tread. The base of the “T” measured 11 cm (4.3 in) in a diagonal direction. The left portion of the “T” measured 19 cm (7.5 in) and the right portion measured 5 cm (2.0 in). There was also a 12 cm (4.7 in) long tear in the tread. The tear was diagonal and began 4 cm (1.6 in) from the side wall and terminated 2 cm (0.8 in) from the sidewall.

**Figure 5.** Damaged left rear tire

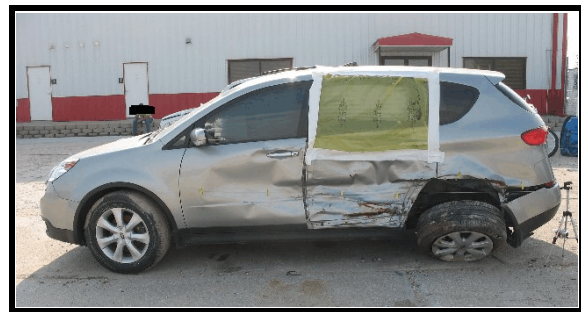
The 2006 Subaru Tribeca sustained moderate left side plane damage from the impact with the Chevrolet pickup (**Figure 6**). The direct damage began 68 cm (26.8 in) aft of the front axle and extended 254 cm (100 in) rearward along the left side plane. The height of the maximum door crush was 63 cm (24.8 in) from the ground and was located near the trailing edge of the left rear door. The left rear door was jammed shut.

**Figure 6.** Left side damage, Subaru Tribeca

The suspension trailing arm for the left rear wheel was fractured and separated at the wheel from impact with the pickup. At the time of the inspection, the wheel/tire had a positive camber of approximately 45 degrees. The left rear bumper fascia was dislodged and tilted downward. The combined direct and induced damage began 65 cm (25.6 in) aft of the front axle and extended 265 cm (104.3 in) rearward along the left side plane. Six crush measurements were documented at the mid-door level as follows: C1 = 0 cm, C2 = 9 cm (3.5 in), C3 = 18 cm (7.0 in), C4 = 15 cm (5.9 in), C5 = 6 cm (2.4 in), C6 = 0 cm. The maximum lateral crush was located at C3 and was 61 cm (24.0 in) above the ground. The Collision Deformation Classification (CDC) for the impact with the pickup was 10LZEW2.

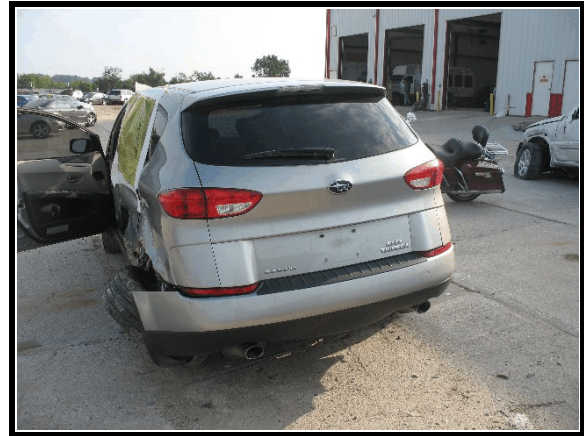
**Figure 7.** Light scratches to left bumper corner and area below tail light

The police report stated that the right rear of the Subaru contacted the left side of the Mercedes after the initial impact with the Chevrolet pickup. There were no indications of damage on the right rear corner. There were, however, several light scratches located at the left rear bumper corner and below the left tail light that seem consistent with the impact. The CDC for this second event was 06BLEE1.

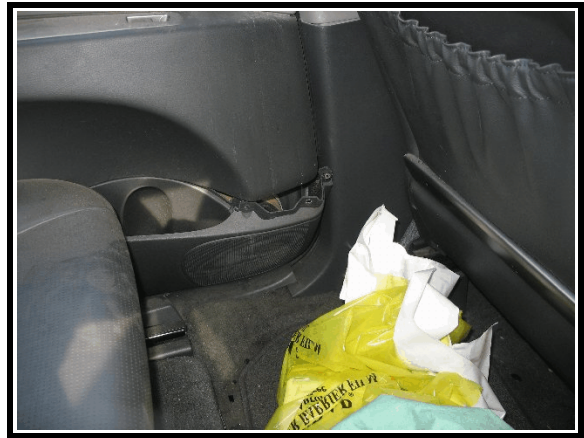
**Figure 8.** Left lower door intrusion

The 2006 Subaru Tribeca sustained minor interior damage as a result of passenger compartment intrusion (**Figure 8**). The lower leading edge and the rear upper quadrant of the left rear door and left A-pillar sustained lateral intrusion. As a result of the lateral intrusion, the inboard area of the left rear door was pressed against the second row seat cushion

Position	Intruded Component	Magnitude of Intrusion	Direction
Second row left	Door/Rear upper quadrant	9 cm (3.5 in)	Lateral
Front row left	A-pillar	4 cm (1.6 in)	Lateral

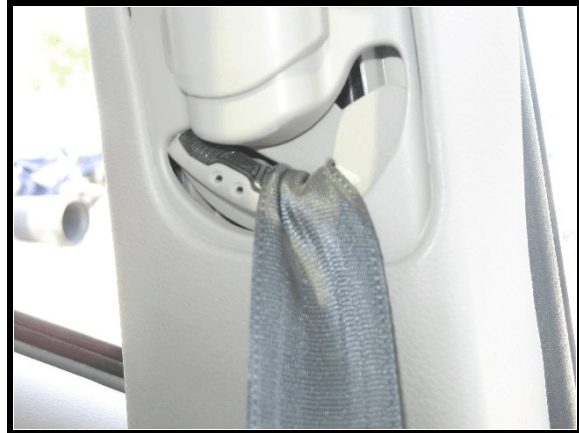
**Figure 9.** Driver's belt restricted in used position

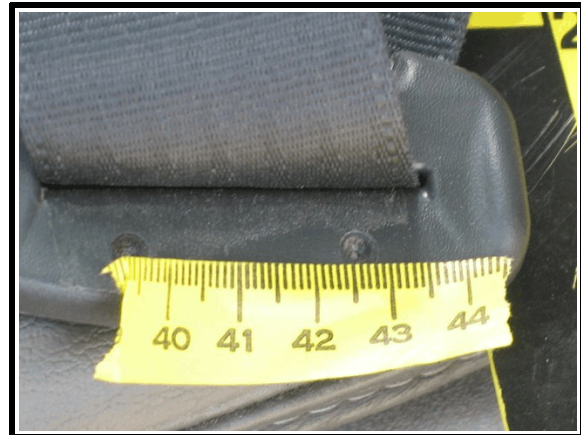
The 2006 Subaru Tribeca was configured with 3-point manual lap and shoulder belts for all five seating positions. Both front seat safety belts were equipped with retractor pretensioners and adjustable D-rings that were in the full down position. The driver's safety belt was configured with a sliding latch plate and an Emergency Locking Retractor (ELR). At the time of the vehicle inspection, the driver's retractor was restricted in the used position as a result of pretensioner actuation (**Figure 9**). A 6.5 cm (2.6 in) linear plastic transfer from the plastic-covered latch plate was located 61 cm (24.0 in) above the anchor and extended across the entire width of the webbing. There was an area of abrasion located in the belt path of the latch plate (**Figure 10**). The abrasion extended across the entire width of the belt path.

**Figure 10.** Loading to driver's seat belt latch

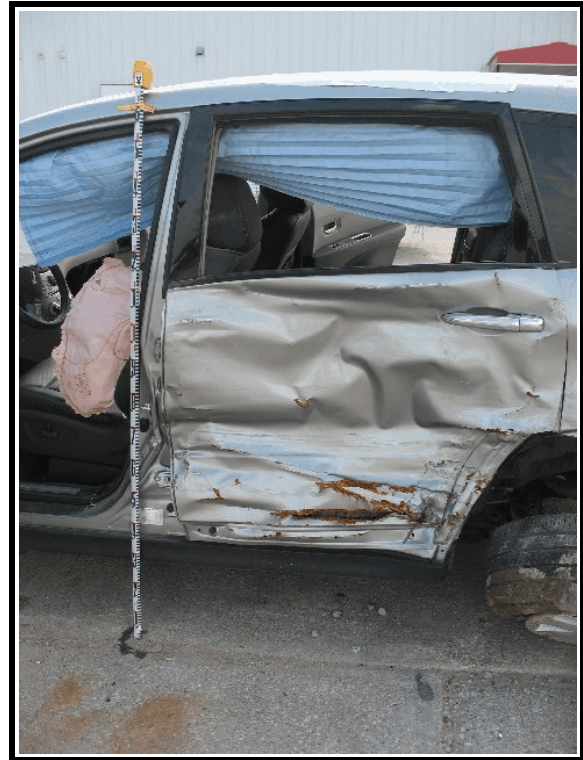
The Tribeca was also equipped with side curtain air bags and seat mounted side air bags. The left side curtain and left seat mounted air bags deployed as a result of the impact with the pickup truck (**Figures 11-12**). The right side air bags did not deploy. The curtain air bags included curtain air bag modules in the roof rail behind the C-pillars and sensors located forward of the rear wheels.

The left side curtain air bag deployed vertically from roof cladding. The curtain measured 166 cm (65.3 in) in length and 47 cm (18.5 in) in height. It provided coverage for both the first and second rows of the vehicle. The curtain was attached to the left A-pillar by a 3 cm (1.2 in) tether. The forward portion of the curtain was comprised of a single piece of nylon cloth that measured 28 cm (11.0 in) in width and 31 cm (12.2 in) in height. The rear of the curtain was secured to the vehicle by a fabric tether that was located in the roof just aft of the C-pillar. There were no indications of damage or contact to the curtain.

**Figure 11.** Exterior view, side air bags

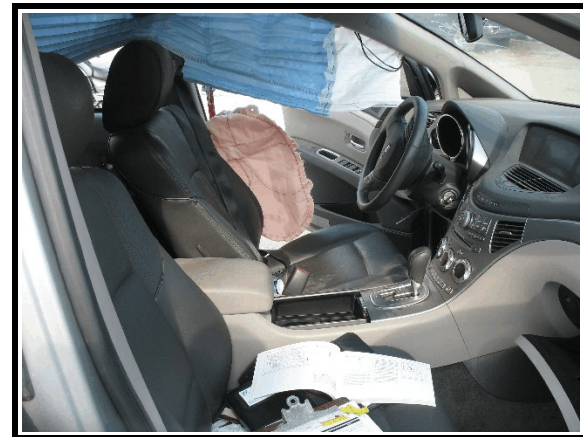
The left side air bag deployed longitudinally from the driver's seat back. The deployed air bag measured 32 cm (12.6 in) wide by 59 cm (23.2 in) high in its deflated state. The air bag was generally oval in shape. There were a set of three 0.5 cm (0.2 in) vent ports on both the outboard and inboard aspect of the air bag. There was one 2 cm (0.8 in) circular vent port located on the leading edge of the outboard aspect of the air bag. There were no indications of damage or contact to the side air bag.

**Figure 12.** Interior view, side air bags
