**CALSPAN ON-SITE CERTIFIED ADVANCED 208-COMPLIANT
VEHICLE CRASH INVESTIGATION
CALSPAN CASE NO: CA08025**

**VEHICLE: 2008 SUBARU B9 TRIBECA
LOCATION: PENNSYLVANIA
CRASH DATE: MAY 2008**

**SCI CASE NO: CA08025
VEHICLE: 2008 SUBARU B9 TRIBECA
LOCATION: PENNSYLVANIA
CRASH DATE: MAY 2008**

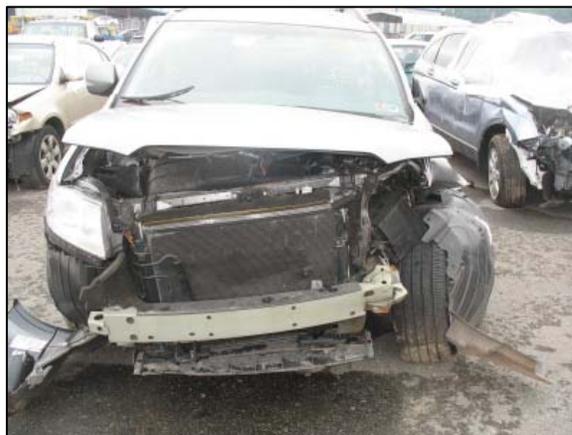
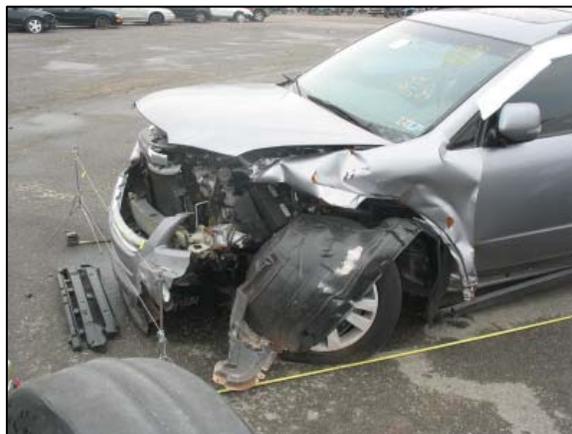
The 2008 Subaru B9 Tribeca sustained moderate severity frontal damage as result of the impact with the Oldsmobile (**Figures 4 and 5**). The damaged components included, but were not limited, to the front bumper fascia, bumper beam, upper radiator support, left headlight assembly, left fender, and the left front suspension components. During the crash sequence, the front of the Oldsmobile engaged the Subaru's front left corner, outboard of the bumper reinforcement beam. As the vehicles crushed, the Oldsmobile remained engaged with the left side Subaru which resulted in contact to the left front wheel assembly. This contact resulted in a fracture of the left front ball joint and lower control arm.

The front bumper fascia exhibited direct contact damage that began 36 cm (14 in) left of the vehicle centerline and extended 41 cm (16 in) to the front left corner. The maximum frontal crush which measured 4 cm (1.6 in) was documented at the left corner of the bumper beam. A crush profile that was comprised of six equidistant points was documented along the reinforcement beam and was as follows: C1 = 4 cm (1.6 in), C2 = 4 cm (1.6 in), C3 = 4 cm (1.6 in), C4 = 2 cm (0.8 in), C5 = 0 cm, C6 = 0 cm.

The Collision Deformation Classification (CDC) for this impact was 12-FLEE5. The left front door was jammed in the closed position. The right front, rear, and the hatch remained closed during the crash and were operational at the time of the SCI inspection. The windshield was fractured at the lower left aspect. The front side door glazing contained an aftermarket tint film. The side, rear, and sunroof were found closed and undamaged at the time of the SCI inspection.

Figure 4: Overall view of the Subaru's frontal damage.

Figure 5: Left lateral view of the Subaru.

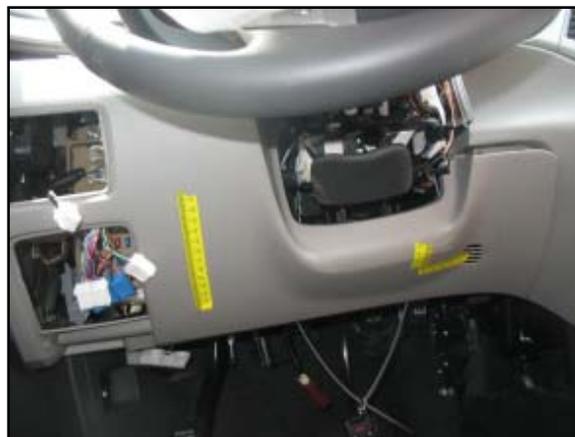
bolster (**Figure 6**). The first scuff was located 19 cm (7.5 in) left of the steering column centerline and measured 8 cm (3 in) in length. A second scuff was located 6 cm (2.5 in) right of the steering column centerline. This scuff measured 3 cm (1 in) in length and 4 cm (1.5 in) in width. There was no intrusion or interior damage associated with the exterior crash force.

Figure 6: Knee bolster contact points.

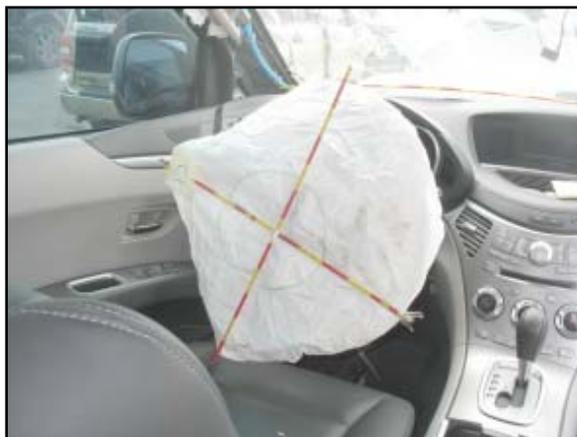
As a result of the crash, the driver's frontal air bag deployed (**Figure 7**). The driver's air bag was conventionally located in the center of the steering wheel hub and was concealed by three cover flaps. The top cover flap measured 8 cm (5 in) in height and width. The symmetric lower cover flaps measured 7 cm (2.8 in) in height and 6 cm (2.5 in) in width. The air bag measured 61 cm (24 in) in diameter in its deflated state. It was tethered by two straps and was vented by two ports at the 10 and 2 o'clock positions. There was no damage or occupant contact evidence present on the air bag. Dirt was noted on the lower right quadrant of the bag.

Figure 7: Driver's frontal air bag.

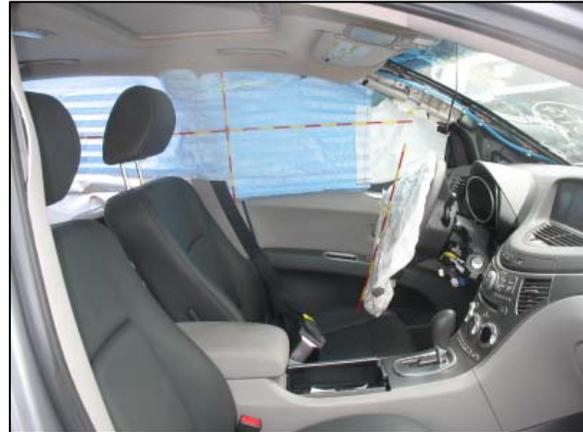
The Subaru was equipped with seat-mounted side impact air bags for the front seats and side impact/rollover IC air bags for the outboard seating positions. As a result of the crash, the left IC air bag deployed (**Figure 8**). The air bag was rectangular in shape and measured 165 cm (65 in) in length. The height of the curtain air bag membrane measured 46 cm (18 in) and it extended 5 cm (2 in) below the belt line at the front left position. The height of the curtain air bag membrane provided head protection from the roof side rail to belt line of the vehicle.

Figure 8: Deployed left side curtain air bag.

A sail panel was attached to the forward aspect of the air bag and coverage the void created at A-pillar junction. The panel was trapezoidal in shape and measured 15 cm (6 in) in height and 31 cm (12 in) in width. The IC air bag was free of crash related damage and occupant contact points. The front left aspect of the curtain air bag had been cut post-crash.
