On-Site Tour Bus Investigation  
Dynamic Science, Inc. (DSI), Case Number DS08026  
2007 BCI Falcon 45 Tour Bus  
Nevada  
August 2008

1. Report No. DS08026	2. Government Accession No.		3. Recipient Catalog No.	
4. Title and Subtitle On-Site Tour Bus Investigation		5. Report Date September 4, 2009

14. Sponsoring Agency Code		
15. Supplemental Notes				
16. Abstract This on-site investigation focused on the tires that were installed on a 2007 BCI Falcon 45 tour bus. The bus was being used as a shuttle bus and was traveling northbound in the middle lane of three-lane interstate highway. There were 37 passengers on the bus. The left front tire experienced a tread separation and the vehicle veered to the left, crossed the inboard lane and concrete shoulder and struck a metal guardrail with its front left bumper (Event 1). As the guardrail yielded, the bus continued forward and struck a concrete barrier with its front right bumper (Event 2). According to the police report, 37 occupants including the driver were injured. A total of 30 passengers were transported, four to a Level I trauma center, six to Level II trauma centers, and 20 to various hospitals. Seven passengers were injured

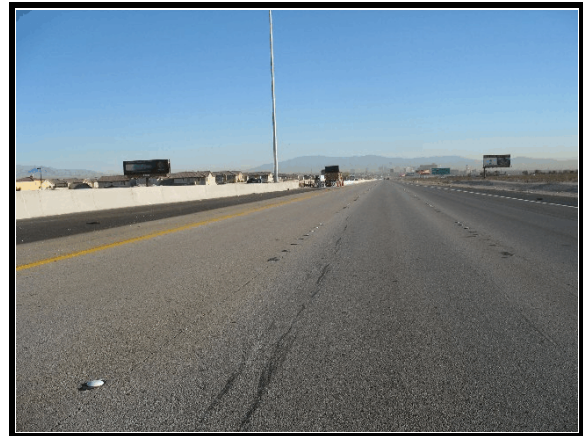
Occupants of the bus reported that they heard a tire blowout. Evidence of the tread separation in the form of a tire scuffmark was located on the left part of the center travel lane (**Figure 3**). This evidence was documented during the SCI scene inspection.

**Figure 3.** Area of tread separation

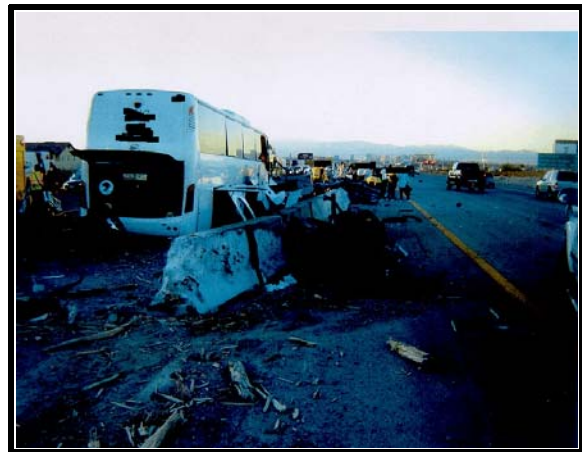
**Figure 4.** Area of impact, showing guardrail and concrete barrier (police photo)

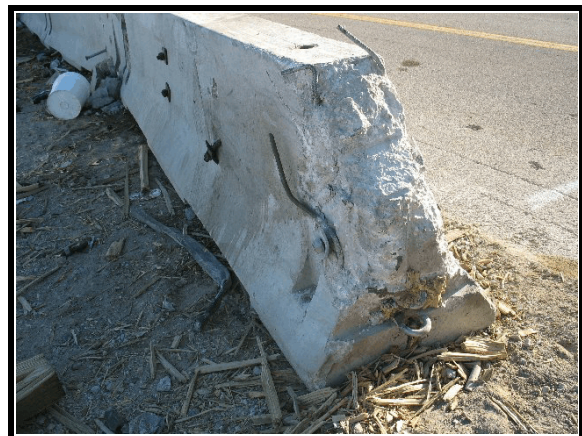
The driver reported that he felt the bus move downward in the front. The tire came apart and the bus traveled sharply to the left. The driver stated to the police that he did not brake because he learned in training that it would compound the problem. The bus veered to the left, crossed the inboard lane and concrete shoulder, and struck a metal guardrail with its left front bumper (**Figure 4**). The distance from the start of the scuffmark to the guardrail impact measured 92.5 m (303.5 ft). As the guardrail yielded, the bus continued forward an additional 21 m (68.9 ft) and struck a concrete barrier with its right front bumper (**Figure 5**).

**Figure 5.** Struck concrete barrier

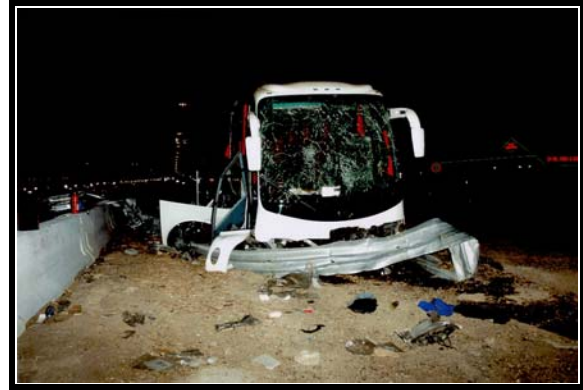
The bus came to rest facing north the median (**Figure 6**). During the crash, several tires and undercarriage components were displaced from the vehicle. The right front wheel was fractured from

the axle and came to rest east of the northbound roadway, approximately 73.2 m (240 ft) right of the vehicle. The second axle, brake assembly and inboard and outboard tires were displaced and came to rest on the paved shoulder, 4 m (13.2 ft) rearward of the vehicle's back end. The entire third axle with its left and right wheels fractured as a unit and came to rest 1.6 m (95.3 ft) rearward of the vehicle's back end.

**Figure 6.** Final rest (police photo)

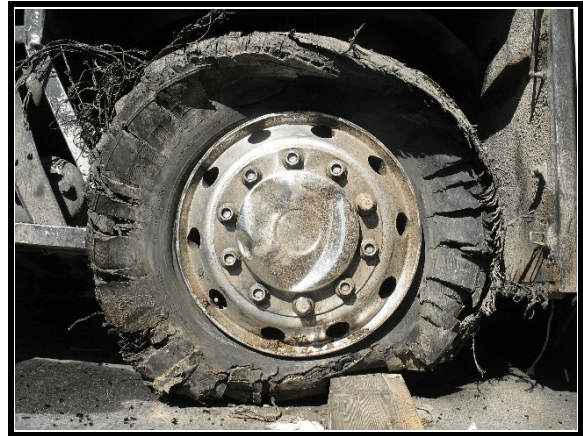
**Figure 7.** Front axle 1, left tire

The tire sustained tread separation along the entire circumference (**Figures 7-8**). Five pieces of tread were recovered; the largest piece measured 24 cm (9.4 in) wide by 260 cm (102.3 in) in length. In descending order, the remaining pieces measured 14 cm (5.5 in) wide by 102 cm (40.1 in) long, 5 cm (1.9 in) wide by 126 cm (49.6 in) long, 10 cm (3.9 in) wide by 55 cm (21.7 in) long, and 8 cm (3.1 in) wide by 15 cm (5.9 in) long. It was estimated that 90% of the tread was recovered post-crash. The Tire Identification Number (TIN) for this tire was HAD7 B3JX 3806. The tire was manufactured in the 38<sup>th</sup> week (September) of 2006. The tire was flat and had a tread depth of 11 mm (14/32 in). The tire was restricted due to damage to the frame forward of the wheelwell.

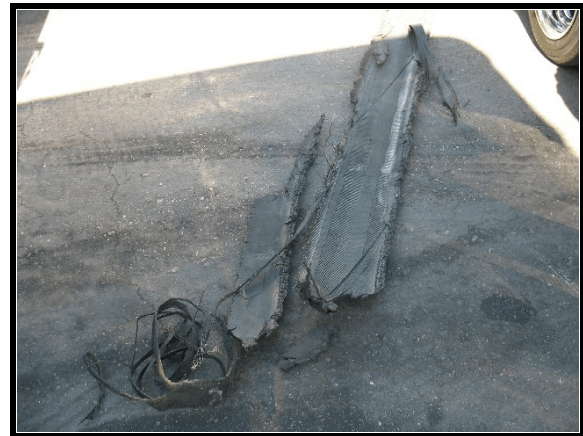
**Figure 8.** Tread from front axle 1, left tire

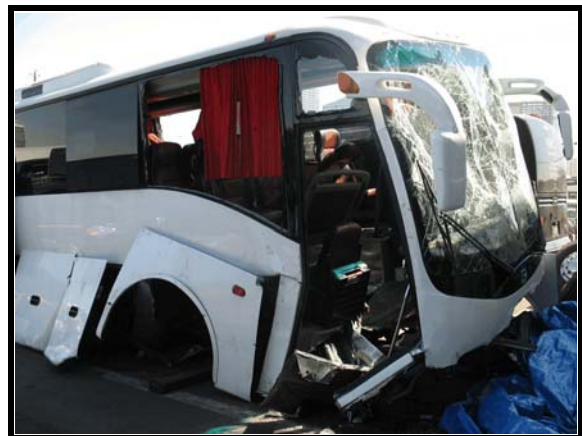
The 2007 BCI bus sustained severe damage from the impacts to the metal and concrete barriers (**Figure 12**). There was 240 cm (94.4 in) of direct damage distributed across the front end.

On the right side, the right front A-pillar base was deformed rearward 61 cm (24 in). The bottom base of the right front door measured 62 cm (24.4 in) in width; the width at the top was 81 cm (31.9

**Figure 12.** Right front damage

in). The B-pillar was deformed 17 cm (6.7 in) rearward. The right front door was torn from the vehicle. There were areas of scraping/cracking above the rear bumper at the right rear that was 13 cm (5.1 in) wide by 80 cm (31.4 in) high. Both rear axles had been fractured from the vehicle and the luggage area was torn open. The gear box was separated from the axle and was displaced to the left. The aluminum fuel tank had been penetrated and the fuel had escaped at the scene (**Figure 13**). The inverted V-shaped damage was to the forward right side of the tank and measured 41 cm (16.1 in) horizontally along the base and 35 cm (13.7 in) vertically.

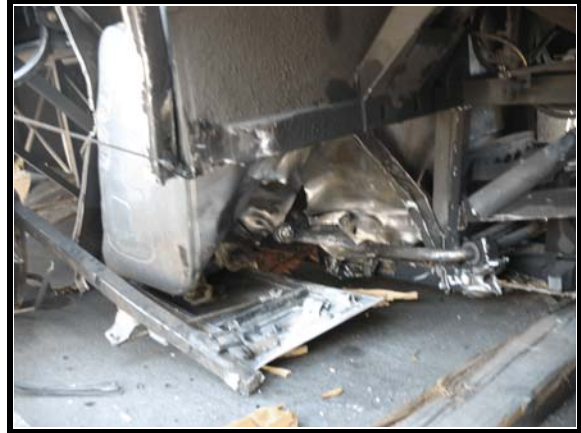
**Figure 13.** Fuel tank damage

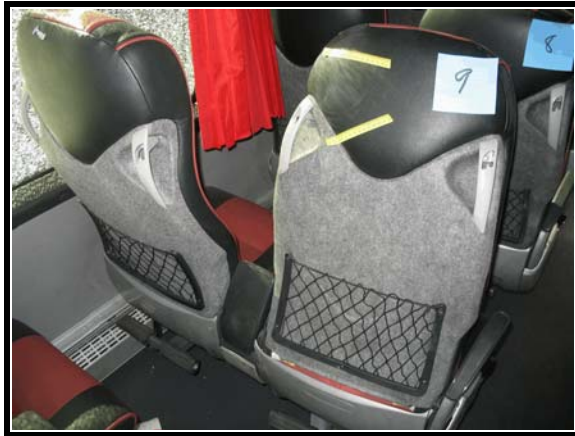
There was damage and contact to various components of the rear seats that are described in Table 3. Examples of the damage and contact evidence are shown below (Figures 14-15).

**Figure 14.** Scuffing and seat back movement

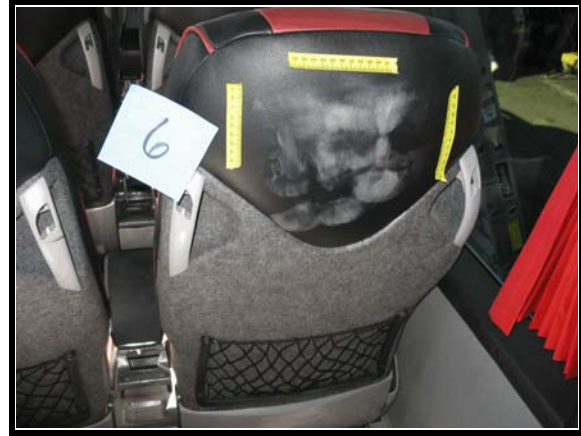
**Figure 15.** Facial contact to seat back
