On Site Tour Bus Crash Investigation - Office of Defects Investigation
Dynamic Science, Inc. (DSI), Case Number DS08028
2001 Prevost Marathon Tour Bus Class A Recreational Vehicle
Nevada
August 2008

1. Report No. DS08028	2. Government Accession No.		3. Recipient Catalog No.	
4. Title and Subtitle On Site Tour Bus Class A Recreational Vehicle Crash Investigation			5. Report Date July 21, 2009

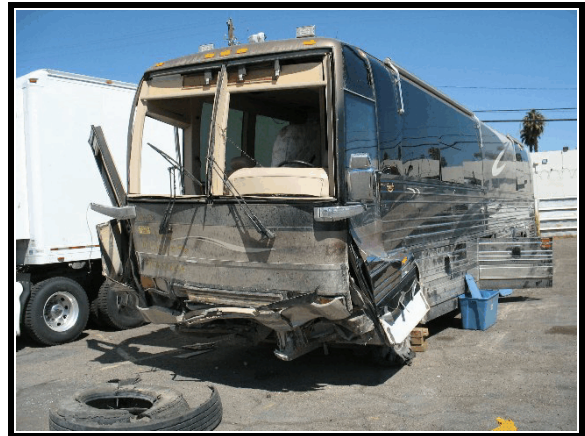
Figure 1. Subject vehicle, 2001 Prevost Marathon

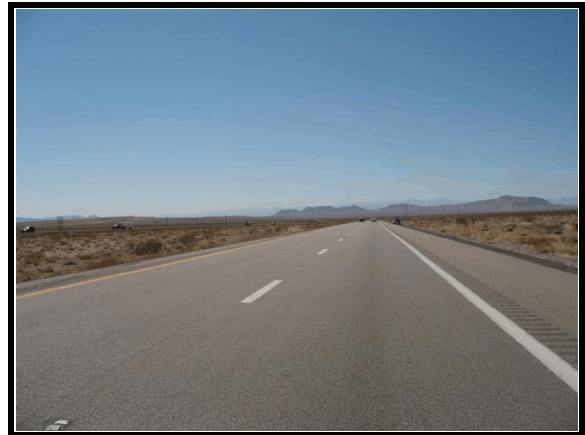
This single vehicle crash occurred off road, adjacent to the southbound lanes of a divided interstate highway (**Figure 2**). The roadway was configured with two lanes that were separated by dashed white lines. The roadway was bordered on the right by a solid white fog line and an asphalt shoulder with a rumble strip. The roadway was bordered on the left by a solid yellow line and an asphalt shoulder with a rumble strip. The roadway was of asphalt construction and had a negative 1% grade. Adjacent to the paved shoulder was a descending 2.9 m (9.5 ft) wide gravel covered shoulder. A wide uneven dirt-covered median separated the northbound and southbound lanes. The median was approximately 1.8 m (6 ft) lower in elevation than the roadway surface. The weather was clear with scattered clouds. The temperature was 41 degrees C (106 degrees F) at the nearest reporting station, and the winds were blowing 14.4 km/h (9 mph) from the northeast. The crash occurred at 1625 hours. The speed limit at this location was 121 km/h (75 mph).

Figure 2. Southbound roadway

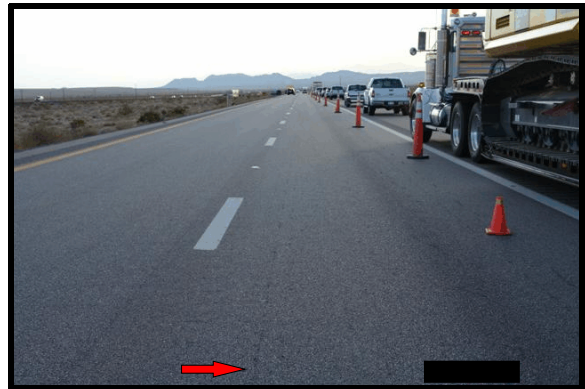
The left front tire sustained a complete tread separation due to unknown reasons (**Figure 3**). The damaged tire was located on a steer axle and caused the driver to lose control of the vehicle. The PrevoSt initiated a left trajectory, crossed the adjacent travel lane and departed the roadway on the left roadway edge (**Figure 4**). The police identified a point where both front tires began marking, and then identified an area in the inboard lane where the left front tire began depositing flat tire scuffs. It appears that the driver may have braked initially, and then taken his foot off the brake. Based on the tire marks, the bus traveled 69 m (225 ft) before departing the roadway and entering the median. At a point just beyond where the bus left the roadway, the police located a portion of the left front tire tread. As the PrevoSt continued southbound in the median, the vehicle generated a set of tire furrows in the soil. Along the path of the vehicle were three distinct undulating dirt embankments that were perpendicular to the path of the vehicle. The PrevoSt traveled off road for 105 m (345 ft) before impacting the first embankment (Event 1) and then traveled 4 m (13 ft) before impacting the second (Event 2). During the embankment impacts, the

Figure 3. Tread separation marking (police photo)

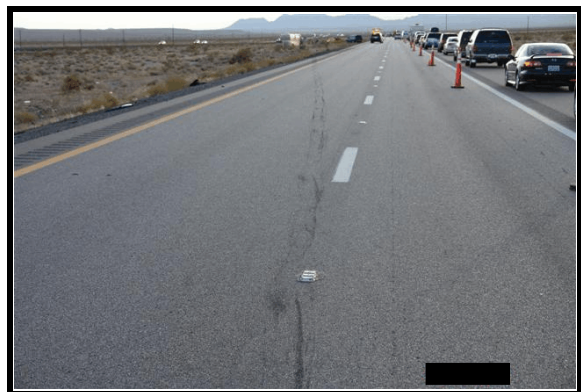
Figure 4. Left side roadway departure (police photo)

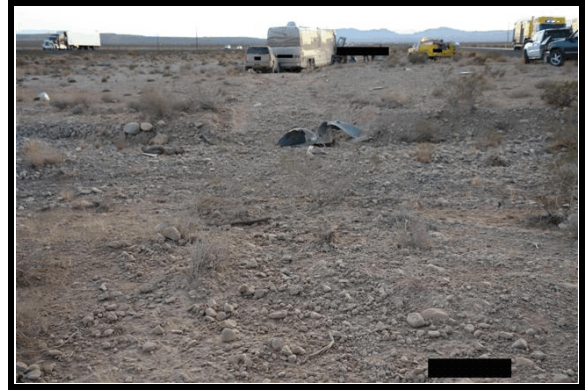
front right tire became restricted. When this tire became restricted, the tread was cut and peeled away from the casing by the wheel well's metal structure. After impacting the third embankment (Event 3), the occupant was ejected through the front windshield area. It is not known if the windshield had been damaged or dislodged prior to the ejection. Portions of the windshield were located just south of the second embankment. The occupant was ejected forward and to the front of the bus and was subsequently run over.

Figure 5. Area of impact with last embankment and final rest (police photo)

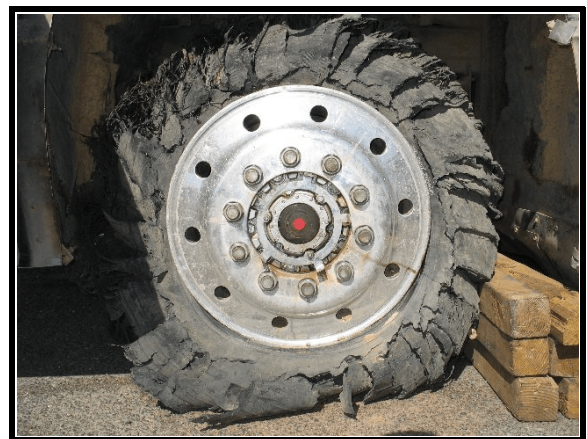
Tire damage: The tread separated from the carcass (**Figure 6**). Four sections of tread were recovered. The largest section of separated tread measured 145 cm (57.0 in) in length by 19 cm (7.4 in) in width. This section was rubber tread with belts still partially attached. The belts were frayed at the ends. The section consisted of three center ribs and was separated from the tire lengthwise along the grooves. The ribs measured 4 cm (1.6 in) in width and the grooves measured 1 cm (0.4 in) in width. There were small holes observed in the tread grooves which measured 5 mm (0.2 in) in diameter and were located at 30 mm (1.2 in) intervals lengthwise along the tread. The next largest section

Figure 6. Left front tire

was 97 cm (38.1 in) in length by 5 cm (2.0 in) in width. This section consisted of a single rib which separated evenly along the grooves, and had no ply material attached. The next largest section was 43 cm (16.9 in) in length by 11 cm (4.3 in) in width. This section consisted of two ribs across its width, which separated evenly along the grooves, and had no ply material attached. The last section of tread was 42 cm (16.5 in) in length by 13 cm (5.1 in) in width. This section consisted of one rib from the tire shoulder and had a section of sidewall attached. There was no foreign debris present in the separated tread or carcass. There were no indications of punctures or cuts.

The tire carcass was deboned. The belts were partially detached and frayed and the sidewalls were cracked and deformed. The carcass was damaged and attempts to identify evidence of punctures was unsuccessful. The air valve was recessed in a port in the rim and was undamaged.

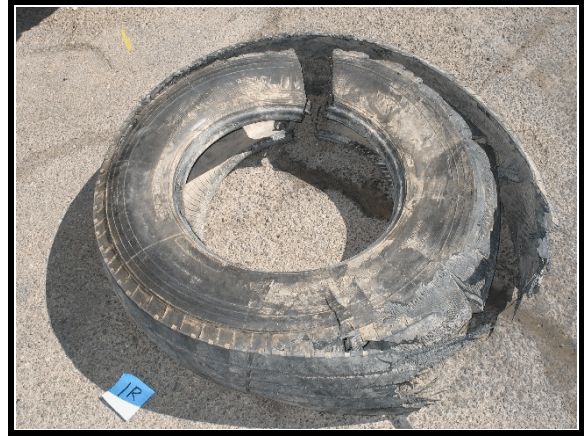
Tire damage: The tire sustained partial tread separation in two areas (**Figure 7**). The longer section of separated tread measured 210 cm (82.7 in) in length and measured 30 cm (11.8 in) from shoulder to shoulder. The tread section remained attached at one end and acted as a flap. The width of this section consisted of the entire ribbed section and the shoulders, and was separated at the inner and

outer sidewalls. The shorter section of separated tread measured 32 cm (12.6 in) in length and also was attached at one end as a flap. The separated tread consisted of rubber tread as well as belts. There was damage to the bead and the sidewalls. The tread exhibited some gouges; however, there were no punctures or debris in the tire. There was a section of intact tread which was located between the two flaps that measured 87 cm (34.2 in) in length. The tire casing sustained cuts or tears which ran laterally across the width. There were tears in the sidewalls which began at the shoulder and ran radially toward the bead. Inspection of the subject vehicle revealed that the source of damage to this tire was probably due to longitudinal crush to the wheel well which resulted in tire restriction (**Figure 8**). The tire had been cut through laterally so that it could be removed from the rim at the crash scene.

Figure 7. Right front tire

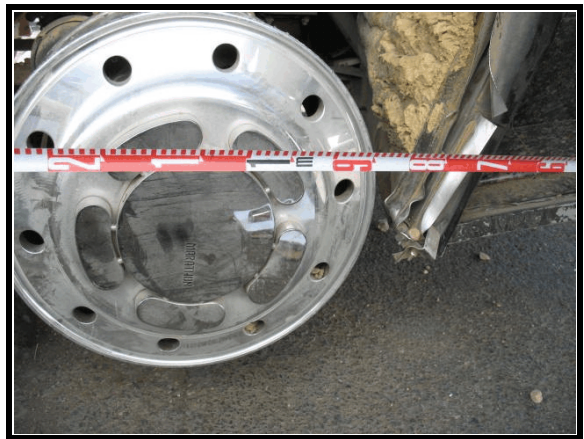
Figure 8. Right front wheel/wheel well

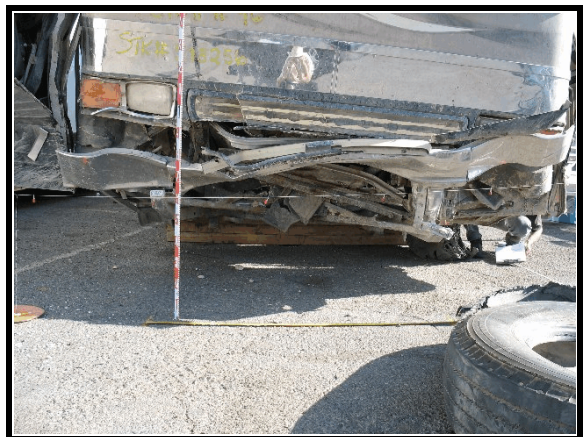
The vehicle sustained moderate frontal and undercarriage damage due to impacts with embankments and ground (**Figure 9**). The direct damage began at the front right bumper corner and measured 263 cm (103.5 in) to the left. Six crush measurements were documented at the bumper level as follows: C1 = 20 cm (7.8 in), C2 = 22 cm (8.7 in), C3 = 23 cm (9.0 in), C4 = 26 cm (10.2 in), C5 = 45 cm (17.7 in), C6 = 42 cm (16.5 in). There was longitudinal crush to the structural cross members between the frame rails. The frame rails were 145 cm (57 in) apart. The maximum crush measured 99 cm (38.9 in) at the center point between the frame rails.

Figure 9. Front bumper damage

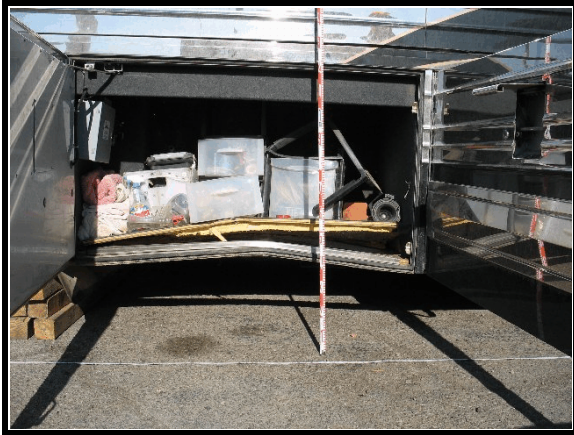
The left side panel below the driver's position was deformed rearward 28 cm (11.0 in). There was 9 cm (3.5 in) of vertical crush to the left side rail below the first compartment panel (**Figure 10**). There was 7 cm (2.8 in) of vertical crush to the left side rail below the fourth compartment panel, as well as vertical crush to the wood flooring within the compartment (**Figure 11**). On the back end of the vehicle, there was a slight deformation due to intra-unit contact with the towed GMC. Also, the trailer hitch was deformed and the tail pipe

Figure 10. Left side rail/floor vertical crush

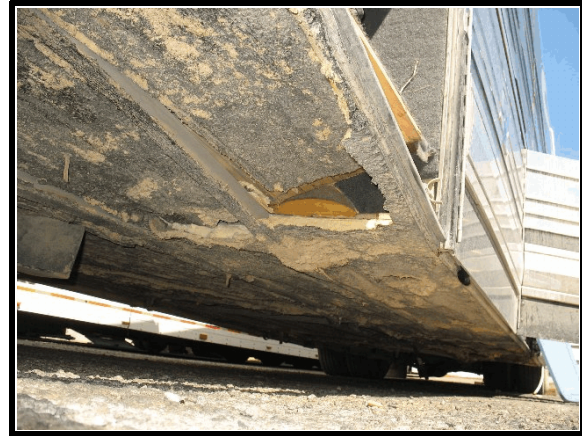
Figure 11. Damage to area below storage compartment

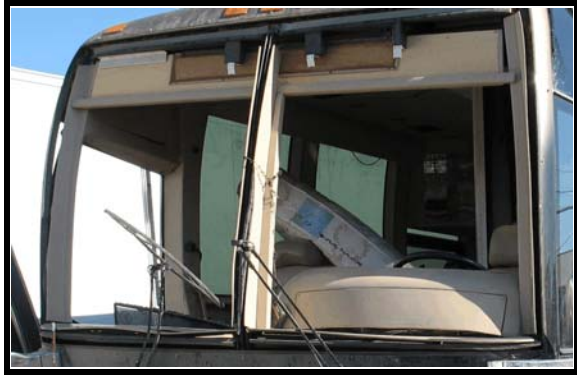
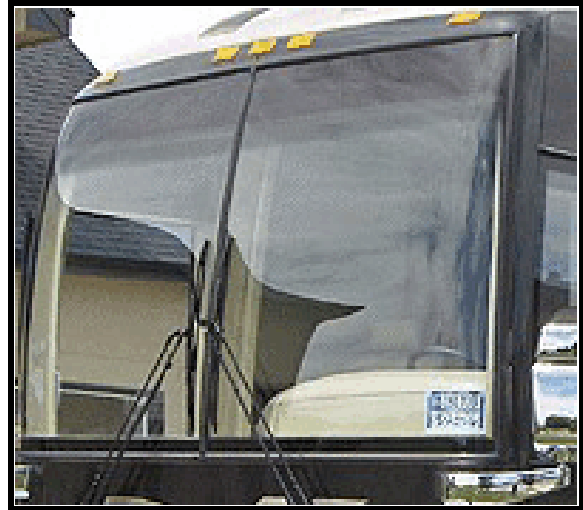
The windshield was configured in two sections and both sections of glazing were displaced during the crash (**Figures 12-13**). Glass from the windshield was located at the scene in the traveled path of bus. The glass had been displaced and then run over by the bus. The glazing probably was dislodged while the vehicle was traveling across the median and then fully displaced upon impact with the second embankment. Since both sides were displaced, it was not clear if occupant loading was related to the windshield displacements.

Figure 12. Front view of windshield

Figure 13. Exemplar view of windshield

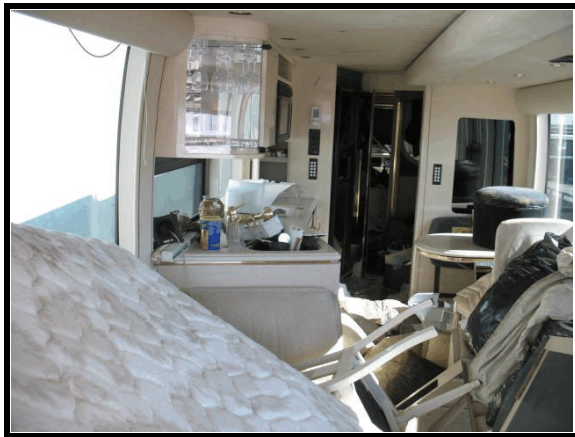
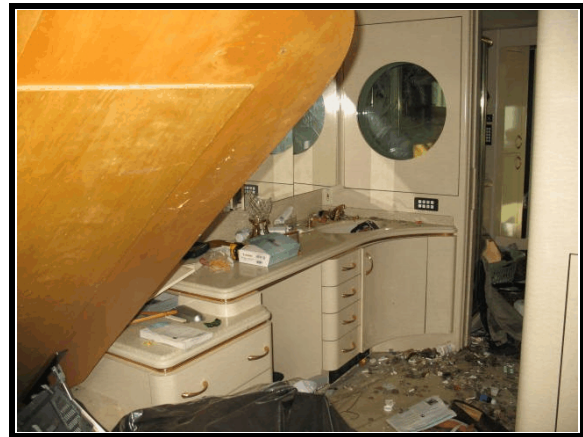
The Prevost bus interior sustained moderate damage to the forward and aft sections due to the off-road travel and the impacts with the dirt embankments (**Figures 14-15**). Numerous loose objects were strewn throughout the vehicle. Prior to the vehicle inspection, relatives of the driver had gone through the vehicle to remove personal and high value items.

Figure 14. Overview of forward area (living room/kitchen)

Figure 15. Overview of aft section (bedroom)

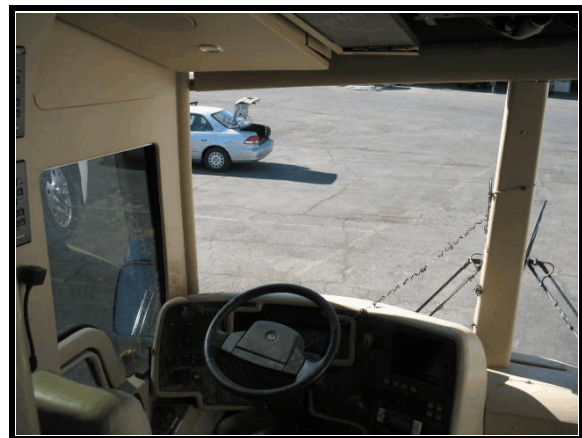
The 67-year-old driver of the Prevost was sitting upright in the leather bucket seat and was not using the manual lap belt (**Figure 16**). As the left front tire tread separated, the driver began braking and then appeared to take his foot off the brake. The driver probably pitched forward slightly as he braked. The bus veered to the left and departed the roadway. As the vehicle departed the roadway, there was a change in elevation and the driver likely was displaced in an upward direction. As the vehicle struck the first embankment, the driver was displaced in a forward direction. The driver moved in a similar fashion as the vehicle struck the third embankment, and probably deformed the steering column at this point. According to the interviewee, the driver remained in his seated position after the crash. The driver sustained musculoskeletal strains to his left shoulder and lower back that were probably a result of impact forces. He was removed from the vehicle by emergency personnel and transported to a local trauma center he was treated and released.

Figure 16. Overview of driver's seat position

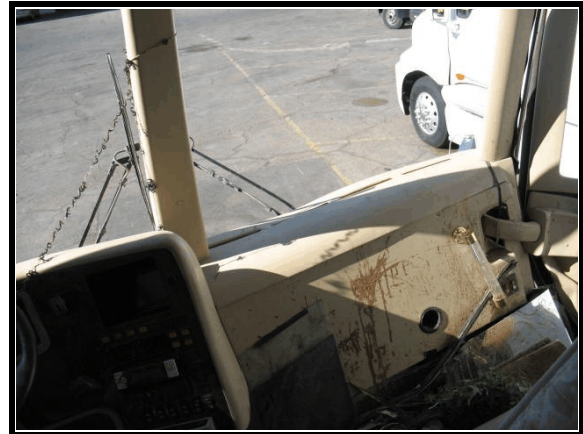
The unrestrained 63-year-old female front right occupant was probably either sitting in the front right seat or was in the proximity of the front right seat as the vehicle left the roadway (**Figure 17**). She was probably displaced forward to some degree as the driver initially braked. As the vehicle left the roadway, there was a change of elevation and this occupant was probably displaced in an upward direction. During the impact with the first embankment, she may have come into contact with the right instrument panel or the base of the windshield. As the vehicle struck the third embankment, both the windshield and this occupant were displaced forward and were ejected into the path of the bus. As the bus ran over this occupant, her body became entrapped just forward of the front axle. The body stayed in this location and traveled with the bus until the bus came to rest. She sustained fatal injuries and was pronounced deceased at the scene.

Figure 17. Area of front right windshield ejection
