On-Site Rollover Investigation  
Dynamic Science, Inc. (DSI), Case Number DS08029  
2006 GMC Envoy  
Arizona  
July 2008

1. Report No. DS08029	2. Government Accession No.	3. Recipient Catalog No.	
4. Title and Subtitle  On-Site Rollover Investigation		5. Report Date  August 3, 2009

**Dynamic Science, Inc.  
Crash Investigation  
Case Number: DS08029**

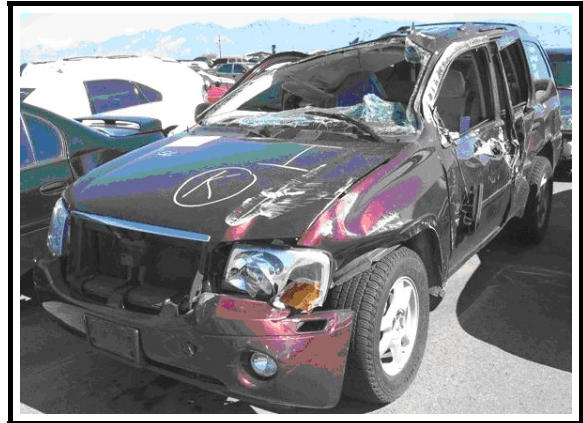
**Figure 1.** Subject vehicle, 2006 GMC Envoy

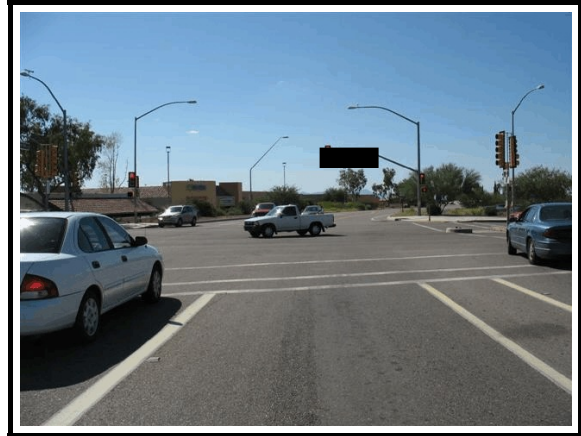
The crash site was a four-leg intersection of an east/west roadway and a north/south roadway (**Figure 2**). The east leg of the intersection consisted of a right turn lane, a westbound through lane and a left turn lane, which were separated by a double yellow stripe from a westbound lane. The profile measurement for the westbound lane was -2.7 percent at 61 m (200 ft) prior to impact, -3.1

**Figure 2.** Subject vehicle's westward approach to intersection

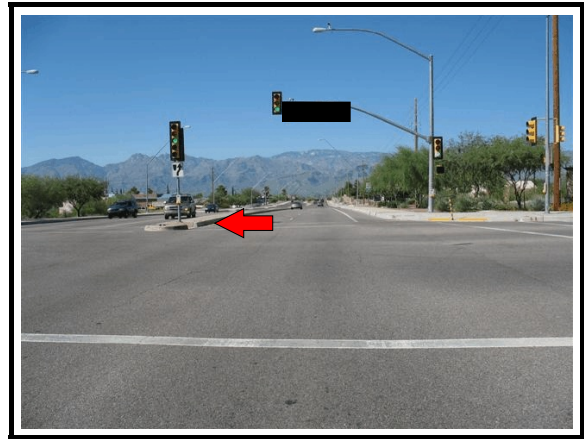
The initial impact displaced the GMC to the right and the vehicle began a clockwise rotation. The Pontiac was displaced to the left in a counterclockwise rotation. The left side of the GMC impacted the right rear tire area of the Pontiac (Event 2). The GMC's tires tripped on the pavement and the vehicle overturned with its left side leading (Event 3). The vehicle rolled a total of two quarter turns and came to rest back on its left side facing north in the northbound lanes (**Figure 3**) near the center median.

**Figure 3.** Area of impact, heading northbound. Arrow marks area of final rest for the GMC.

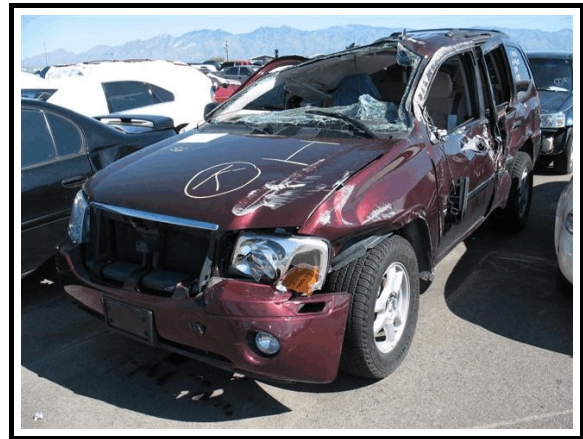
The GMC sustained minor front end and left side damage as a result of the impact with the Pontiac (Event 1). The front bumper fascia was gouged and deformed, the front grille was completely detached, the left headlamp was cracked, and the left front fender was crushed (**Figure 4**). Contact damage to the left front fender began at the front left bumper corner and extended 43 cm (16.9 in) rearward down the left side plane. The maximum lateral crush to the fender was 20 cm (7.9 in).

**Figure 4.** Front and left side damage

The direct damage to the front bumper began at the front left bumper corner and extended 54 cm (21.2 in) to the right. Six crush measurements were documented at the bumper level as follows: C1 = 7 cm (2.8 in), C2 = 4 cm (1.6 in), C3 = 0 cm, C4 = 0 cm, C5 = 0 cm, C6 = 0 cm. The maximum crush to the bumper measured 7 cm (2.8 in) and was located at C1. The Collision Deformation Classification (CDC) for the first impact was 10FLEW1.

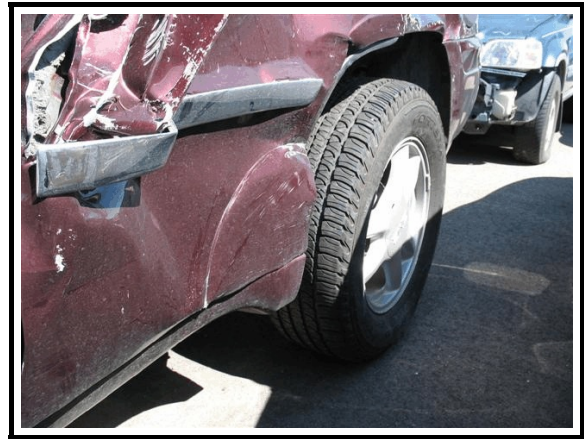
The GMC sustained minor damage to the area just forward of the left rear tire from a side-slap type impact with Pontiac (Event 2). The direct damage began along the frame rail 23 cm (9.0 in) forward of the wheel well and extended rearward to the wheel well (**Figure 5**). The damage extended vertically in an arc that ended at the wheel well and measured 38 cm (14.9 in) in height. The CDC for this impact was 09LPEN1.

**Figure 5.** Left wheel well contact

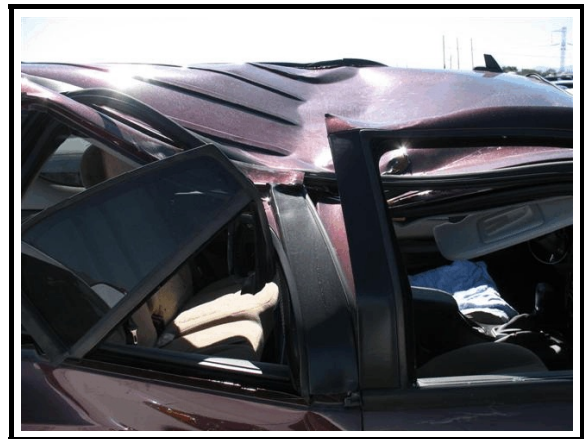
There were areas of light scratching located along the upper right front door that measured 21 cm (8.3 in) and along the right rear door that measured 81 cm (31.8 in). Most of the damage on the right side occurred at the roof rail lateral to the B-pillar (**Figure 6**). The maximum lateral crush at this location measured 9 cm (3.5 in). The front right window frame was pulled outward, probably during extrication efforts.

**Figure 6.** Damage to right roof rail

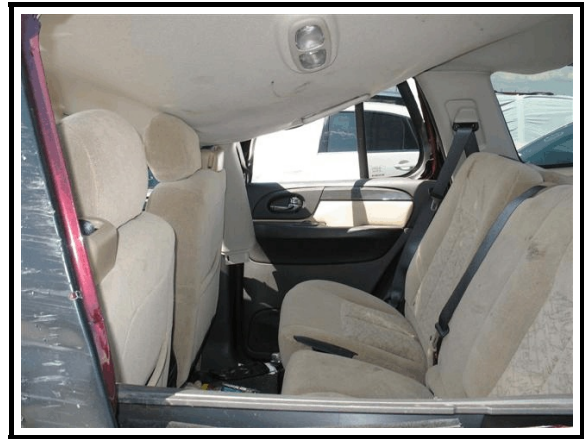
The right A- and B-pillar, roof side rail, and the roof intruded vertically (**Figure 7**). The right A-pillar, roof side rail, left front and second door panels intruded laterally.

**Figure 7.** Roof intrusion

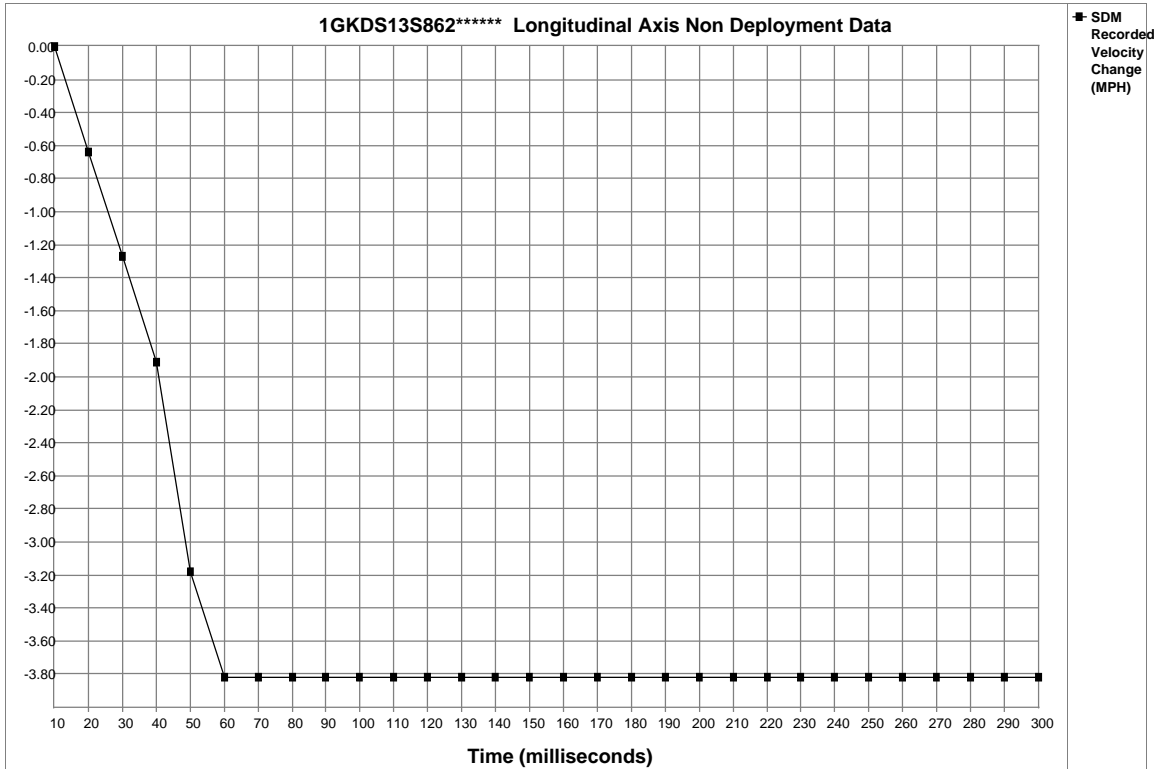
For the GMC, the EDR reported a maximum velocity change of 21.4 km/h (13.3 mph) at 290 milliseconds (ms) after algorithm enable (AE). The maximum longitudinal Delta-V was -6.2 km/h (-3.8 mph) and occurred at 60 ms. The lateral Delta-V was 12.2 km/h (7.6 mph) at 90 ms, was stable for 170 ms, and then rose to 20.5 km/h (12.7 mph) at 290 ms. The second spike was probably due to the side-slap impact.

Time (milliseconds)	10	20	30	40	50	60	70	80	90	100	110	120	130	140	150
SDM Longitudinal Axis Recorded Velocity Change (MPH)	0.00	-0.64	-1.27	-1.91	-3.18	-3.82	-3.82	-3.82	-3.82	-3.82	-3.82	-3.82	-3.82	-3.82	-3.82
Time (milliseconds)	160	170	180	190	200	210	220	230	240	250	260	270	280	290	300
SDM Longitudinal Axis Recorded Velocity Change (MPH)	-3.82	-3.82	-3.82	-3.82	-3.82	-3.82	-3.82	-3.82	-3.82	-3.82	-3.82	-3.82	-3.82	-3.82	-3.82

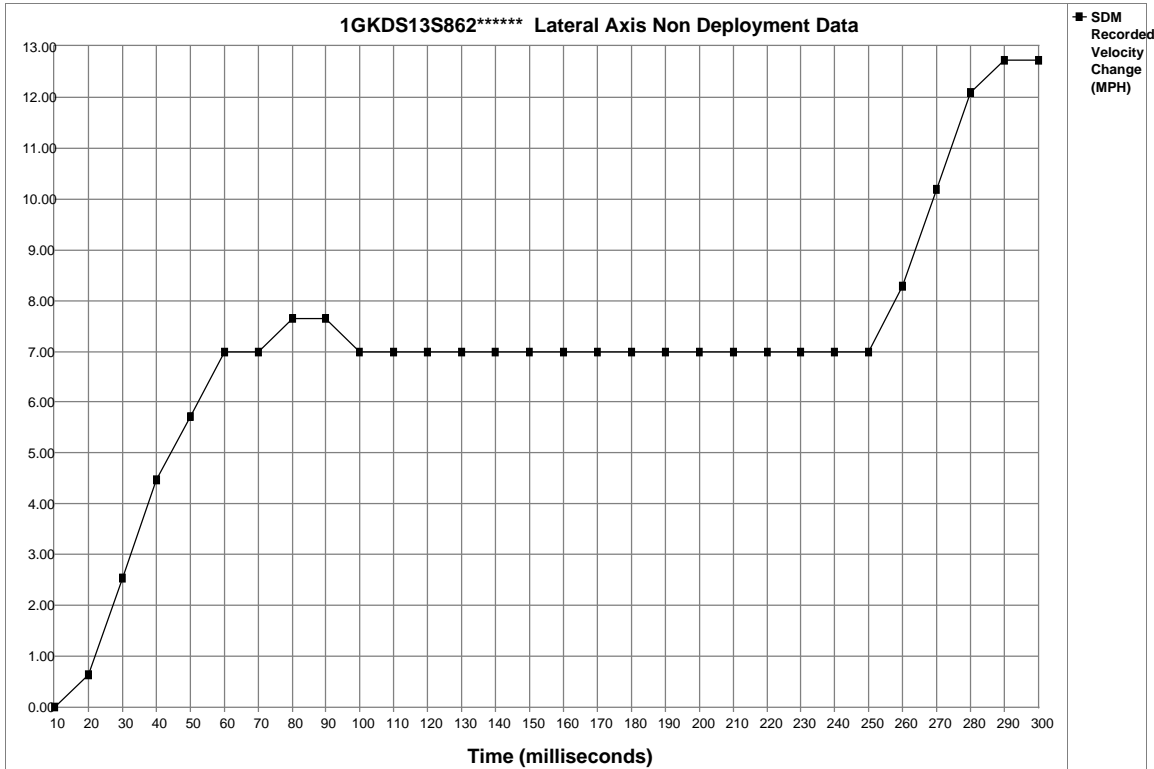
Time (milliseconds)	10	20	30	40	50	60	70	80	90	100	110	120	130	140	150
SDM Lateral Axis Recorded Velocity Change (MPH)	0.00	0.64	2.55	4.46	5.73	7.00	7.00	7.64	7.64	7.00	7.00	7.00	7.00	7.00	7.00
Time (milliseconds)	160	170	180	190	200	210	220	230	240	250	260	270	280	290	300
SDM Lateral Axis Recorded Velocity Change (MPH)	7.00	7.00	7.00	7.00	7.00	7.00	7.00	7.00	7.00	7.00	8.28	10.19	12.10	12.73	12.73
