ON-SITE SIDE IMPACT INFLATABLE OCCUPANT PROTECTION INVESTIGATION

CASE NUMBER - IN08031
LOCATION - TEXAS
VEHICLE - 2008 HONDA ACCORD EX-L
CRASH DATE - June 2008

1. <i>Report No.</i> IN08031		2. <i>Government Accession No.</i>		3. <i>Recipient's Catalog No.</i>	
4. <i>Title and Subtitle</i> On-Site Side Impact Inflatable Occupant Protection Investigation Vehicle - 2008 Honda Accord EX-L Location - Texas			5. <i>Report Date:</i> August 11, 2009

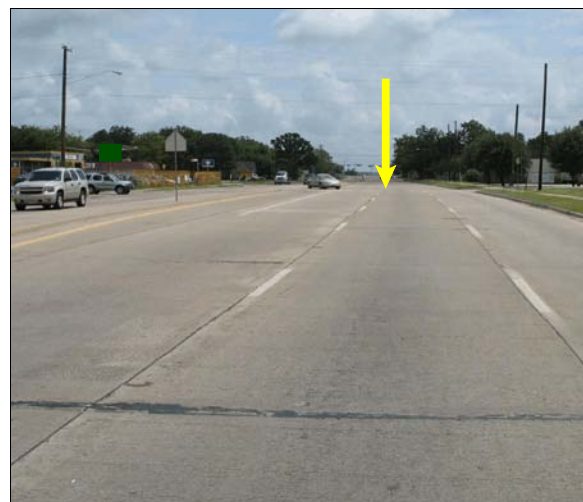
Figure 1: 2008 Honda's east-northeast travel path, while negotiating slight left-hand curve, in inside lane approaching 4-leg intersection; arrow indicates approximate point of impact with 1991 Honda

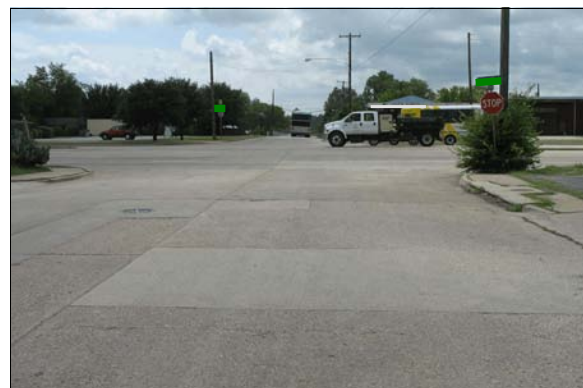
Figure 2: 1991 Honda's south-southeastern path of travel after starting from STOP sign on north leg of intersection; impact occurred near front of truck traveling eastward through intersection

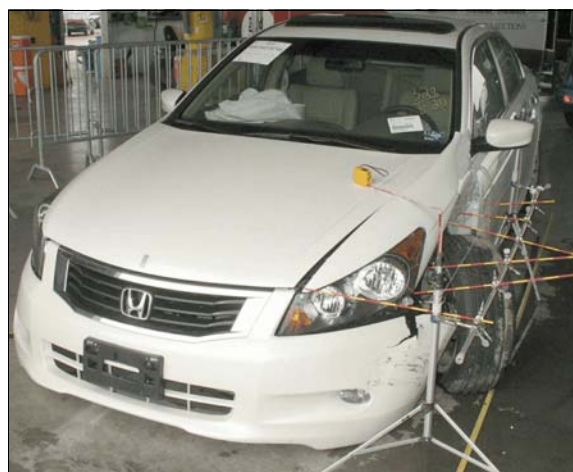
Figure 3: 2008 Honda's left front damage from impact by front of 1991 Honda

Exterior Damage: The 2008 Honda’s initial contact with the 1991 Honda involved the left side (event 1) with the damage distributed on approximately the front third (Figures 3, 4, and 6). Direct damage began at the left front bumper corner and extended 137 centimeters (53.9 inches) along the left side. The direct damaged ended 214 centimeters (84.3 inches) forward of the left rear axle. Residual maximum crush was measured as 15 centimeters (5.9 inches) at C₃-C₄. The 2008 Honda’s side slap contact with the 1991 Honda involved the left side (event 2) with the damage distributed on approximately the back third (Figure 7). Direct damage began 30 centimeters (11.8 inches) forward from the left rear axle and extended 125 centimeters (49.2 inches) to the left rear bumper corner. Residual maximum crush was measured as 9 centimeters (3.5 inches) at C₂. The table below shows the case vehicle’s crush profile.

to the front bumper fascia and hood (i.e., pushed rightward—**Figures 3 and 5**). No obvious induced damage or remote buckling was noted to the remainder of the Honda's exterior.

Damage Classification: Based on the vehicle inspection, the Collision Deformation Classifications for the Honda were: **11-LYEW-1 (330 degrees)** for the initial impact (event 1), **09-LBEW-2 (270 degrees)** for the side slap impact (event 2), and **12-FRWN-3 (0 degrees)** for the wheel impact (event 3). The Missing Vehicle algorithm of the WinSMASH reconstruction program was used on both this Honda's highest and second highest severity impacts. The Total, Longitudinal, and Lateral Delta Vs for the highest severity impact were, respectively: 9.0 km/h (5.6 mph), -7.8 km/h (-4.8 mph), and 4.5 km/h (2.8 mph). Based on this contractor's experience, this collision fits the reconstruction model, but the calculated longitudinal and lateral Delta Vs appear to be low because the wheel assembly is stiffer than the normal side structures and a significant portion of the impact occurred at the wheel assembly. The results for the side slap impact were, respectively: 6.0 km/h (3.7 mph), 0.0 km/h (0.0 mph), and 6.0 km/h (3.7 mph). These results appear reasonable.

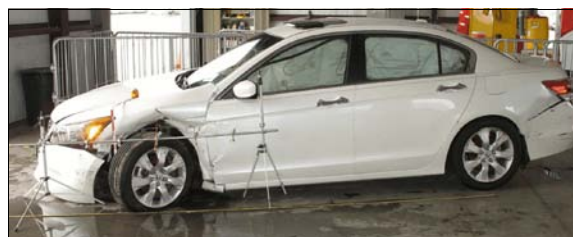
Figure 4: Damage to 2008 Honda's left side from impacts with 1991 Honda; initial impact to left front and subsequent side slap impact to left rear

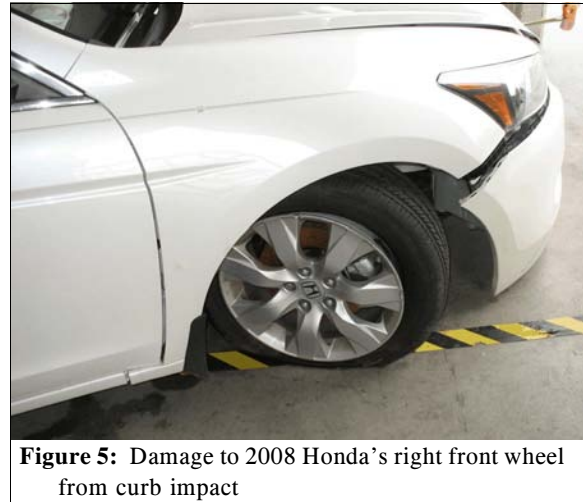
Figure 5: Damage to 2008 Honda’s right front wheel from curb impact

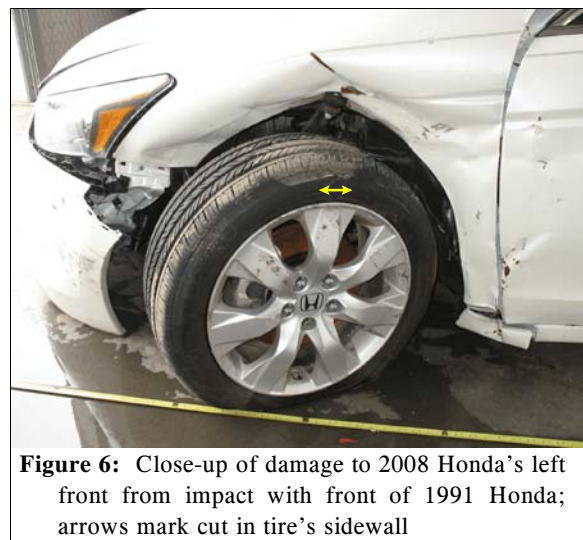
Figure 6: Close-up of damage to 2008 Honda’s left front from impact with front of 1991 Honda; arrows mark cut in tire’s sidewall

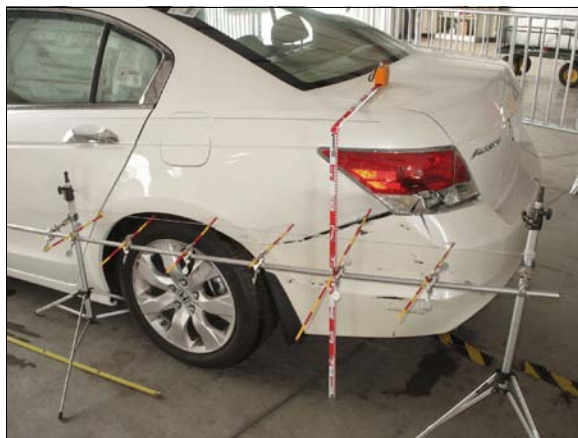
Figure 7: Side slap damage to 2008 Honda’s left rear from impact with right side of 1991 Honda

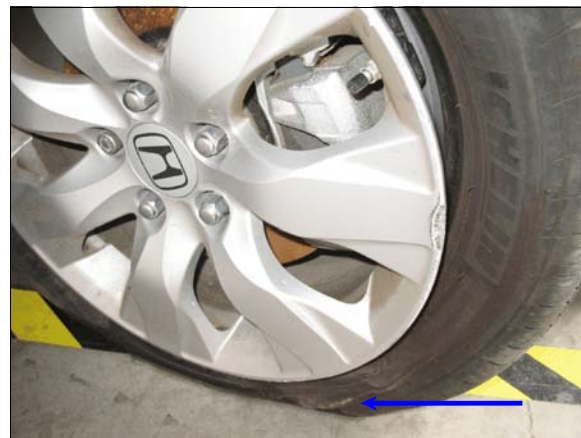
Figure 8: Rim and tire damage to 2008 Honda’s right front wheel; arrow indicates cut in sidewall

The wheelbase on the Honda’s left side was shortened 2 centimeters (0.8 inches) while the right side was shortened 5 centimeters (2.0 inches). During the initial impact the Honda’s left front bumper fascia, left fender, and left front door were directly damaged and crushed inward. The left front wheel assembly was damaged and crushed backward and the front of the wheel was rotated outward. As a result of the side slap impact, the Honda’s left quarter panel and left rear bumper fascia were directly damaged and crushed inward. When the Honda impacted the curb (event 3), the right front wheel assembly was directly damaged and crushed rearward and the front of the tire was rotated outward (Figure 8). As a result of the crash, there was induced damage

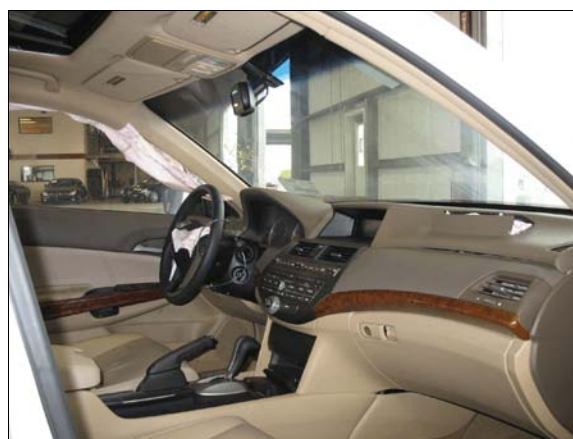
Interior Damage: Inspection of the 2008 Honda's interior revealed that all the doors remained closed and operational. There was no evidence of occupant contact on the interior surfaces of the Honda (**Figure 9**). There was no evidence of intrusion to the interior, no of compression to the energy absorbing shear capsules in the steering column, and no deformation to the steering wheel rim.

Figure 9: 2008 Honda's front seating areas

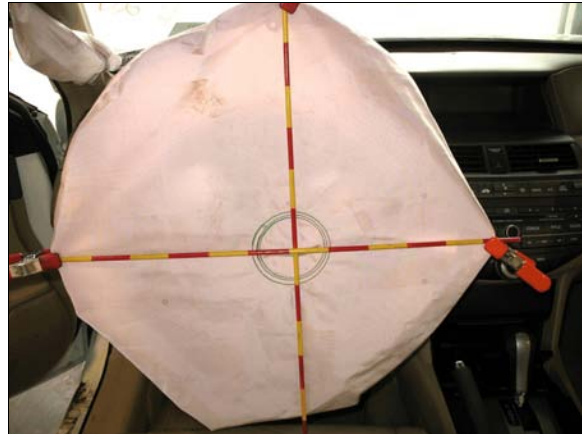
The driver air bag was located in the steering wheel hub. An inspection of the air bag module's cover flaps and the air bag's fabric revealed that the cover flaps opened at the designated tear points. There was no evidence of damage during the deployment to the air bag or the cover flaps. The driver's air bag was designed with two tethers. The driver's air bag had two vent ports, located on the backside near the center at the 10 and 2 o'clock positions. The deployed driver's air bag was round with a diameter of 59 centimeters (23.2 inches). An inspection of the driver's air bag fabric revealed multiple deployment scuffs but no contact evidence apparent on the air bag's fabric (**Figure 10**).

Figure 10: Honda's deployed driver air bag showing only deployment scuffs on bag's surface

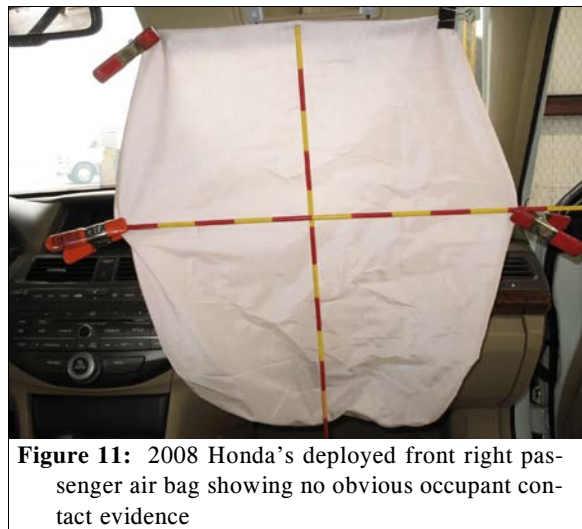
The front right passenger's air bag was located in the top of the instrument panel (**Figure 9**). An inspection of the front right air bag module's cover flaps and the air bag's fabric revealed that the cover flaps opened at the designated tear points. There was no evidence of damage during the deployment to the air bag or the cover flaps. The front right passenger's air bag was designed without any tethers. The front right air bag had two vent ports, located at the 10 and 2 o'clock positions. The deployed front right air bag was rectangular with a height of 60 centimeters (23.6 inches) and a width of 52 centimeters (20.5 inches). An inspection of the front right passenger's air bag fabric revealed no contact evidence on the air bag's fabric (**Figure 11**).

Figure 11: 2008 Honda's deployed front right passenger air bag showing no obvious occupant contact evidence

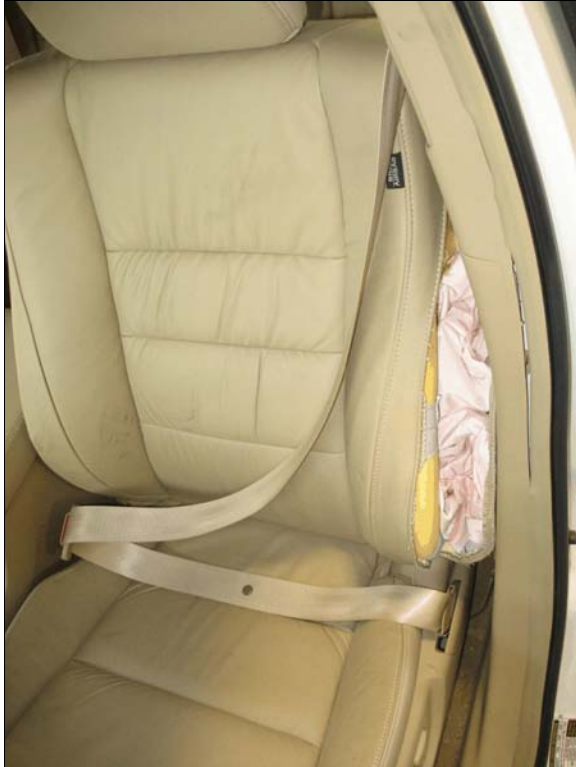
The Honda's driver and right front side impact inflatable occupant protection systems (air bags) were located along of the driver's and front right passenger's seat backs, respectively. The air bags were mounted at the top of the seat back and extended downward approximately 50 centimeters (19.7 inches). The bags were attached within the seat back near its outside surface and deployed through a front tear seam (**Figures 12 and 13**).

Figure 12: Location of 2008 Honda's deployed driver side impact air bag

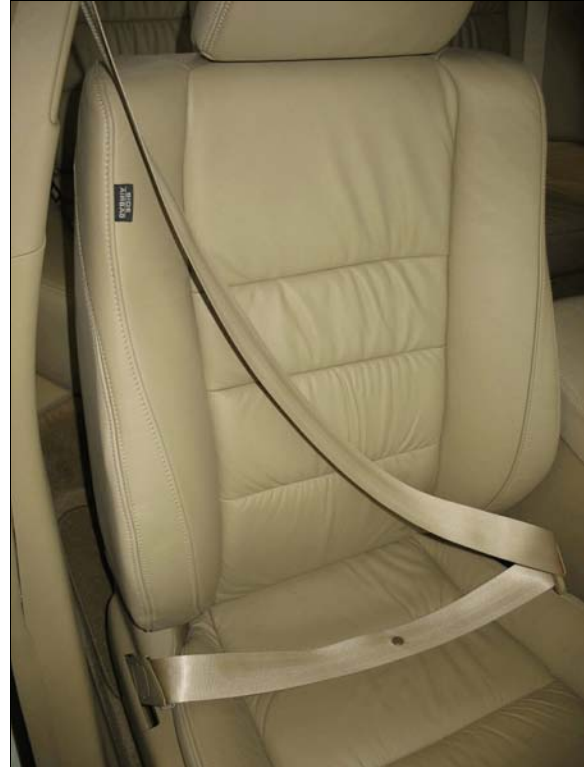
Figure 13: Location of 2008 Honda's non-deployed right front side impact air bag

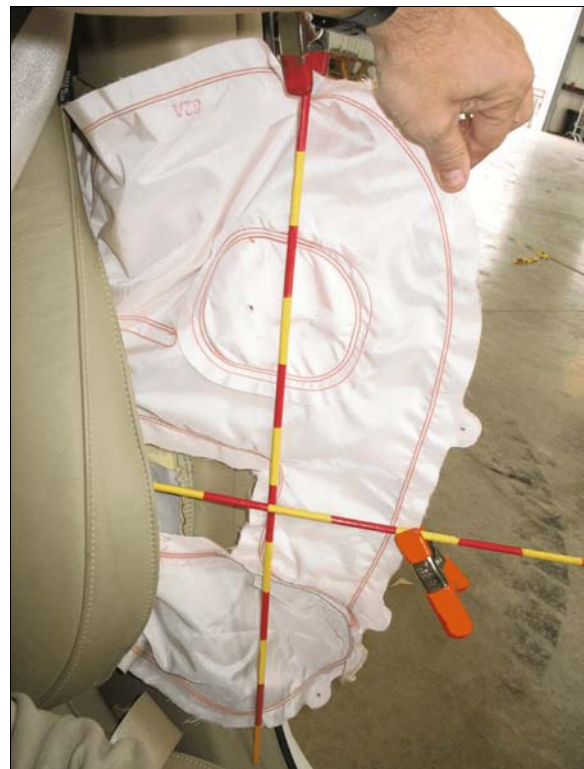
The driver's side air bag was designed with two inflation chambers and the top chamber had a stitched oval area that served to tether the air bag (**Figure 14**). The air bag had one vent port, located at the 12 o'clock position on the outboard surface when viewed from the left side of the vehicle. The deployed side impact air bag was elliptical with a height of 60 centimeters (23.6 inches) and a width (i.e., forward excursion) of approximately 25 centimeters (9.8 inches). An inspection of the driver's air bag fabric revealed no occupant contact evidence on either the outboard or inboard surfaces. A scuff on the outboard surface was present, probably from contact with the interior door surface.

Figure 14: Interior surface of 2008 Honda's deployed driver side impact air bag showing no apparent evidence of occupant contact

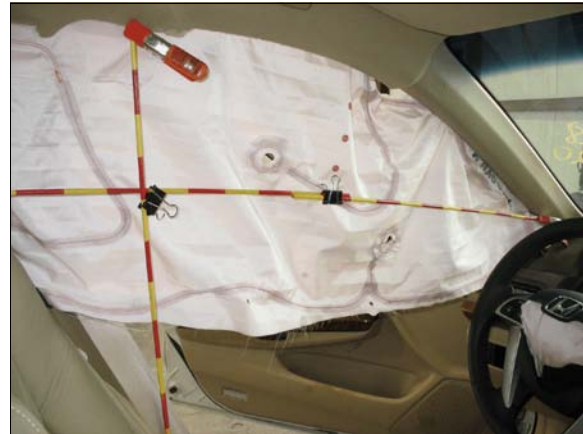
The side curtain air bag was designed with inflation chambers adjacent to the driver and second row left seat positions. There were no external vent ports. Inspection of the air bag revealed no evidence of damage due to deployment on either the outboard or inboard surfaces and no occupant contact evidence on the interior surfaces of the air bag's fabric (**Figure 16**).

Figure 16: Inboard surface of 2008 Honda's other side inflatable (curtain) air bag showing no apparent occupant contacts along driver's seating portion of bag's surface
