**CALSPAN ON-SITE BACK OVER INCIDENT INVESTIGATION**

**SCI CASE NO.: CA08032**

**VEHICLE: 2004 NISSAN ALTIMA**

**CRASH DATE: JULY 2008**

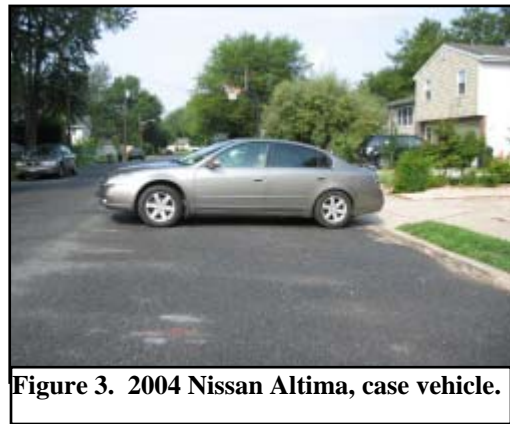
**Figure 3. 2004 Nissan Altima, case vehicle.**

The vehicle in this incident was a 2004 Nissan Altima SL sedan (**Figure 3**). The Nissan was manufactured in 01/04 and was identified by Vehicle Identification Number (VIN): 1N4AL11D94C (production number deleted). The Nissan was equipped with a 2.5-liter, four-cylinder engine, a four-speed automatic transmission, and front-wheel drive. The tires on the vehicle were P205/65R16 mounted on OEM alloy wheels. The Nissan was not equipped with a backup camera or parking assist system.

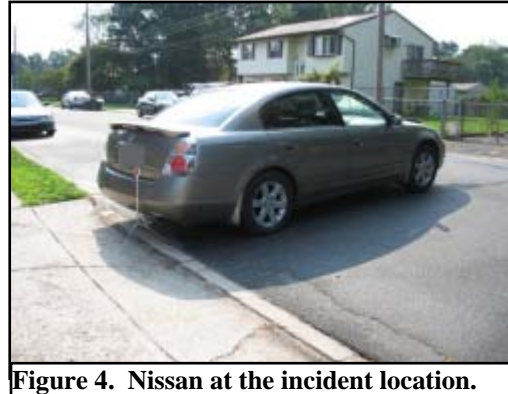
**Figure 4. Nissan at the incident location.**

The driver backed the Nissan approximately 6 meters (20 feet) and struck the non-motorist at the mouth of the driveway. The sibling ran to the front left door and alerted the driver of the incident. The driver stopped the Nissan, placed the transmission selector in drive and pulled the vehicle forward (south) approximately 0.3-0.6 (1-2 feet). The driver did not detect the non-motorist in the rear view mirror during the backing maneuver. **Figure 4** is of Nissan at the location of the incident.

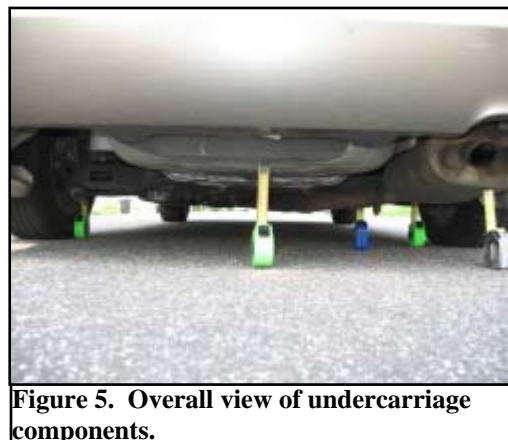
**Figure 5. Overall view of undercarriage components.**

The SCI investigator inspected the vehicle during the on-site investigation. Due to the passage of time between the incident and the investigation, evidence of contact was not present on the Nissan's rear bumper fascia or undercarriage. **Figure 5** is an overall view of the undercarriage components.

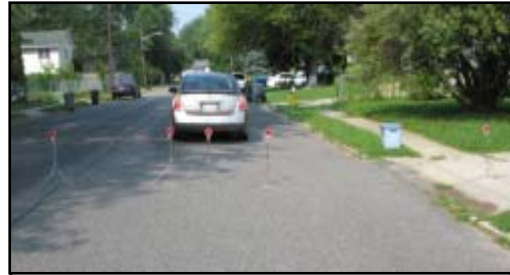
**Figure 6. Overall view of targets with driver using the rear view mirror.**

The rear visibility was measured using an 8 cm (3") diameter reflective red marker that was positioned in a stand and set 71 cm (28") above the ground. The driver stated that she used the rear view mirror at the time incident; therefore, she was asked to locate the reflective marker looking in the rear view. The driver located the target 4.6 meters (15 feet) rear of the rear bumper along the centerline of the vehicle. The driver continued a straight line of sight that intersected the ground at a point that was 14 m (45.9 feet) from the rear bumper. Lateral cones of visibility were established with driver looking into the door mounted mirrors. The left lateral cone of visibility measured 3 meters (9.8 feet) with a right lateral cone of 4.8 meters (15.7 feet). Based on this visibility study, it appeared that the non-motorist entered the blind zone as he approached the vehicle, thus resulting in this back over incident.

**Figure 6** is an overall view of the driver locating the target using the rear view mirror. The Rear Visibility Diagram is attached as **Figure 7** of this report. Included as **Attachment A** of this report is the Not In Traffic Surveillance Forms.

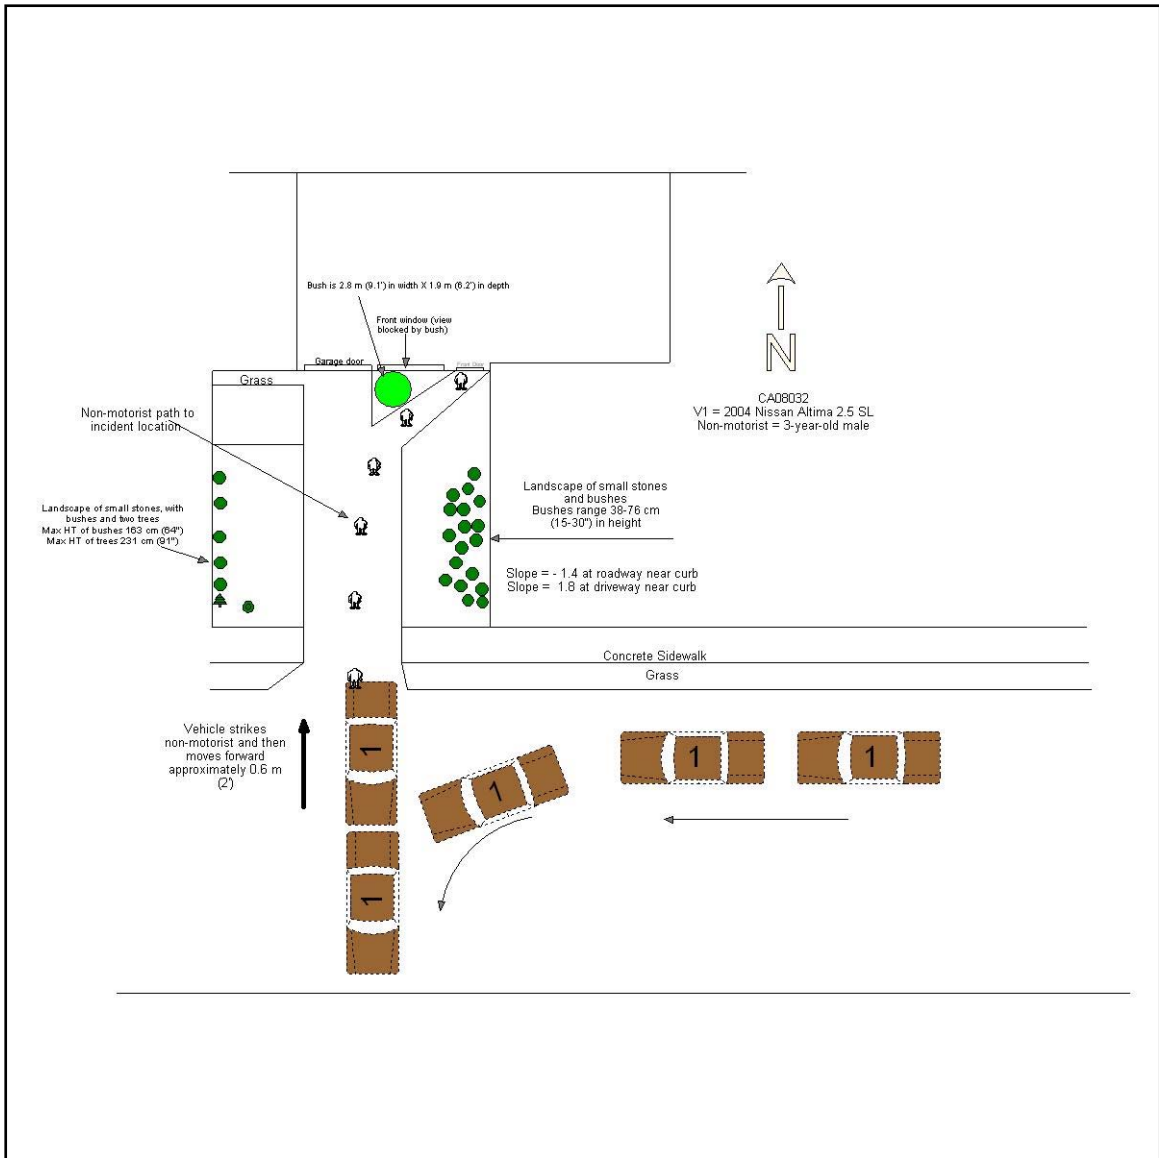
**Figure 8: Incident Schematic**

located on the north side of a two-lane east/west road. A concrete surfaced driveway that measured 3.3 meters (10.8 feet) in width and 8.9 meters (29.2 feet) in length extended from the residence to the roadway. The roadway measured 10.3 meters (33.9 feet) wide and was surfaced with asphalt. The driveway was bordered by a red colored decorative concrete border that was 4.6 cm (1.8”) in height. Adjacent to the border was a landscaped area that consisted of decorative stone, shrubs, and small trees. The landscaping did not interfere with the driver’s vision during this backing incident. Due to the crown of the roadway, there was a negative grade of -1.4 percent as the vehicle approached the mouth of the driveway. A positive grade of 1.8 percent was present leading from the mouth of the driveway towards the garage. The Incident Schematic is attached as **Figure 8** of this report.
