TRANSPORTATION RESEARCH CENTER

ON-SITE CERTIFIED ADVANCED 208-COMPLIANT VEHICLE INVESTIGATION

CASE NUMBER - IN08033
LOCATION - MISSOURI
VEHICLE - 2007 CHEVROLET MALIBU LS
CRASH DATE - September 2008

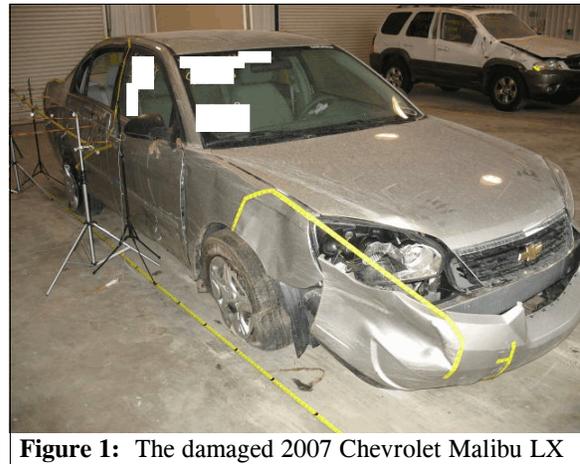
Figure 1: The damaged 2007 Chevrolet Malibu LX

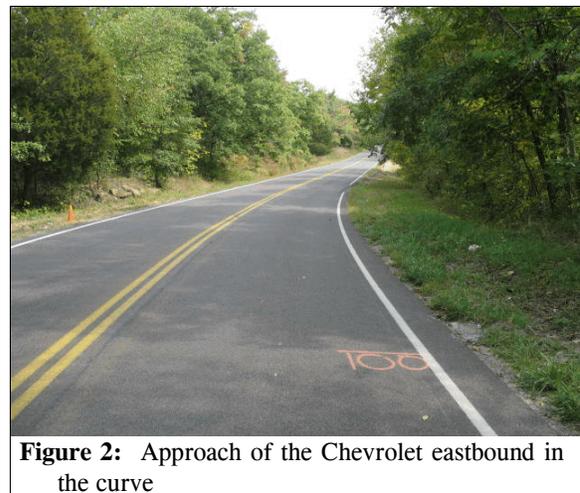
Figure 2: Approach of the Chevrolet eastbound in the curve

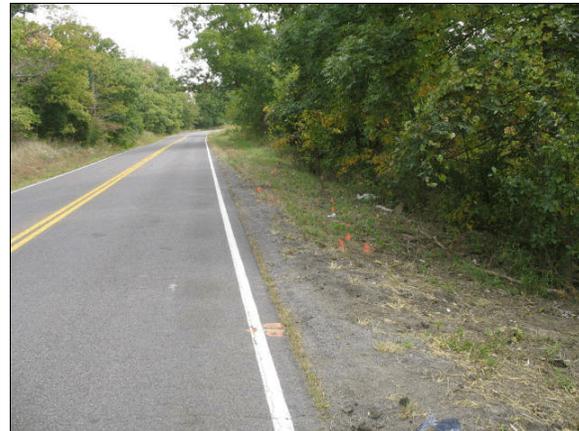
Figure 3: Location where the Chevrolet departed the south side of the roadway

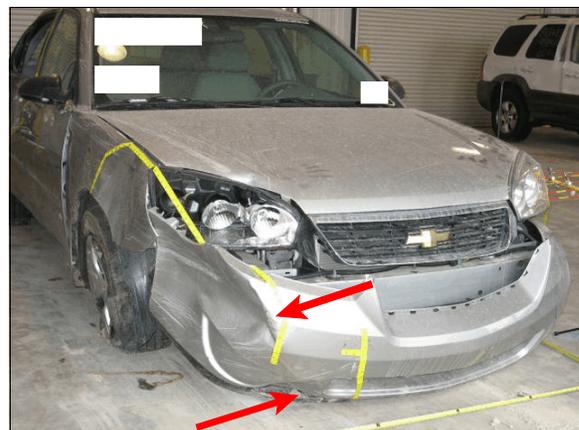
Figure 4: Bottom arrow shows impact location on lower bumper fascia with a rock (event 1), top arrow shows impact location with a tree (event 3)

Exterior Damage: The damage from the multiple impacts involved the front plane, both side planes, top plane and the right side wheels. The direct damage from the initial impact to a rock (event 1) began 34 cm (13.4 in) right of the centerline and extended 27 cm (10.6 inches) to the right on the lower portion of the bumper fascia. This impact involved only the plastic bumper fascia and there was no crush to the metal bumper bar. The second impact with the same rock (event 2) involved the right front wheel, and it was displaced rearward 12 cm (4.7 in) and loaded into the back of the wheel well.

The direct damage on the front right bumper corner from the impact to a tree (event 3) began at the corner of the bumper fascia and extended 5 cm (2 in) to the left. This impact involved only the plastic bumper fascia. There was no crush to the bumper bar. The direct damage extended 91 cm (35.8 in) along the right side on the right fender.

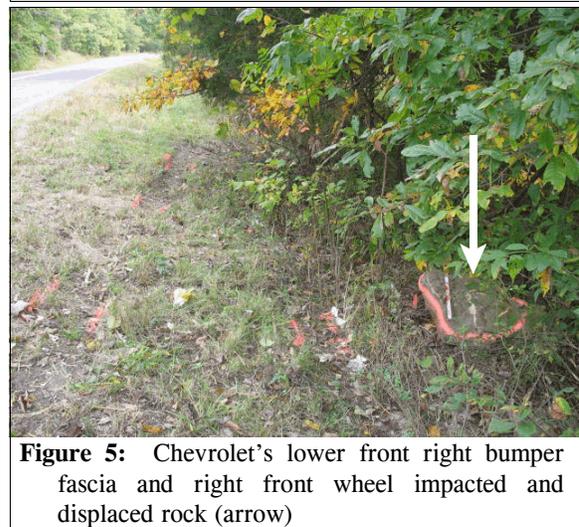
Figure 5: Chevrolet's lower front right bumper fascia and right front wheel impacted and displaced rock (arrow)

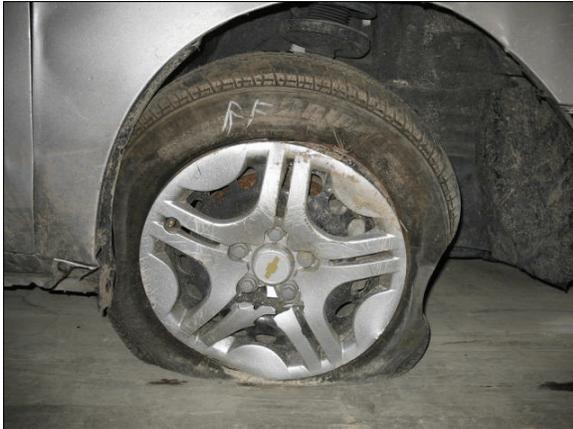
Figure 6: Damage to right front wheel from impact with a rock

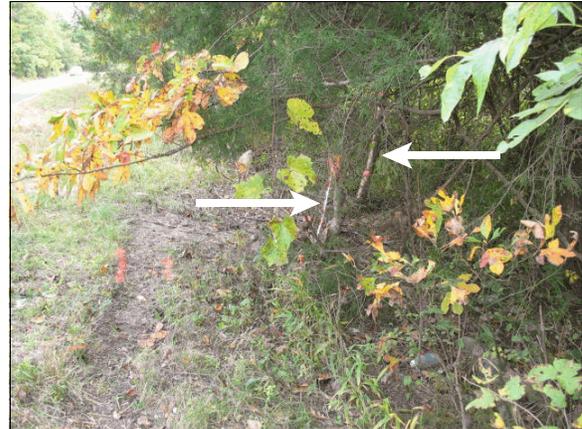
Figure 7: Arrow on left shows tree impacted by the front right bumper corner (event 3); arrow on right shows tree sideswiped by right rear door and quarter panel (event 4)

The direct damage on the right rear door and quarter panel from a sideswipe to a tree (event 4) began 122 cm (48 in) forward of the right rear axle and extended 206 cm (81.1 in) rearward on the side. The maximum residual crush was 7 cm (2.8 inches) and occurred at C₄. A sideswipe to a another tree (event 6) also partially overlapped the damage from event 4, but this event appeared to consist of only scratches. The table below shows the crush profile for event 4.

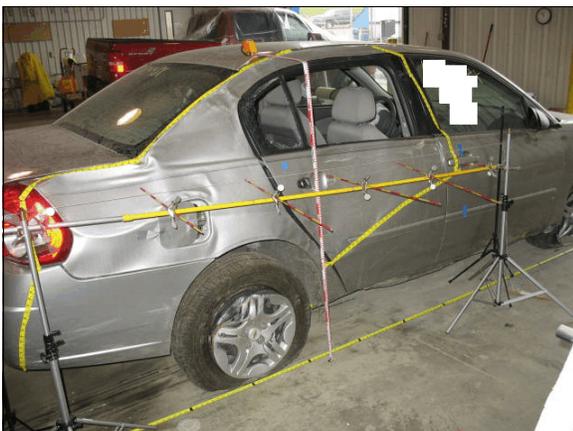
Figure 8: Damage to right side from sideswiping two trees (events 4 and 5)

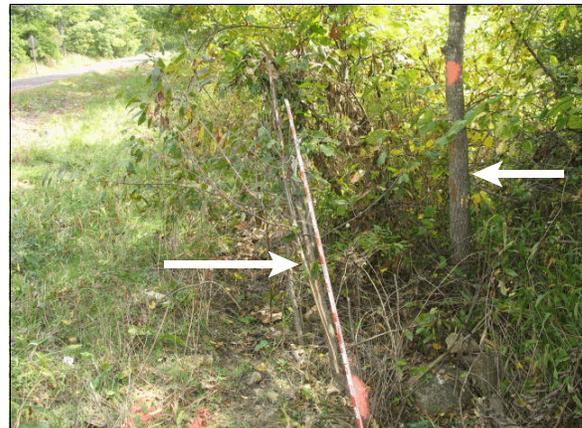
Figure 9: Chevrolet's front bumper impacted tree (arrow on left, event 5) and right quarter sideswiped another tree (arrow on right, event 6)

The direct damage from a tree impact to the front bumper (event 5) began 37 cm (94 in) right of the centerline and extended 24 cm (9.4 in) to the right on the bumper. This impact only scuffed the plastic bumper fascia and produced no crush to the bumper bar.

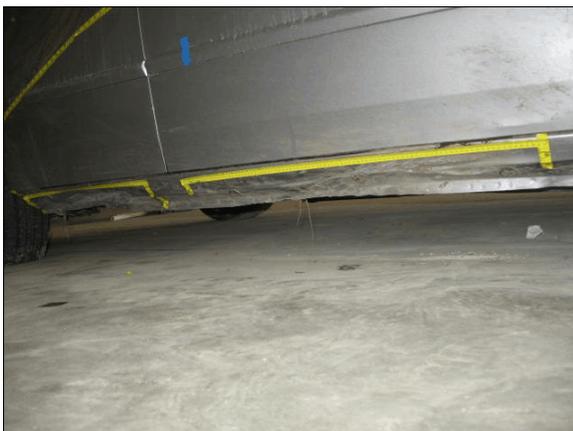
Figure 10: Damage to right rocker panel from impact with a rock (event 7)

The direct damage on the right rocker panel from a sideswipe to a rock (event 7) began 194 cm (76.4 in) forward of the right rear axle and extended 148 cm (58.3 in) rearward. The maximum crush was 5 cm (2 in) and occurred at C₄. The table below shows the crush profile for event 7.

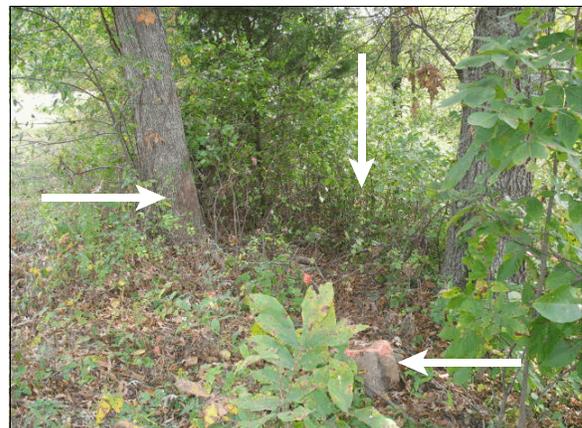
(events 8 and 9) and the left fender (**Figure 12**) sideswiped a 69 cm (27.2 in) diameter tree (**Figure 11**, event 10) as the vehicle came to final rest. At final rest of the vehicle was located 5.8 m (19 ft) off the south roadway edge heading southeast.

Figure 11: Impacts with rock, wire fence, and tree (events 7-10), and final rest

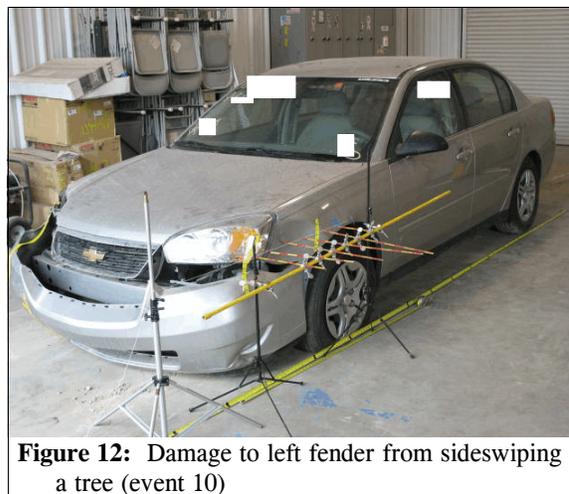
Figure 12: Damage to left fender from sideswiping a tree (event 10)

The direct damage from a tree impact to the left fender (event 10) involved the left side of the bumper fascia and the fender. The direct damage began 27 cm (10.6 in) forward of the left front axle and extended 38 cm (15 in) forward along the fender. The maximum residual crush was 7 cm (2.8 in) and occurred at C₄. The table below shows the crush profile for event 10.

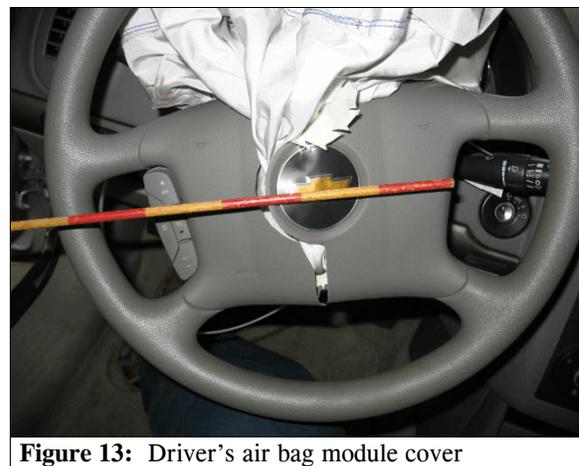
The driver's frontal air bag was located within the steering wheel hub and the module cover was a bi-fold configuration (**Figure 13**)

Figure 13: Driver's air bag module cover

constructed of pliable vinyl. Each flap was 10 cm (4 in) in width and 15 cm (6 in) in height. There was a cutout on the left flap to accommodate the Chevrolet emblem on the right flap. The air bag module cover flaps opened at the designated tear points. The deployed air bag (**Figure 14**) was round with a diameter of 60 cm (23.6 in) and was designed with four tethers and two vent ports. The vent ports were 3 cm (1.2 in) in diameter and were located at the 11 and 1 o'clock positions. Each tether was 11 cm (4.3 in) in width. There was no damage to the air bag and no discernable evidence of occupant contact. A localized area of dark scuffing was present on the front upper right quadrant of the air bag, but this did not appear to be occupant contact and was possibly the result of deployment or post-crash handling of the air bag.

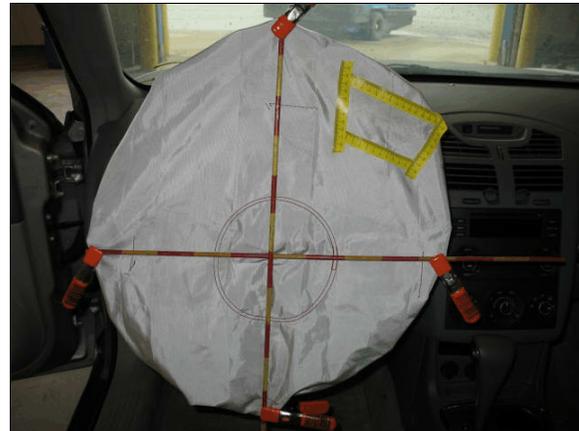
Figure 14: The driver's air bag; yellow tape outlines a dark scuff, but it did not appear to be an occupant contact

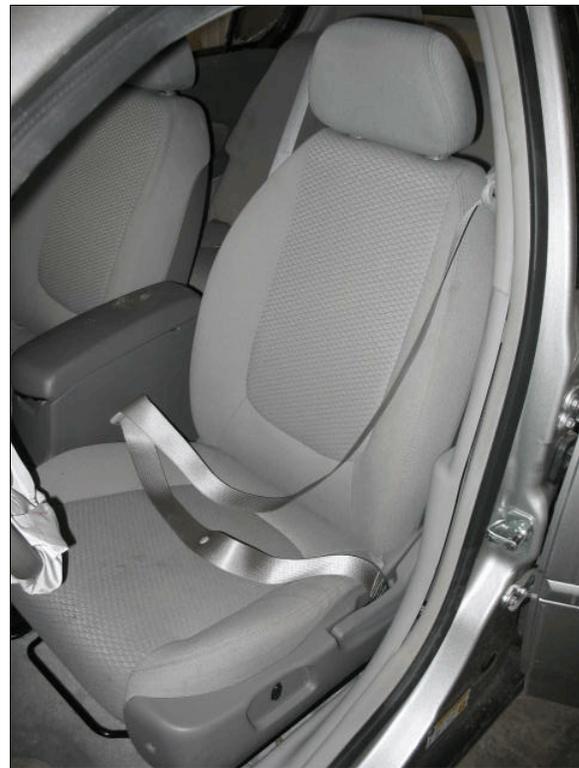
The driver's seat belt was found with the retractor jammed and a length of belt webbing extended out of the retractor (**Figure 15**), which supported the EDR reported actuation of the pretensioner during the crash. The length of belt was 133 cm (52.6 in) as measured from the stop button to the D-ring. The inspection of the D-ring revealed load abrasions on the plastic (**Figure 16**) and usage scratches on the latch plate. The evidence indicated that the driver was restrained at the time of the crash. The other seat positions were not occupied.

Figure 15: Driver's seat belt

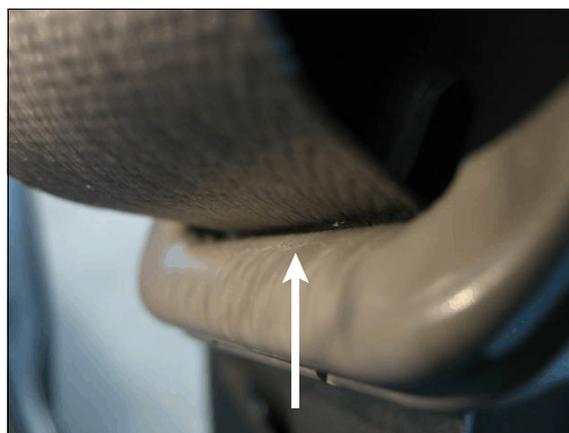
Figure 16: Arrow shows abrasions on driver’s D-ring
