ON-SITE ROLLOVER INVESTIGATION

CASE NUMBER - IN08034

VEHICLE - 2007 FORD RANGER XLT

CRASH DATE - September 2008

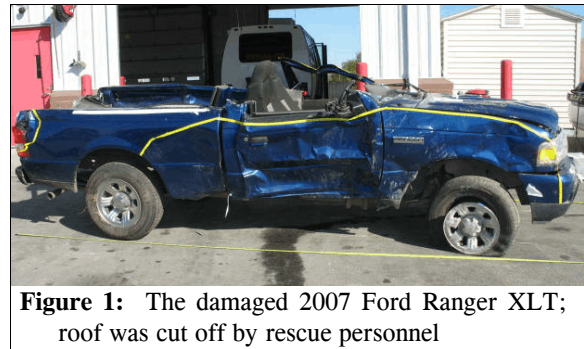
Figure 1: The damaged 2007 Ford Ranger XLT; roof was cut off by rescue personnel

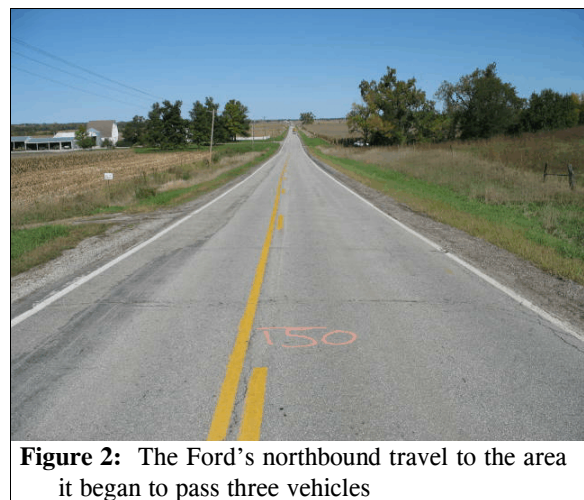
Pre-Crash: The Ford's restrained 47-year-old male driver was traveling north behind two passenger vehicles and a tractor-semitrailer at a witness reported speed of 72 km/h (45 mph). The Ford's driver began to pass the vehicles as they traveled down a 5% negative grade (**Figure 2**). As the Ford was passing, its left side wheels departed the west edge of the roadway and the driver steered right and reentered the roadway

Figure 2: The Ford's northbound travel to the area it began to pass three vehicles

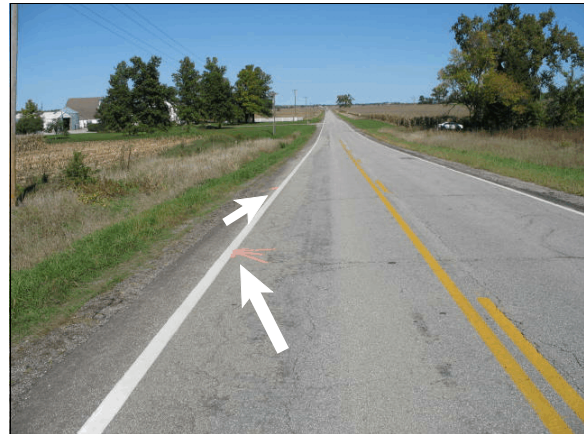
(Figure 3). The vehicle crossed the southbound lane and the driver steered left as the vehicle reentered the northbound lane. As a result of the left steering maneuver, the vehicle began to yaw counterclockwise. The vehicle's right front and right rear tires produced yaw marks on the roadway as the vehicle rotated counterclockwise toward the west roadside where the rollover occurred (Figure 4).

Figure 3: Arrows show police reported area of initial roadway departure and area where Ford reentered the roadway

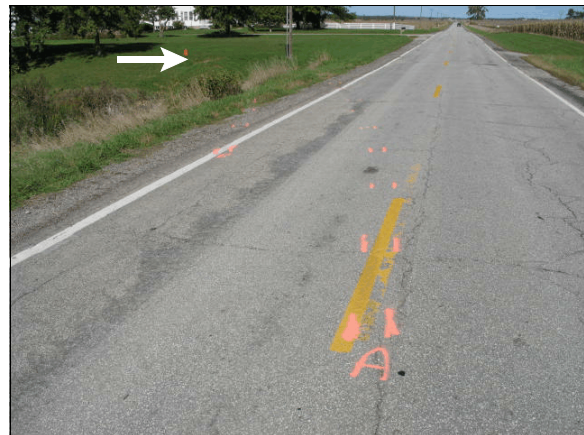
Figure 4: Fords yaw marks leading to area of rollover; yaw mark A is from right rear tire and other mark is from right front tire; arrow shows location of Ford's final rest

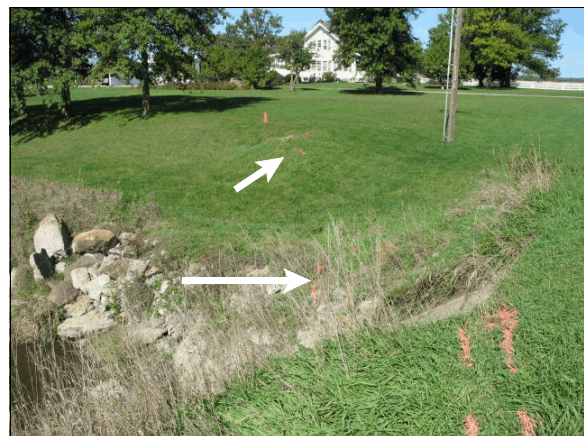
Crash: The Ford was yawed counterclockwise 105 degrees from the roadway's northbound direction as it departed the west shoulder and entered the grass. The vehicle traversed 9 meters (29.5 feet) down a negative 18% grass slope at which point it traveled off the edge of the culvert (Figure 5) and began to rollover right side leading (rollover initiation type: fall-over). As it was airborne, it fell a vertical distance of 1.1 meters (3.6 feet) from the edge of the culvert and traversed a horizontal distance of 7 meters (23 feet) as it fell to the point of touchdown. The right side of the vehicle (Figure 6) touched down on the north embankment of the stream (Figure 5) and the vehicle continued to rollover as it again became airborne. It continued to rotate counterclockwise as it rolled over and the top impacted the ground (Figure 5) near the top of the embankment. The vehicle then rolled onto its left side to final rest heading southeast (Figure 7). The vehicle rolled over a total of three quarter turns across a horizontal distance of 19.6 m (64.3 ft) from the point it traveled off the edge of the culvert to its final rest position.

Figure 5: Location where Ford traveled off the edge of the culvert and became airborne; arrow in foreground shows location where right side of vehicle touched down on the stream embankment during first quarter turn; arrow in background shows area where top impacted the ground during second quarter turn

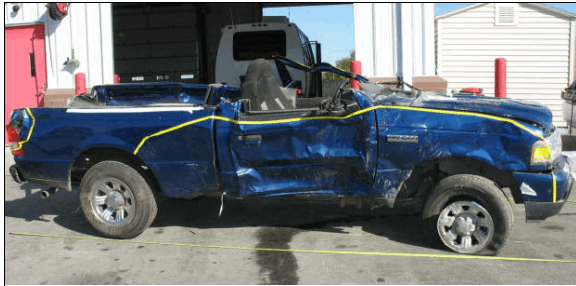
Figure 6: Damage to Ford's right side from the initial touchdown on the north stream embankment during the first quarter turn of the rollover

Exterior Damage: The damage from the rollover involved the top and both sides of the vehicle (Figures 6, 8 and 9). The direct damage to the top plane extended the full length and width of the top. It was not possible to determine the maximum crush to the roof since it had been cut off the vehicle. The direct damage to the right side began 26 cm (10.2 in) forward of the right rear axle and extended 322 cm (126.8 in) forward along the right side. The maximum residual crush to the right side was 25 cm (9.8 in) and

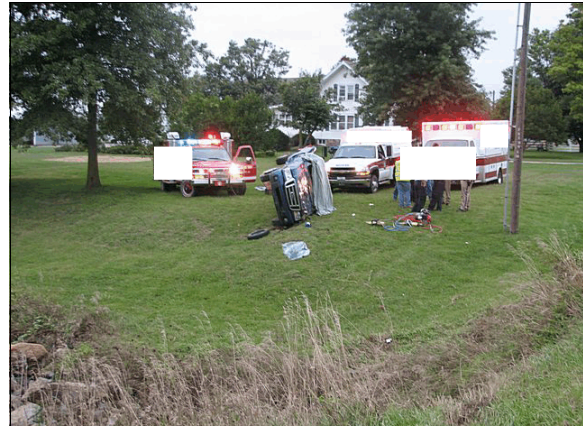
Figure 7: Coroner's on-scene photographs of Ford's final rest position

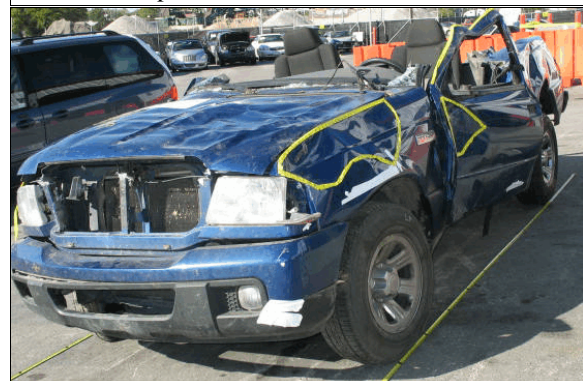
Figure 8: Damage to the Ford's hood and left side from the rollover

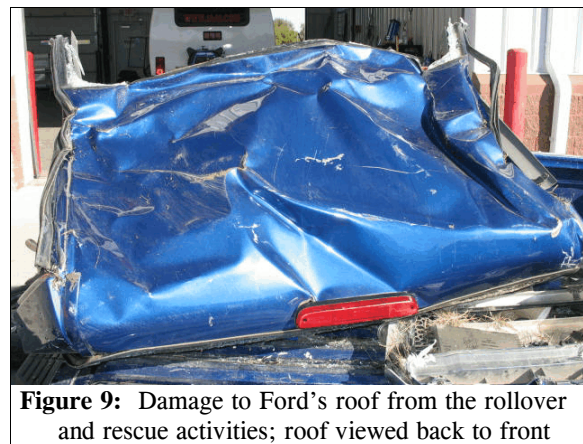
Figure 9: Damage to Ford's roof from the rollover and rescue activities; roof viewed back to front

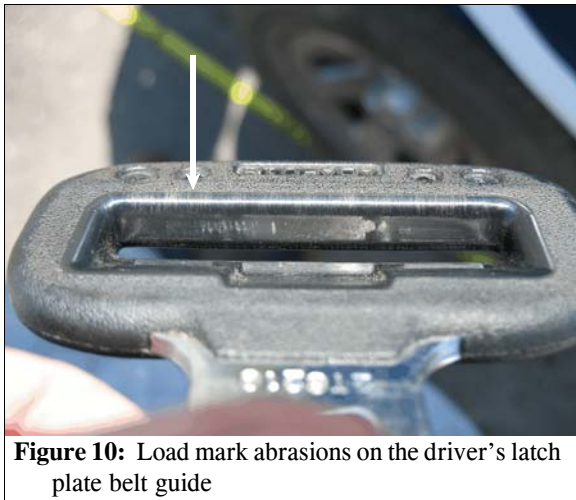
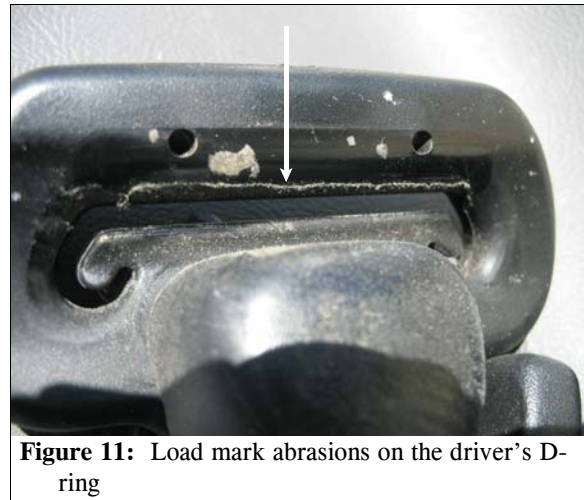
The driver's latch plate was found latched in the buckle and the seat belt had been cut out of the vehicle. A portion of it was being used to tie the left front door closed. Inspection of the latch plate and D-ring revealed load abrasions on the latch plate belt guide (**Figure 10**) and the D-ring (**Figure 11**). The on-scene photographs showed a portion of the cut seat belt across the driver's chest. The evidence indicated that the driver was restrained by the lap-and-shoulder belt. The remaining seat positions were unoccupied.
