ON-SITE ROLLOVER INVESTIGATION

CASE NUMBER - IN08035
LOCATION - ILLINOIS
VEHICLE - 2008 HYUNDAI SANTA FE LIMITED
CRASH DATE - August 2008

June 4, 2009

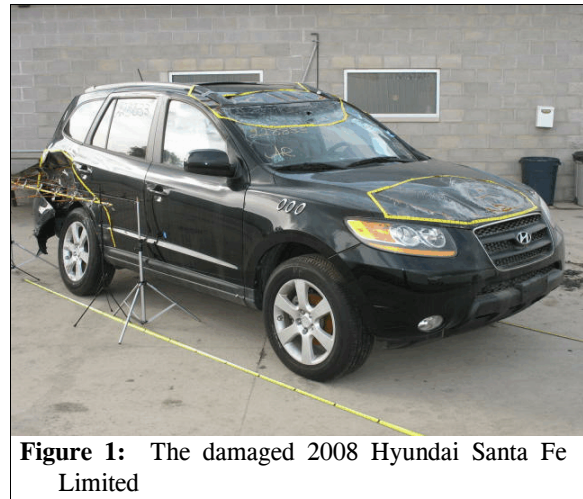
Figure 1: The damaged 2008 Hyundai Santa Fe Limited

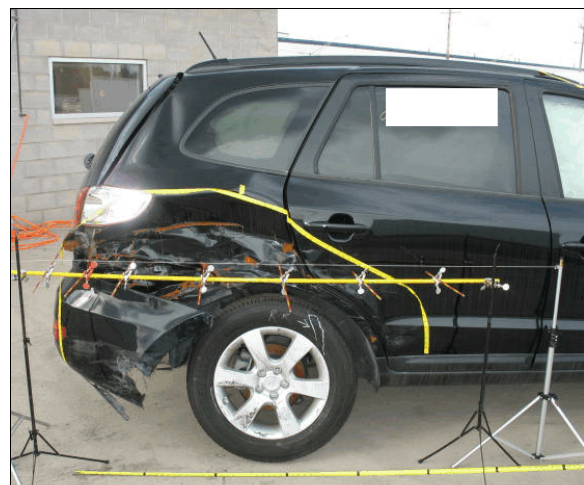
Crash: The front of the Jeep impacted the right rear side of the Hyundai (Figure 4, event 1). The impact engaged the rear portion of the Hyundai's right rear door as well as the right rear wheel and quarter panel. The direction of force was within the 1 clock sector and the impact force was sufficient to trigger deployment of the Hyundai's right side curtain air bag and the front right seat back-mounted side impact air bag. The impact caused the Hyundai to rotate clockwise and it traveled into the east leg of the intersection. The vehicle was equipped with Electronic Stability Control (ESC), but the impact induced significant rotation such that the driver was unable to regain control. As the vehicle rotated, it rolled over (event 2) with the left side leading, two quarter turns (Figures 5 and 6) and came to final rest on its top on the eastbound lane heading west (Figure 7). The Jeep continued through the intersection and came to final rest on the northeast corner of the intersection heading north.

Figure 4: Damage to the right quarter panel, right rear wheel and right rear door from impact with the front of the Jeep

Exterior Damage: The Hyundai’s impact with the Jeep involved the right side plane. The right rear door, right rear wheel, right quarter panel, and right side of the back bumper cover were all directly damaged. The direct damage began 64 cm (25.2 in) forward of the right rear axle and extended 152 cm (59.8 in) rearward on the right side. The crush measurements were taken at the mid-door level, and the maximum crush was 18 cm (7.1 in) occurring at C₂. There was no change to the right or left side wheelbase, and the induced damage involved the right rear door, right quarter panel, and back bumper cover. The vehicle’s right side crush profile is shown in the table below.

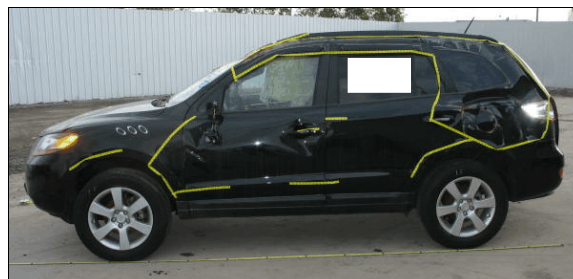
Figure 5: Damage to the Hyundai's left side plane from the rollover (outlined in yellow tape)

The Hyundai’s rollover involved the left side plane and the top plane (**Figures 5 and 6**). The left fender, left front wheel, left front door, left side view mirror, left rear door, left quarter panel, left roof side rail, all the left side pillars, hood, windshield, windshield header, roof, and right and left luggage racks were directly damaged. The direct damage on the left side plane began 72 cm (28.3 in) rear of the left rear axle and extended 376 cm (148 in) forward on the left side. The direct damage on the top plane began 123 cm (48.4 in) forward of the left rear axle and involved the full width of the roof [110 cm (43.3 in)], the upper portion of the windshield, and a 124 x 56 cm (48.8 x 22 in) area at the front of the hood (**Figure 6**). The maximum vertical crush to the roof structure was 4 cm (1.6 in) and occurred to the windshield header (**Figure 8**). It was located 12 cm (4.7 in) left of the center of the right A-pillar. There was no lateral displacement of either roof side rail or A-pillar. Induced damage from the rollover involved the left side plane, windshield, hood, and roof.

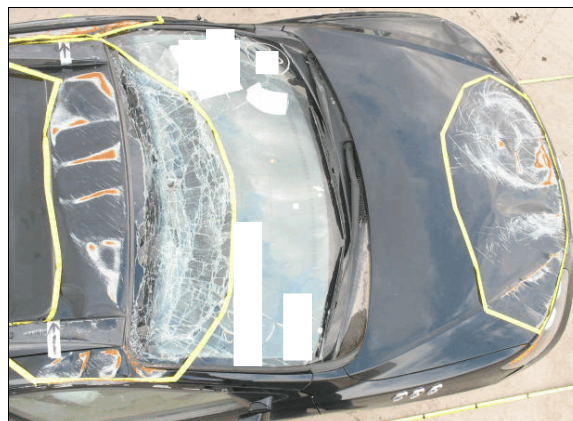
Figure 6: Damage to the top plane from the rollover; arrows on roof show direction of formation of abrasions on plastic of luggage rack

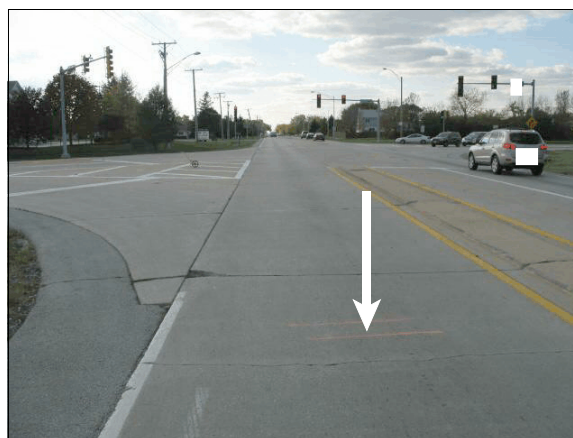
Figure 7: View west in eastbound lane; arrow shows area where the Hyundai came to final rest

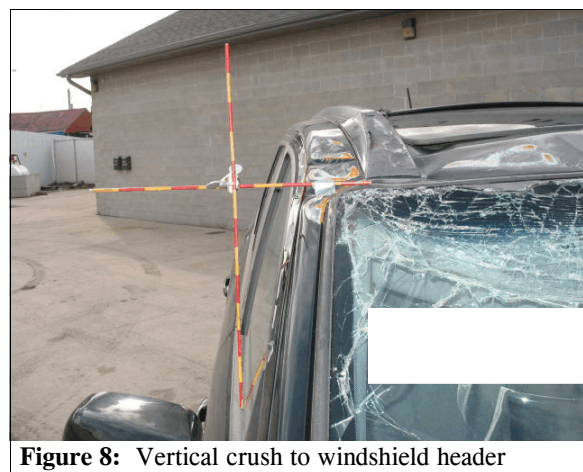
Figure 8: Vertical crush to windshield header

The Hyundai sustained 11 intrusions into the front row and one intrusion in the cargo area. The front row intrusions all occurred on the vertical axis and involved the windshield header, roof, windshield, right roof side rail, right A-pillar and the roof console. The most severe intrusion into the driver's occupant space involved the windshield, which intruded 7 cm (2.8 in). The most

severe intrusion into the front right passenger's occupant space also involved the windshield, which intruded 13 cm (5.1 in). The windshield header and right A-pillar also intruded 4 cm and 3 cm (1.6 in and 1.2 in), respectively into the front right occupant space. The right side panel rear of the C-pillar intruded laterally 3 cm (1.2 in) into the vehicle's cargo space.

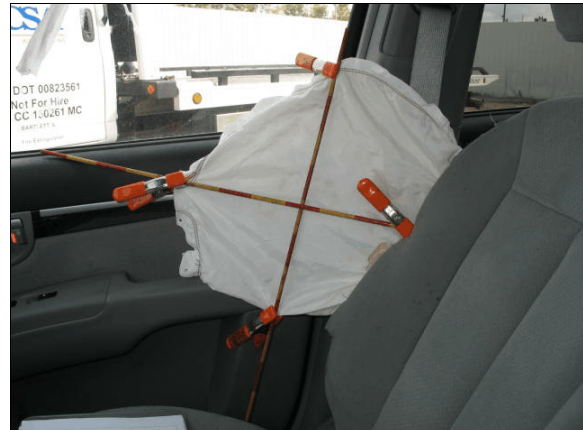
The front right seat back-mounted side-impact air bag was located within the front right outer seat back. It was oval-shaped and was 31 cm (12.2 in) in width and 40 cm (15.7 in) in height (Figure 9). It was not equipped with tethers or vent ports. No damage or discernable occupant contact evidence was found on the air bag.

Figure 9: The Hyundai's front right seat back-mounted side impact air bag

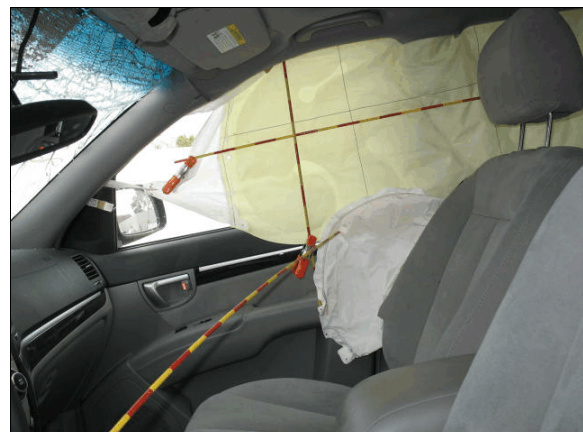
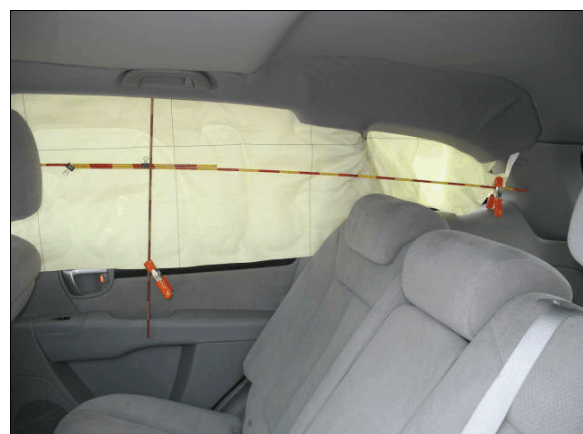
The right side curtain air bag (Figures 10 and 11) was housed within the right roof side rail.

Figure 10: The front portion of the Hyundai's right side curtain air bag

Figure 11: Back portion of the Hyundai's right side curtain air bag

It was 186 cm (73 in) in width and 42 cm (16.5 in) in height. It was not equipped with any visible vent ports. A triangular shaped fabric, 20 cm (7.9 in) wide, connected the side curtain air bag to a nylon tether rope that was anchored to the A-pillar. This tether rope was 24 cm (9.4 in) long and 2 cm (0.8 in) wide. It had been cut in two and the cut was located 8 cm (3 in) from the A-pillar. The gap between the triangular shaped fabric and the window frame at the belt line was 16 cm (6.3 in) and 10 cm (3.9 in) above the rope tether. The back of the side curtain air bag was attached to the C-pillar by a tether that was 11 cm (4.3 in) long and 2 cm (0.8 in) wide. There was no damage or discernable occupant contact located on the side curtain air bag. The left side impact curtain air bag and seat back-mounted side impact air bag did not deploy in this crash.
