# INDIANA UNIVERSITY

## ON-SITE ROLLOVER INVESTIGATION

CASE NUMBER - IN08037  
LOCATION - MICHIGAN  
VEHICLE - 2008 FORD ESCAPE XLT  
CRASH DATE - September 2008

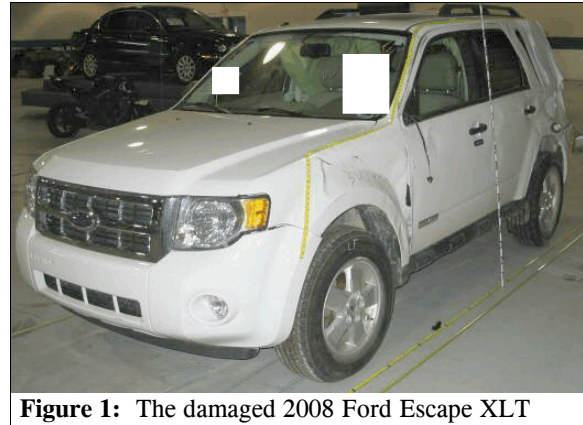
**Figure 1:** The damaged 2008 Ford Escape XLT

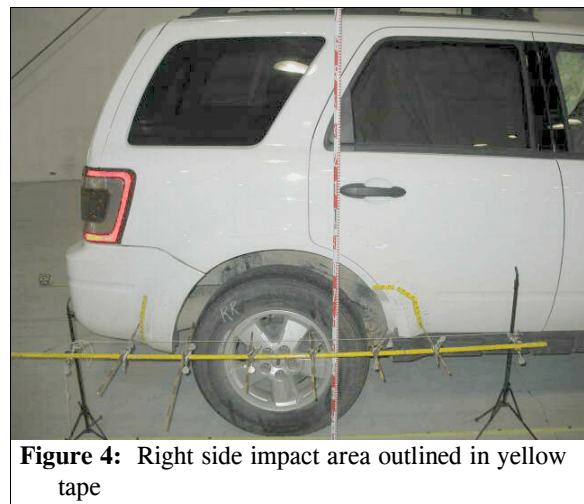
Figure 4: Right side impact area outlined in yellow tape

**Exterior Damage:** The damage from the impact with the Toyota involved the Ford's right rear side plane. The direct damage began 57 cm (22.4 in) forward of the right rear axle and extended 111 cm (43.7 in) rearward along the right side (**Figure 4**). There was direct damage to the lower back portion of the right rear door and quarter panel as a result of this impact, but there was no sheet metal crush because the front of the Toyota primarily engaged the right rear wheel. There were only scuffs on the sheet metal of the door and quarter panel, and the right rear wheel was negatively cambered approximately 10 degrees. The right and left side wheelbases were unchanged. Induced damage involved the left quarter panel.

**Damage Classification:** The Collision Deformation Classifications were **02-RZEW-1 (70 degrees)** for the impact with the Toyota and **00-LDAO-3** for the rollover. The WinSMASH program could not be used to calculate the Ford's Delta V for the right side impact because the Toyota was not inspected and the Ford sustained no residual crush as a result of the impact. The crash severity for the right side impact was estimated to be minor. The severity of the rollover damage was minor since there were only surface scratching and dents on the vehicle's left side.

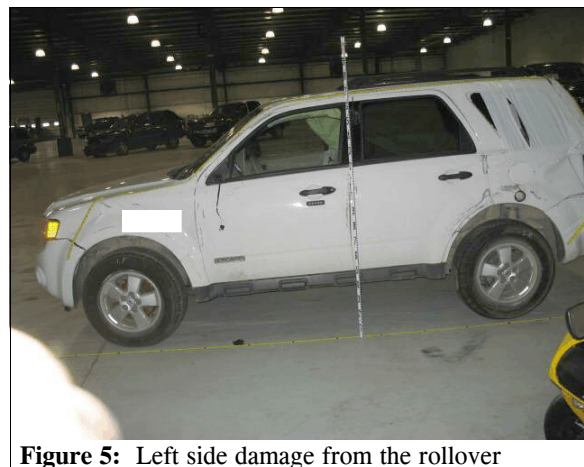
Figure 5: Left side damage from the rollover

The damage from the rollover involved the entire left side plane (**Figure 5**), beginning 39 cm (15.3 inches) forward of the left front axle and extending 370 cm (145.7 in) rearward to the

back bumper. The vehicle sustained no vertical and lateral crush on the roof structure and there was no induced damage.

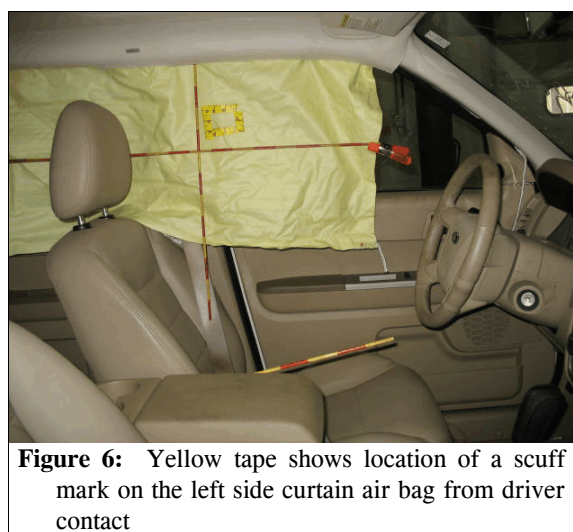
**Vehicle Interior:** The inspection of the Ford's interior revealed scuff marks on the inflatable left side curtain air bag (**Figure 6**) due to loading by the driver's face. A scuff mark was also present on the back of the driver's seat belt buckle, probably due to loading by the driver's right hip. A scuff mark was located on the glove box door (**Figure 7**), due to loading by the front right passenger's right knee. There was no deformation on the steering wheel rim or steering column, and the vehicle sustained no passenger compartment intrusions. The right rear door and tailgate were jammed shut while the remaining doors remained closed and operational. The windshield glazing was in place and cracked due to impact forces and the second left rear glazing was disintegrated due to impact force during the rollover. The pre-crash status of all the window glazing was closed or fixed with the exception of the sunroof, which the driver stated was partially open at the time of the crash.

**Figure 6:** Yellow tape shows location of a scuff mark on the left side curtain air bag from driver contact

The driver's inflatable side curtain air bag was located within the left roof side rail and extended from the top of the A-pillar to the C-pillar (**Figure 6** and **Figure 9**). The inflatable side curtain air bag was 148 cm (58.3 in) in width and 42 cm (16.5 in) in height. The scuff mark (**Figure 6**) associated with the driver's face contacting the air bag was located 40 cm (15.7 in) rear of the front edge of the air bag and 15 cm (5.9 in) from the top. At the belt line, the gap between the front of the air bag and the A-pillar was 25 cm (9.8 in). The gap at the top of the air bag was 9 cm (3.5 in).

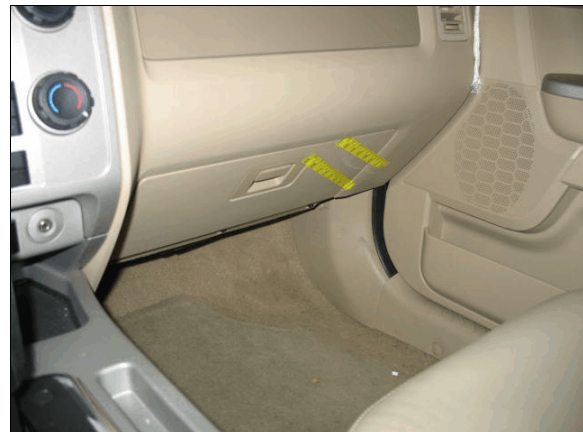
**Figure 7:** Glove box contact by front right passenger

The Ford’s impact with the Toyota initially displaced the front right passenger forward and to the right, opposite the Ford’s 2 o’clock direction of force, and her right knee impacted and scuffed the glove box door. She was redirected to the left and toward the roof within her seat belt as the Ford rolled over onto its left side. She remained restrained in her seat and exited the vehicle through the right front door after passers-by tipped the vehicle back onto its wheels.

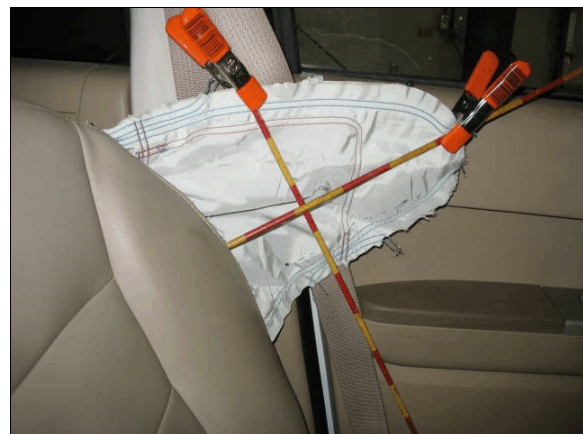
The driver's seat back-mounted side impact air bag was mounted within the left side of the seat back. The air bag was 26 cm (10.2 in) in height as measured at the seat back and 27 cm (10.6 in) in width (**Figure 8**). There was what appeared to be one vent port at the front of the air bag that was 2 cm (0.8 in) in width. There was no damage and no discernable occupant contacts on the air bag.

**Figure 8:** Driver's seat back-mounted side impact air bag

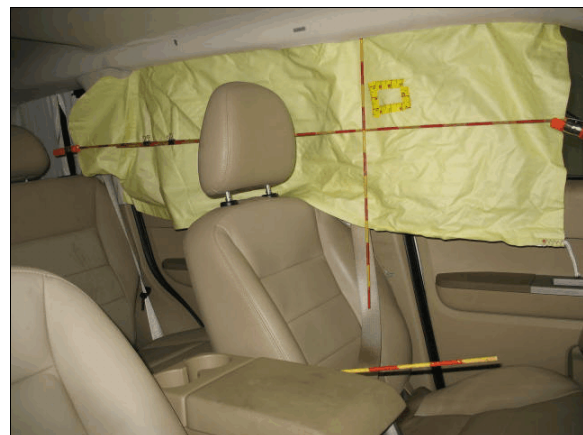
**Figure 9:** Entire left inflatable side curtain air bag

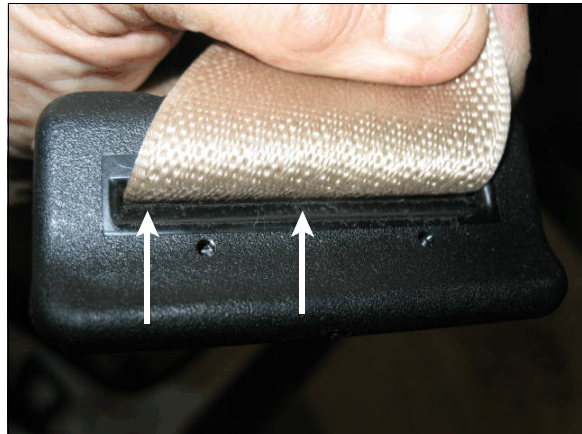
Inspection of the driver's seat belt assembly revealed light load abrasions on the latch plate belt guide (**Figure 10**), but none on the belt webbing or D-ring. Also, the retractor was jammed and the belt webbing would not retract. The length of belt that was extended out of the retractor was 97 cm (38.1 in) as measured from the stop button to the D-ring. There was no reduction in the length of the buckle-stalk, which indicated that the buckle-mounted pretensioner did not actuate during the crash. The seat belt loading evidence and condition of the retractor supported the driver's interview statement that she was restrained by the lap-and-shoulder belt.

**Figure10:** Driver's seat belt latch plate guide; arrows show light load abrasions on the plastic
