On-Site Side Air Bag Investigation  
Dynamic Science, Inc. (DSI), Case Number DS08039  
2007 Honda Civic  
Washington  
November 2008

**Dynamic Science, Inc.  
Crash Investigation  
Case Number: DS08039**

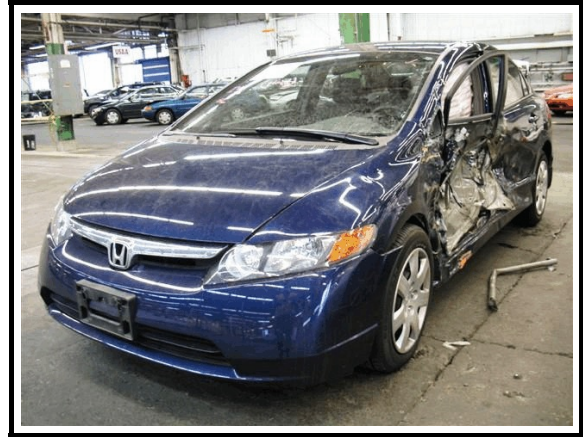
**Figure 1.** Subject vehicle, 2007 Honda Civic LX

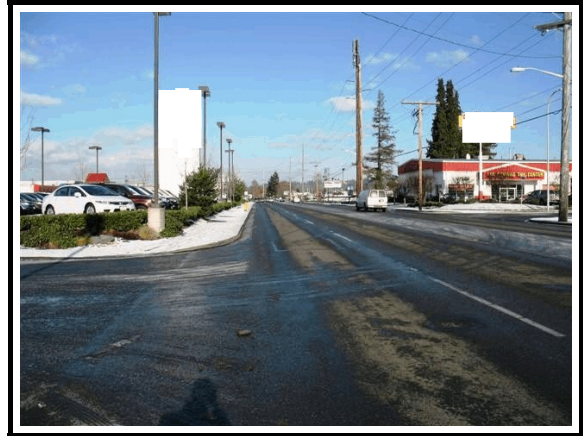
The crash site was the three-leg T-intersection of a north/south roadway and an east/west roadway (**Figure 2**). The north/south roadway comprised two through lanes in each direction and a two-way left turn lane. The two-way left turn lane was separated from the through lanes by yellow dashes, solid stripes, and raised reflectors. The north/south travel lanes were separated by white dashed stripes and raised reflectors, and the outboard lanes were bordered by solid white fog lines. Outboard of the fog lines were raised concrete curbs and paved sidewalks. The sidewalk that bordered the west curb was 1.83 m (6.0 ft) in width. Abutting the west sidewalk was a raised dirt embankment and shrubbery that ascended to approximately 1.22 m (4.0 ft) above grade. The

**Figure 2.** Crash site, looking north

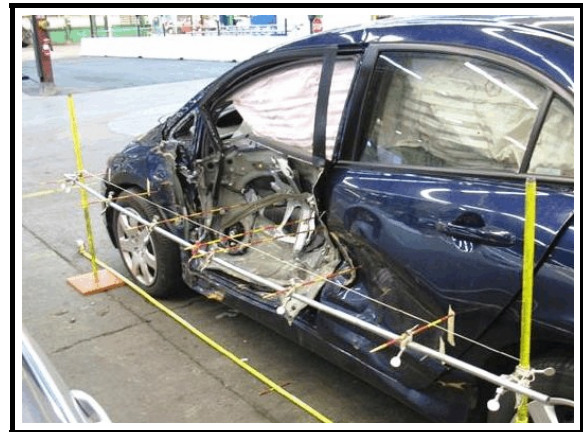
The Honda sustained direct and induced damage to the left side plane. The direct damage began 19 cm (7.5 in) aft of the left front axle and extended 205 cm (80.7 in) rearward. The Field L began 27 cm (10.6 in) forward of the front left axle, extended 254 cm (100 in) rearward, and ended 40 cm (15.7 in) forward of the rear axle. Vertically, the direct damage began at the sill and extended to slightly above the beltline.

There was complete separation of the upper hinge of the front left door, and the impact damage overrode the sill. In accordance with NASS coding guidelines, the procedure for Crush

Average for Underride Damage was used to calculate the crush measurements. Two sets of crush measurements were obtained: one set at mid-door level, and one set at sill level. Measurement stands were set parallel to the vehicle and the reference line was positioned at one-half the vehicle width plus an increment to allow for protruding sheet metal (**Figure 3**). Later, the measurements were adjusted to accommodate the increment. Six crush measurements were taken at mid-door level as follows: C1 = 0 cm, C2 = 9 cm (3.5 in), C3 = 28 cm (11.0 in), C4 = 24 cm (9.5 in), C5 = 4 cm (1.6

**Figure 3.** Crush measurements, left side

in), C6 = 0. Maximum lateral crush was located at 151 cm (59.5 in) forward of the rear axle, between C3 and C4, and measured 31 cm (12.2 in).

The crush gauge was then lowered to sill height, and six crush measurements were taken as follows: C1 = 0 cm, C2 = 0 cm, C3 = 2 cm (0.8 in), C4 = 2 cm (0.8 in), C5 = 0 cm, C6 = 0. The resulting measurements yielded a greater than 13 cm (5.1 in) difference in crush at C3 and C4. Therefore, those crush measurements were averaged to obtain the final crush. The averaged crush measurements were as follows: C1 = 0 cm, C2 = 9 cm (3.5 in), C3 = 15 cm (5.9 in), C4 = 13 cm (5.1 in), C5 = 4 cm (1.6 in), C6 = 0. Maximum crush was not averaged, was located 151 cm (59.5 in) forward of the rear axle between C3 and C4, and measured 31 cm (12.2 in). The Collision Deformation Classification (CDC) for the Honda was 10LYAW2.

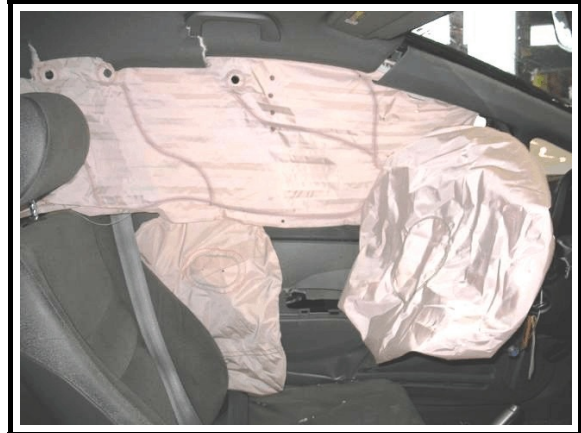
**Figure 4.** Deployed air bags, subject vehicle

At impact, the driver's frontal air bag, left seat-mounted side air bag, and left IC air bag deployed (**Figure 4**), and the safety belt retractor and buckle pretensioners actuated. The driver's frontal air bag deployed through one upper and two lower cover flaps on the steering wheel hub. The cover flaps opened at their tear points and were not damaged. The module cover had moved rearward of the steering column approximately 2 cm (0.8 in) at its upper aspect. The resulting gap between the module and steering column did not constitute damage or malfunction.

The driver's left seat-mounted side air bag deployed during the crash. The air bag deployed from a module in the outboard aspect of the seat back. The air bag was generally oval in shape and measured 52 cm (20.5 in) in length, 35 cm (13.8 in) in width at the upper aspect and 25 cm (9.8 in) in width at the lower aspect. A 5 cm (2.0 in) vent port was located at the leading edge. The air bag revealed no damage or evidence of occupant contact. The air bag covered a section of the door panel that began at the upper edge of the door panel and extended down to the seat cushion, and included the door's rearward upper and lower quadrants.

The vehicle's left IC air bag deployed from the roof side rail. The air bag exhibited 22 longitudinal folds, and measured 180 cm (70.9 in) in width and 42 cm (16.5 in) in width. It was configured with 5 vent ports that measured 2 cm (0.8 in) in diameter. The air bag extended from the A-pillar to the C-pillar, and from the roof side rail to approximately 10 cm (3.9 in) below the top of the front row door panel. There was no damage or suspected occupant contacts observed on the inboard panel. There were a few light-colored marks on the outboard panel that were striations from the roof cladding. The air bag exhibited several green and yellow markings that originated during the manufacturing of the air bag.

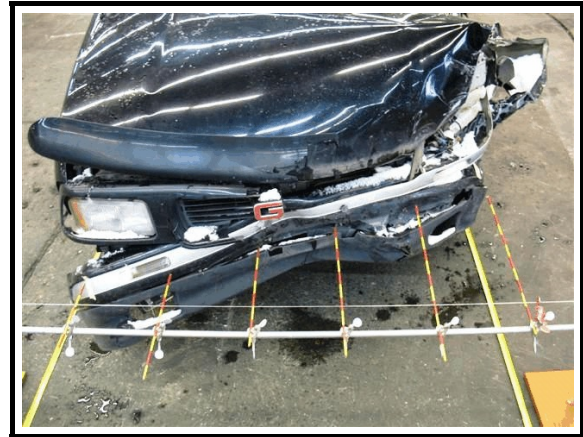
The GMC sustained direct and induced damage to the front end from the vehicle-to-vehicle impact, and left side damage from intra-unit contact. The direct damage to the front end began at the vehicle's front left bumper corner and extended 95 cm (37.4 in) to the right. The vertical extent of direct damage began at the bumper and extended upward to the hood. The Field L began at the front left bumper corner and extended 134 cm (52.8 in) to the front right bumper corner (**Figure 5**).

**Figure 5.** Crush measurements, front end

Six crush measurements were taken at bumper level as follows: C1 = 60 cm (23.6 in), C2 = 40 cm (15.8 in), C3 = 33 cm (13.0 in), C4 = 26 cm (10.2 in), C5 = 10 cm (3.9 in), C6 = 1 cm (0.4 in).

Maximum longitudinal crush was located at C1 and measured 60 cm (23.6 in). The CDC for the GMC was 01FDEW3.
