On-Site Side Air Bag Investigation  
Dynamic Science, Inc. (DSI), Case Number DS08040  
2003 Honda Accord  
Washington  
November 2008

**Dynamic Science, Inc.**  
**Crash Investigation**  
**Case Number: DS08040**

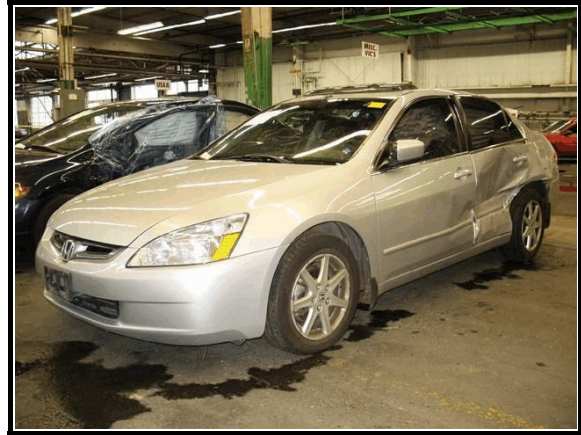
**Figure 1.** Subject vehicle, 2003 Honda Accord

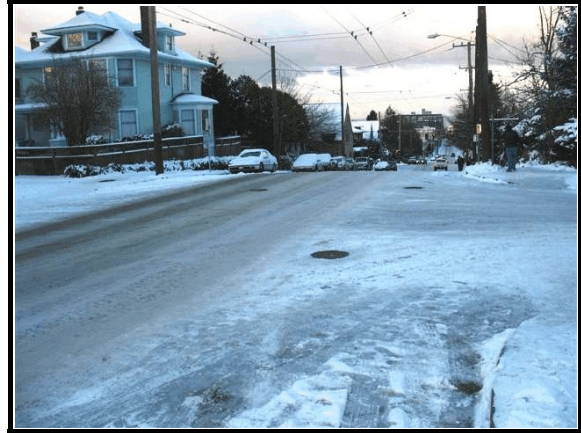
The crash site was a four-leg intersection consisting of an east/west roadway and a north/south roadway (**Figure 2**). The flow for each roadway was undivided for two way traffic. The roadway composition was concrete and it was dry at the time of the crash. The east/west roadway comprised one lane in each direction and curb parking was permitted outboard of the travel lanes. The travel lanes were separated by yellow dash stripes. The roadway width measured 11.7 m (38.5 ft) in its entirety. The travel lanes were not delineated from the parking lanes. Adjacent to the parking lanes

**Figure 2.** Crash site, looking west

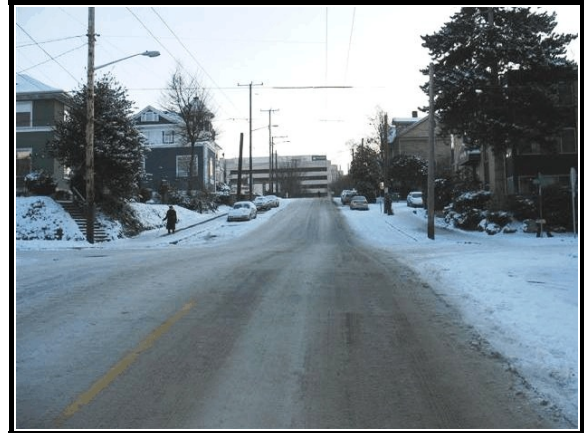
The Honda was traveling eastbound and the Hyundai was traveling southbound as each vehicle entered the intersection (**Figure 3**). While traversing the intersection, the Honda crossed the path of the Hyundai. The driver of the Honda continued to steer the vehicle forward with her foot on the accelerator, and the vehicle was tracking in its original travel lane.

**Figure 3.** Eastbound approach, subject vehicle

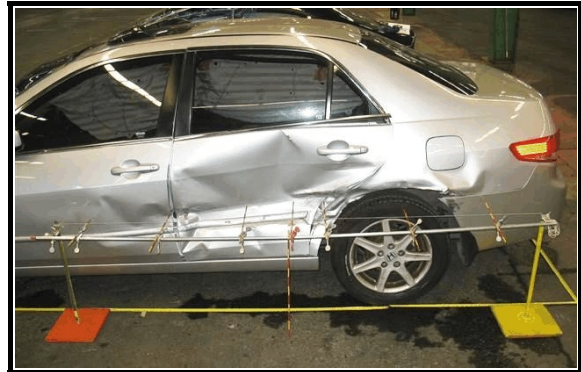
**Figure 4.** Crush measurement left side

Measurement stands were set parallel to the vehicle and the reference line was positioned at one-half the vehicle width plus an increment to allow for protruding sheet metal (**Figure 4**). Six crush measurements were taken at mid-door level as follows: C1 = 0 cm, C2 = 4 cm (1.6 in), C3 = 12 cm (4.7 in), C4 = 12 cm (4.7 in), C5 = 4 cm (1.6 in), C6 = 0. Maximum lateral crush was located at 50 cm (19.7 in) forward of the rear axle, between C3 and C4, and measured 14 cm (5.5 in).

The height of the maximum door crush was located on the second row door and measured 61 cm (24.0 in); the sill height was 28 cm (11.0 in), and the Door Sill Differential (DSD) was 10 cm (3.9 in). The hinges and sill were not damaged in the crash. The left rear door was jammed shut and the window frame was deformed outboard of the vehicle revealing a 2 cm (0.8 in) gap. The Collision Deformation Classification (CDC) for the Honda's first impact was 11LZEW2.

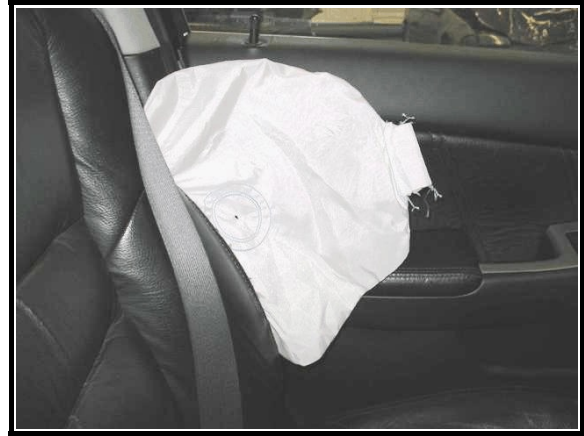
The front row was equipped with seat-mounted side air bags. The driver's seat mounted-side air bag deployed during the first impact (**Figure 5**) through a seam at outboard side of the left seat back. The air bag was hexagonal in shape, measured 34 cm (13.4 in) at its maximum height, and 28 cm (11.0 in) at its maximum width. It was configured with one vent port and had no tethers.

**Figure 5.** Deployed seat-mounted side air bag

In its deflated state, the air bag's area of coverage began at the bottom of the side glass and extended downward to approximately 10 cm (3.9 in) below the armrest. The seat track position was found adjusted between the mid- to full-forward setting and in that position the air bag's rearward aspect began at the B-pillar and extended forward into the door panel's upper rear quadrant. The air bag was not wide enough to extend to the door's longitudinal center. The forwardmost 12 cm (5.0 in) of the armrest was not covered by the air bag.

The seat-mounted side air bag was not damaged and no occupant contacts were identified. A small area of vinyl striations were located on both the inboard and outboard panels and otherwise the seat-mounted side air bag was unremarkable. The driver stated in the interview she did not contact any left side components or air bags during the crash.

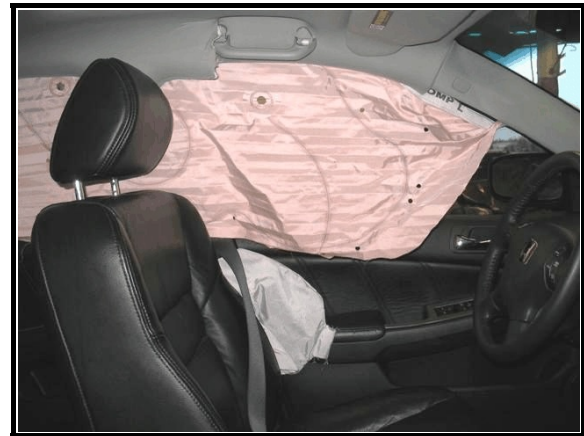
**Figure 6.** Deployed side impact inflatable curtain air bag

The vehicle was equipped with side impact IC air bags and the left side IC air bag deployed during the first impact (**Figure 6**). The left side IC air bag deployed from the roof side rail above the front and second row doors.

The IC air bag had 22 longitudinal folds and measured 170 cm (66.9 in) in width and 43 cm (16.9 in) in length in its deflated state. It was configured with three vent ports that measured 2 cm (0.8 in) in diameter and fourteen smaller vent ports measuring 1 cm (0.4 in) in diameter that were located near a stitching pattern that ran the length and width of the air bag. One external tether attached the air bag to the vehicle at 16 cm (6.3 in) from the top of the A-pillar. The air bag covered approximately 70 percent of the front row window glazing and 100 percent of the second row glazing. Vertically, the air bag extended from the roof rail to 12 cm (3.9 in) below the bottom of the front row side glass and it provided coverage for the driver from the rear upper door panel, the B-pillar, and the safety belt upper anchorage assembly. No damage or occupant contacts were observed on either side of the air bag.
