ON-SITE SIDE IMPACT INFLATABLE OCCUPANT PROTECTION INVESTIGATION

CASE NUMBER - IN08040

VEHICLE - 2007 HONDA ACCORD LX

CRASH DATE - October 2008

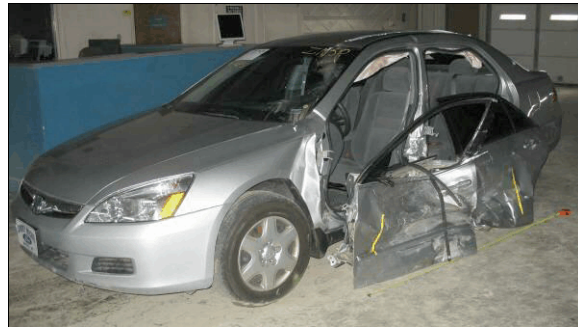
Figure 1: The damaged 2007 Honda Accord LX

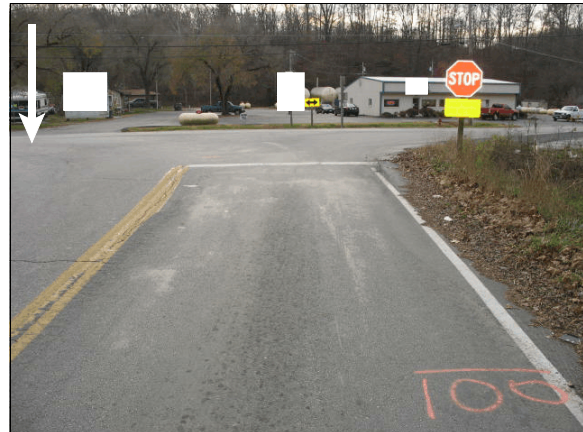
Pre-Crash: The Honda was occupied by a restrained 40-year-old female driver and a restrained 16-year-old female front row right passenger. The Honda was stopped at the stop sign (**Figure 2**) and the driver intended to turn left and proceed southeast. The Ford was occupied by a 16-year-old unrestrained driver and was traveling northwest approaching the intersection (**Figure 3**). The driver intended to continue through the intersection. The Honda's driver stated during the SCI interview that each leg of the intersection had previously been controlled by a stop sign. She

Figure 2: The Honda was stopped at the stop sign and the driver was intending to turn left; number on pavement shows distance in feet to area of impact (indicated by arrow)

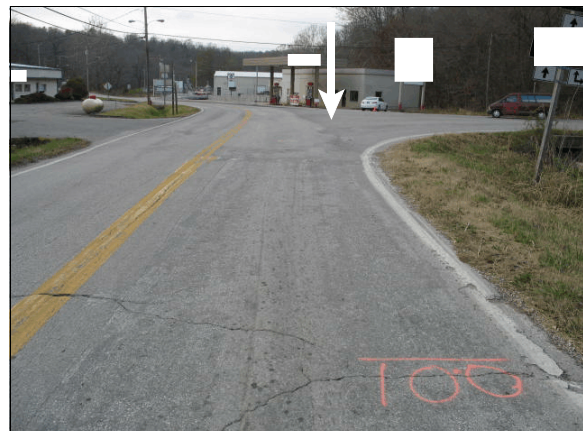
Figure 3: Approach of the Ford southwest to the area of impact (indicated by arrow)

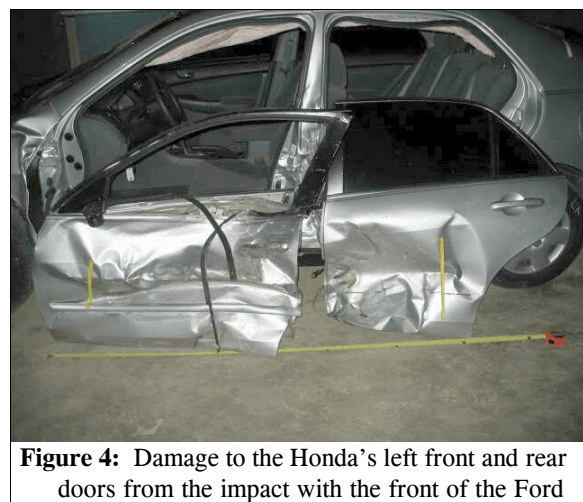
Figure 4: Damage to the Honda's left front and rear doors from the impact with the front of the Ford

Exterior Damage: The impact with the Ford involved the Honda’s left side plane and the left front and rear doors were directly damaged. The direct damage began 58 cm (22.8 in) rear of the left front axle and extended 153 cm (60.2 in) rearward on the doors. Since the left front and rear doors had been cut off the vehicle and could not be adequately reattached to represent their crushed position, it was necessary to extrapolate the crush profile based on the damage to the B-pillar and from the doors. The crush profile was then represented against the door portals using the crush contour gauge (Figure 6). The residual maximum crush occurred on the left front door and was determined from this process to be 28 cm (11 in). It occurred 131 cm (51.6 in) rear of the left front axle and the height of the maximum door crush was 79 cm (31 in). The Door Sill Differential (DSD) was 25 cm (9.8 in). The table below shows the vehicle’s right side crush profile.

Damage Classification: The Honda’s Collision Deformation Classification was **10-LPEW-3 (300 degrees)** for the left side impact with the Ford. The Missing Vehicle algorithm of the WinSMASH program calculated the Honda’s total Delta V as 20 km/h (12.4 mph). The longitudinal and lateral velocity changes were -10 km/h (-6.2 mph) and 17 km/h (10.6 mph), respectively. The results were based only on the Honda’s crush profile and should be considered as a borderline reconstruction of the Honda’s Delta V.

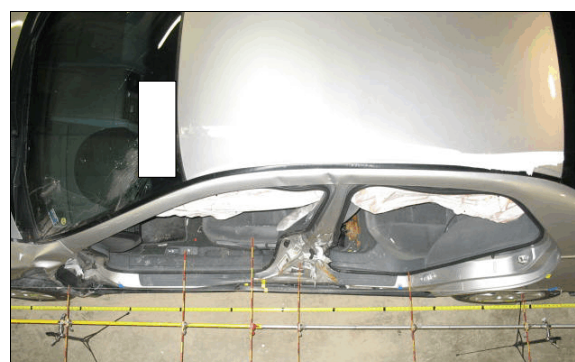
Figure 6: Top view of the crush gauge adjacent to the left side on the Honda showing the extrapolated crush profile

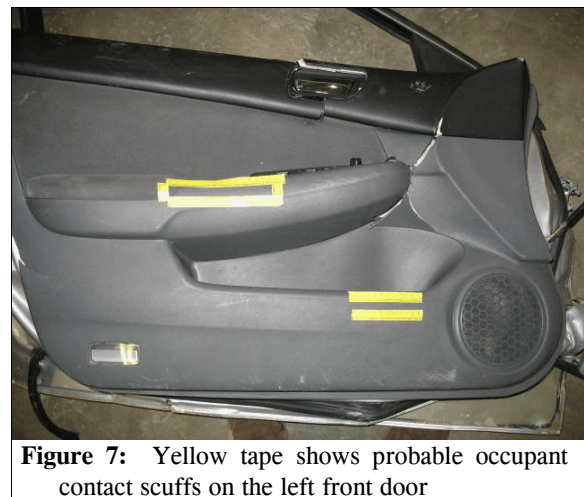
Vehicle Interior: The inspection of the Honda’s interior revealed a light scuff mark on the left side curtain air bag, which probably resulted from contact by the left side of the driver’s head. A light scuff mark 15 cm (5.9 in) in length was also found on the left front door arm rest, and another scuff 11 cm (4.3 in) in length was located on the forward lower quadrant of the left front door panel (**Figure 7**). The scuff on the arm rest was probably the result of loading by the driver’s lower left arm while the scuff mark on the forward lower quadrant of the left front door panel was probably the result of loading by the driver’s lower left leg. The left front and left rear doors were jammed shut and the right front and right rear doors remained closed and operational. All of the side door window glazing was closed and the second left and right rear window glazing was fixed. The left front door window glazing

Figure 7: Yellow tape shows probable occupant contact scuffs on the left front door

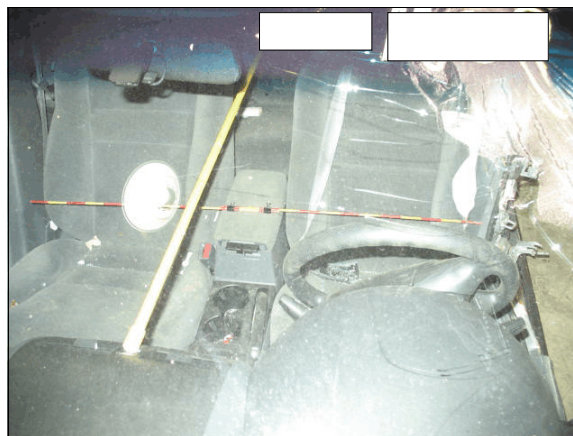
The vehicle sustained 7 passenger compartment intrusions. The most severe intrusions involved the driver's occupant space and all of the intrusions occurred on the lateral axis. The upper rear quadrant of the left front door intruded 16 cm (6.3 in) while the left B-pillar (**Figure 8**), roof side rail, and sill intruded 8 cm (3.1 in), 4 cm (1.6 in), and 3 cm (1.2 in), respectively.

Figure 8: View through windshield to left B-pillar intrusion

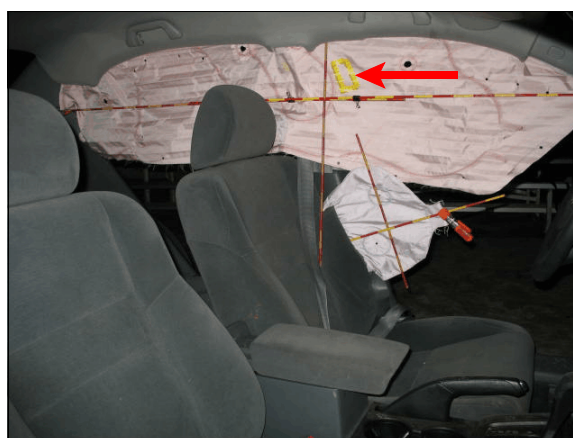
Figure 9: The Honda's deployed left side curtain air bag and seat-back-mounted side impact air bag; arrow shows location of a probable occupant contact scuff mark

The left side curtain air bag was located along the left roof side rail (**Figure 9**) inside the headliner and extended from the A-pillar to the C-pillar. The fold creases on the air bag indicated that it had been folded accordion fashion within the headliner. The deployed side curtain air bag was 171 cm (67.3 in) in width and 38 cm (15 in) in height. There were no visible tethers. What appeared to be a 5 cm (2 in) wide vent port was located at the front of the air bag. Inspection of the air bag revealed a very light scuff mark located 62 cm (24.4 in) rear of the front of the air bag and 10 cm (4 in) below the roof side rail. The location of the scuff mark was consistent with contact by the left side of the driver's head during the crash. There were also numerous black smears on the front portion of the air bag, but these marks appeared to be due to post-crash handling of the air bag.

The driver's seat back-mounted side impact air bag was located in the outboard side of the seat back and deployed through a tear seam. The deployed air bag (**Figure 9**) was oblong and had two circular tethers where both sides of the air bag were sewn together. Each sewn area was 5 cm (2 in) in width. There were no visible vent ports. The deployed air bag was 33 cm (13 in) in height and 25 cm (9.8 in) in width. Inspection of the air bag revealed no damage and no discernable evidence of occupant contact.

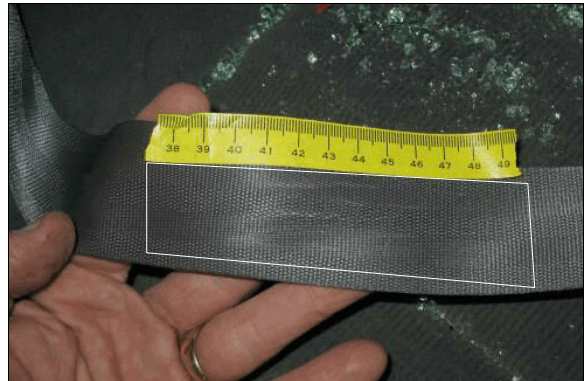
The inspection of the driver's seat belt system revealed historical usage scratches on the latch plate and a area of slight stretching and wrinkling on the belt webbing (**Figure 10**) that was 12 cm (4.7 in) in length, beginning 7 cm (2.8 in) above the stop button. The retractor was also jammed as a result of damage on the left B-pillar and a length of belt webbing was extended out of the retractor consistent with usage in the crash (**Figure 11**). The length of belt was 111 cm (43.7 in) as measured from the stop button to the D-

Figure 10: Area of stretching and wrinkling on driver's seat belt, outlined in white

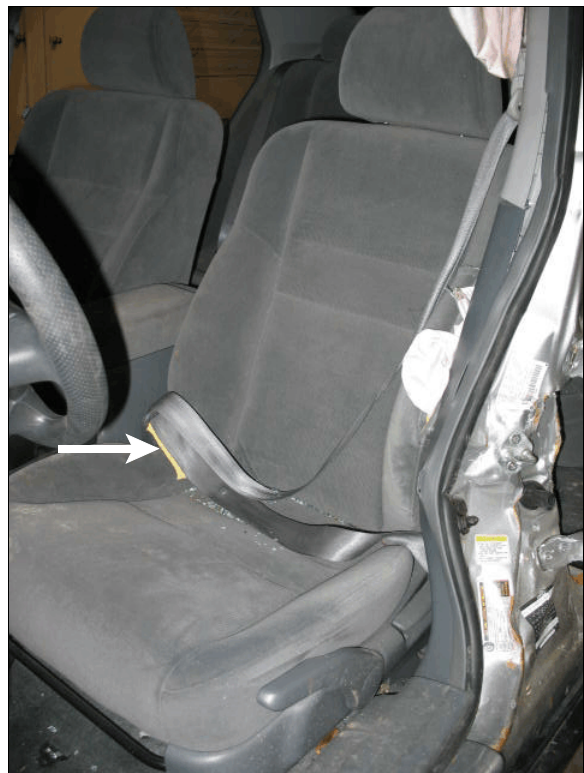
Figure 11: Driver's seat belt; arrow show location of load mark

ring. The evidence indicated that the driver was restrained by the lap-and-shoulder belt and supported her statement that she was restrained in this crash.

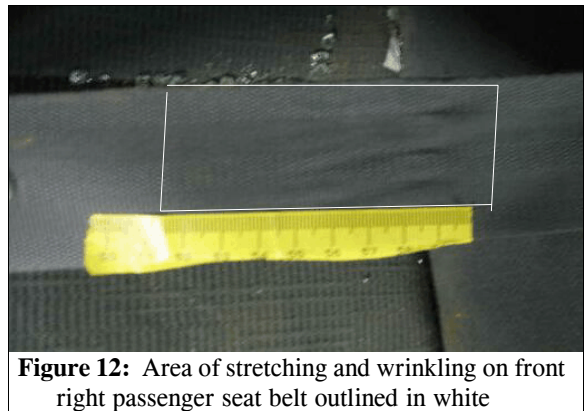
Figure 12: Area of stretching and wrinkling on front right passenger seat belt outlined in white

The inspection of the front right passenger's seat belt system revealed historical usage scratches on the latch plate and a area of stretching and wrinkling on the belt webbing (**Figure 12**) that was 9 cm (3.5 in) in length, beginning 4 cm (1.6 in) above the stop button. The evidence indicated that the front right passenger was restrained by the lap-and-shoulder belt and supported the driver's statement that the passenger was restrained in this crash.
