CALSPAN ON-SITE SIDE AIR BAG DEPLOYMENT INVESTIGATION

SCI CASE NUMBER: CA08044

VEHICLE: 2007 SUZUKI SX4

INCIDENT DATE: SEPTEMBER 2008

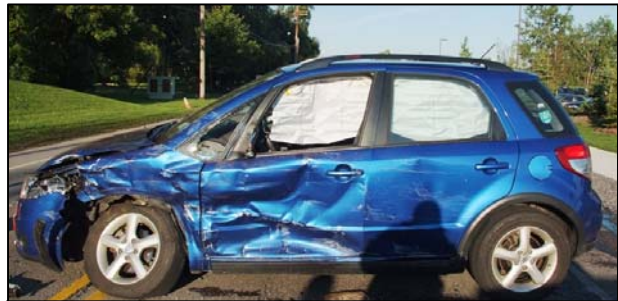
Figure 1: Left side view of the Suzuki at final rest.

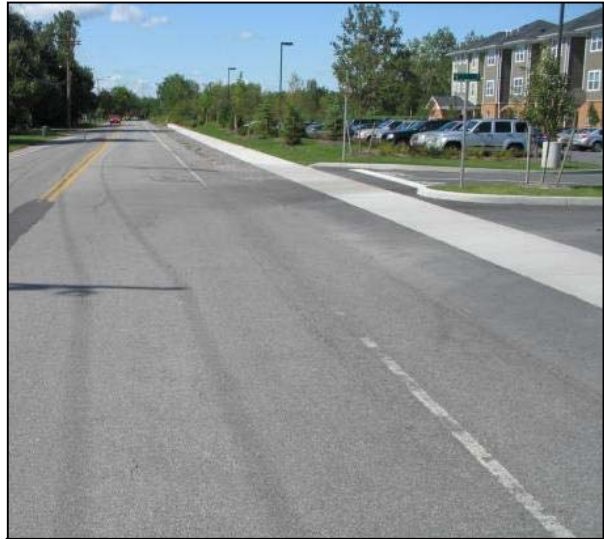
This collision occurred at the intersection of a two lane roadway with a building complex driveway with a raised median (**Figure 2**). The Suzuki was attempting a left turn from the 3.8 m (12.5 ft) wide left turn lane of the 7.4 m (24.3 ft) wide exit driveway out of the complex. This was accompanied by a solid white stop line and a regulatory stop sign off of the right side of the driveway. Adjacent to the left turn lane and separating the exit driveway from the entrance driveway was a 2.9 m (9.5 ft) wide raised median. This median was encompassed by a concrete curb, and had a tree centered at its south end. The crash schematic is attached as **Figure 13**.

Figure 2: Westbound view of the crash site.

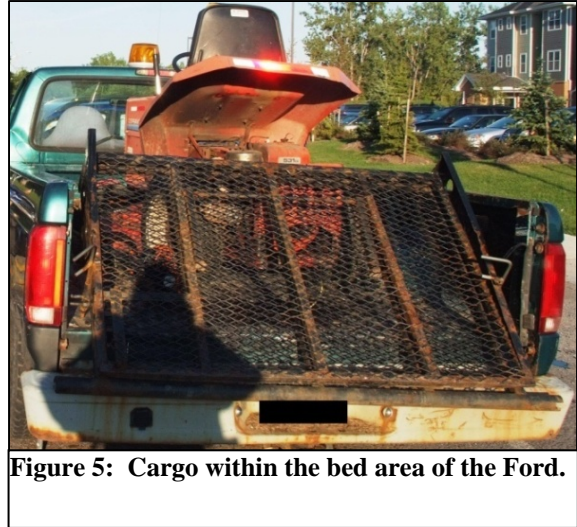
The Gross Vehicle Weight Rating (GVWR) was 2,835 kg (6,250 lb). This pickup truck was equipped with a folding tailgate ramp. At the time of the incident the pickup was transporting a garden tractor and other miscellaneous lawn care tools in the payload bed, with a weight of approximately 680 kg (1,500 lbs). **Figure 5** shows the pickup's bed and cargo, as found on scene by police.

Figure 5: Cargo within the bed area of the Ford.

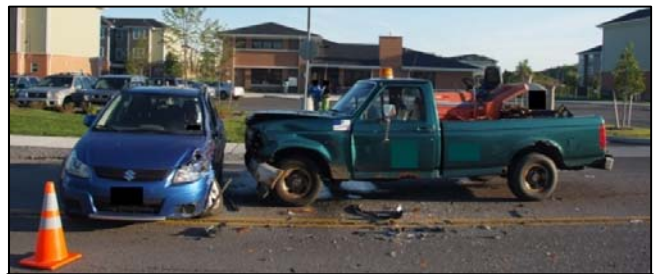
The front of the Ford struck the front left side of the Suzuki. This impact immediately transitioned the Suzuki into a right lateral translation and simultaneously rotated the vehicle clockwise (CW), perpendicular to the frontal plane of the pickup truck. As the vehicles engaged the left side structure of the Suzuki was crushed and displaced laterally. The greater kinetic energy of the pickup truck translated the Suzuki laterally 6 m (19.7 ft) to the west of the impact position. Both vehicles came to rest in the roadway, as depicted in **Figure 6**.

Figure 6: Vehicles at final rest.

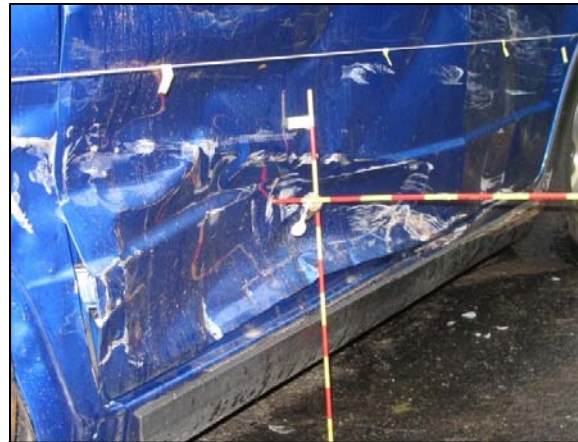
The Suzuki sustained moderate left side damage from the collision. Damage on this plane included all components from the roof to the wheels forward of the aft edge of the rear passenger door. The left mirror was fractured from its mounts. Both the driver and rear passenger doors had damage to the exterior skins consisting of abrasions and lateral crush, but remained operational and in their closed positions. The front fender was crushed and displaced right laterally, coinciding with similar crush and displacement of the left edge of the hood. The left headlight assembly was fractured and hanging

Figure 7: Exterior crush to the left front door of the Suzuki.

The direct and induced damage began at the left front corner and extended 264 cm (104 in) toward the rear, ending 33 cm (13 in) forward of the left rear axle. The accompanying crush profile was measured at mid-door level, minus free space, with the following results: C1 = 0 cm (0 in), C2 = 3 cm (1.2 in), C3 = 9 cm (3.5 in), C4 = 7 cm (3 in), C5 = 15 cm (5.75 in), C6 = 0 cm (0 in). Maximum crush was located at C5. The Door/Sill Differential (DSD) measured 7 cm (2.6 in), located 46 cm (18 in) aft of the left A-pillar (**Figure 7**). The Collision Deformation Classification (CDC) for the damage pattern was 10LYAW2.

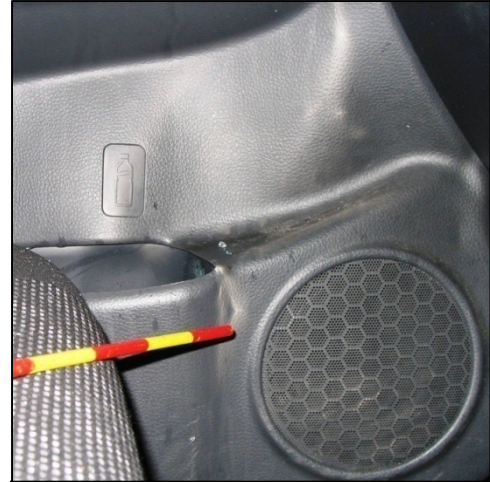
Interior intrusion associated with the collision was limited to the left front door panel. A 2.5 cm (1 in) inward buckling of the interior panel of the driver's door was found immediately aft of the speaker. The door panel armrest was also deflected inward, and an area of buckling was evidenced by stress discoloration in the polymer door skin above the speaker (**Figure 8**). The gearshift between the front seats was fractured from its linkage and displaced from the console. This was attributed to being struck during the crash sequence by the book bag that had been placed on the right front passenger seat. No occupant contact points were located.

Figure 8: Interior door panel intrusion of the Suzuki.

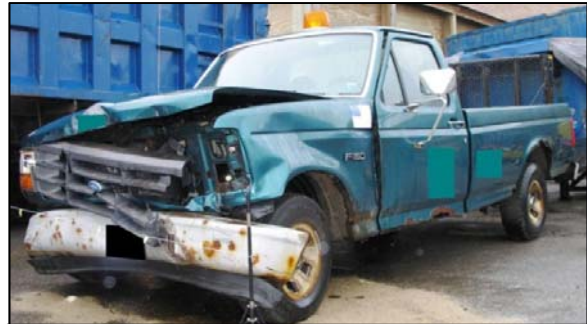
The Ford sustained moderate frontal damage from the collision. Damage in this plane included all components from the hood to the frame forward of the front axle, biased to the left side. The front aspect of both the left and right front fenders were crushed and displaced rearward. The width of direct and induced damage extended 178 cm (70 in) from bumper corner to bumper corner (**Figure 9**). The corresponding crush profile was as follows: C1 = 16 cm (6.3 in), C2 = 24 cm (9.5 in), C3 = 27 cm (10.6 in), C4 = 29 cm (11.4 in), C5 = 20 cm (7.9 in), and C6 = 9 cm (3.5 in). Maximum crush was 29 cm (11.4 in), located at C4. The CDC associated with this damage pattern was 12FDEW2.

Figure 9: Left front oblique damage view of the Ford.

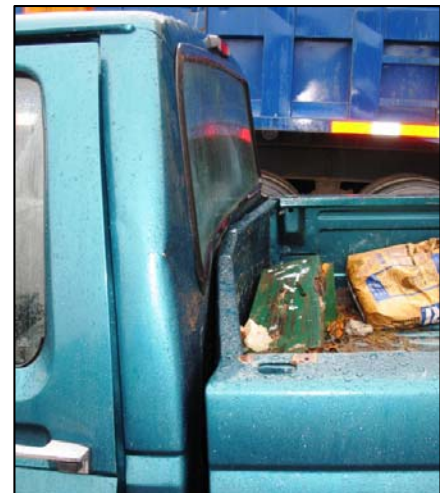
Damage to the front of the pickup bed and rear of the cab was caused by the cargo shifting during the collision. The front of the bed was bowed forward in the center, which contacted the rear of the cab below the rear window glazing and bowed the rear of the cab inward. This caused slight buckling of the exterior metal body panels at the mid-glazing level on the aft of the B-pillars (**Figure 10**).

Figure 10: Cargo area damage of the Ford.

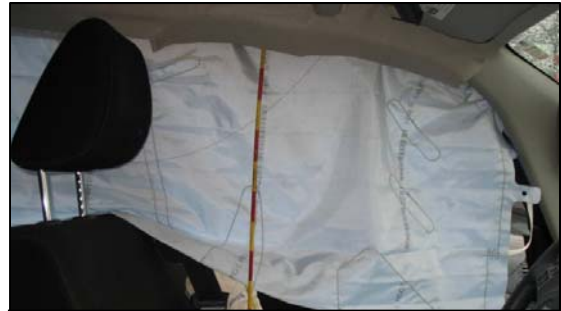
Figure 11: Left side inflatable curtain air bag.

The IC air bag was identified by the manufacturer's number 898409942201 (**Figure 11**). This rectangular shaped air bag was 48 cm (19 in) tall by 157 cm (62 in) long. A 17 cm (6.5 in) long tether held the bag in place at the forward edge. There was no rear tether. This resulted in a 25 cm (10 in) tall by 6 cm (2.5 in) wide trapezoidal void at the rear, immediately to the aft of the left rear passenger head restraint. This air bag had deployed through the edge of the headliner.

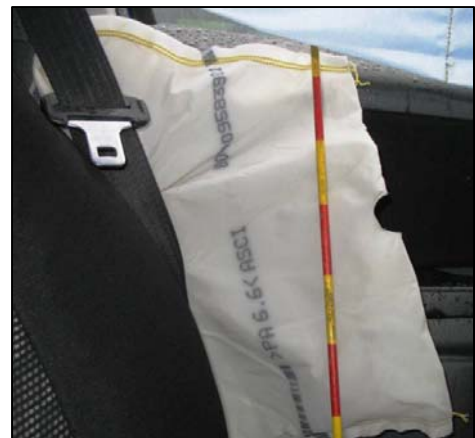
Figure 12: Left front seatback-mounted air bag.

The seatback-mounted air bag was identified by the manufacturer's number 870409583901. This rectangular shaped air bag was 20 cm (8 in) wide by 30 cm (12 in) tall. The air bag had deployed through the stitching on the outboard edge of the seatback at thoracic to lumbar level (**Figure 12**).
