CALSPAN ON-SITE CHILD RESTRAINT SYSTEM CRASH INVESTIGATION

CASE NO: CA08046

VEHICLE: 2002 FORD WINDSTAR

CRASH DATE: SEPTEMBER, 2008

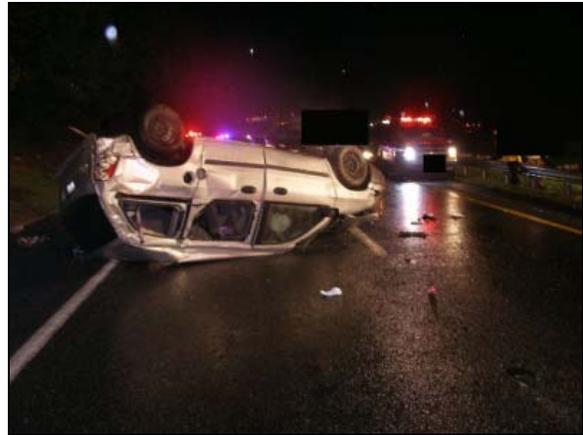
Figure 1 is an on-scene police image of the vehicle at final rest. The Ford departed the right side of a two-lane divided interstate, climbed a steep embankment, and subsequently rolled over 6-quarter turns coming to rest on the highway. As the Ford approached its final rest position, the front and right side of a 2006 Nissan Altima contacted the Ford's left front corner in an end-swipe configuration. The Ford was driven by a 27-year-old restrained female and was occupied by an 8-year-old restrained female front right passenger, a 2-year-old male secured in a forward facing convertible CRS in the second row right position, a 6-year-old restrained female in the third row left position and a 5-year-old male secured in a high-back booster CRS in the third row right position. During the course of the rollover crash, the 8-year-old front right passenger was ejected through the left rear quarter window and was fatally injured. The driver and the three child passengers remaining inside the Ford sustained minor severity soft tissue injuries.

Figure 1: On-scene police image of the Ford at final rest.

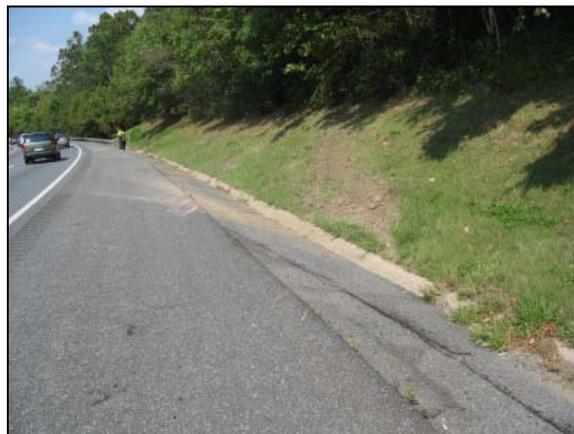
Figure 2: Northeast trajectory view of the Ford at the roadside departure.

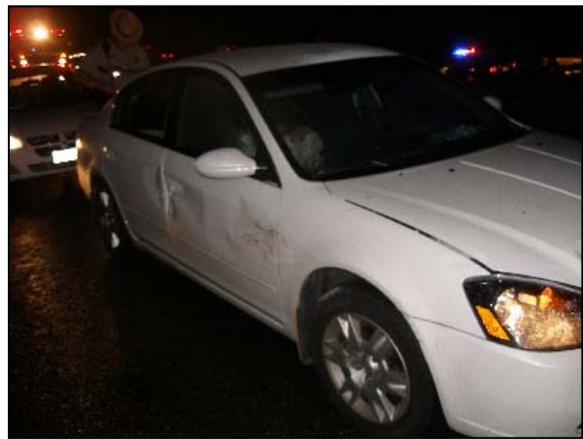
The 2006 Nissan Altima was identified by the VIN 1N4AL11D86C (production sequence deleted). **Figure 3** is an on-scene view of the Nissan. The 4-door sedan was initially travelling behind the Ford and witnessed the crash. As the Ford reentered the interstate and was sliding to rest, the right side plane of the Nissan contacted the front plane of the Ford. It should be noted that the Ford had rolled over and was sliding on its top during the contact. Based a review of the police images, the contact damage was minor. The Nissan was released from the crash scene by the police and was not available for inspection. None of the occupants in the Nissan were injured. The estimated Collision Deformation Classification (CDC) of the Nissan was 01RPEW1.

Figure 3: On-scene right side view of the Nissan.

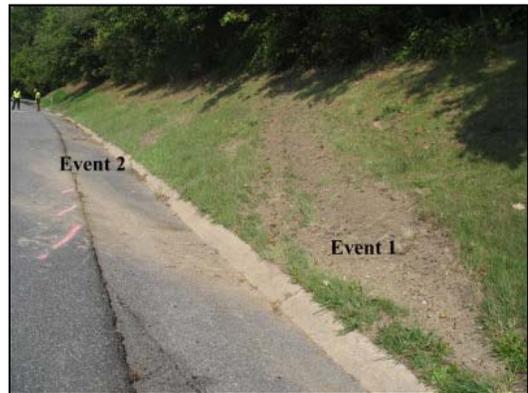
Figure 4: View depicting the errant trajectory of the Ford and the gouges that resulted from Events 1 and 2.

The Ford continued on its northeast trajectory (**Figure 4**), began to climb the embankment and rotated CW. The vehicle traveled 10 m (33 ft) northeast from its initial departure point and had rotated approximately 90 degrees CW when the left rear wheel rim impacted the concrete gutter and the left rear tire produced an adjacent gouge (Event 2). This contact was evidenced by rim’s bead edge that was deformed inboard and by the dirt/grass debris gathered in the adjacent bead. The Ford then climbed and traveled across the embankment while rapidly rotating approximately 630 degrees CW. Two distinct areas of swiping contact were noted to the tree line from the Ford’s back plane (Events 3 and 4). The contact areas in the tree line were separated by a longitudinal distance of 5.2 m (17.1 ft). During the rotation, the Ford was oriented in a non-horizontal attitude, alternating between a pitched up and pitched down attitude in relation to the embankment. The Ford traversed a longitudinal distance of 20 m (65.6 ft) across the embankment during these dynamics. The 8-year-old front right passenger was displaced out

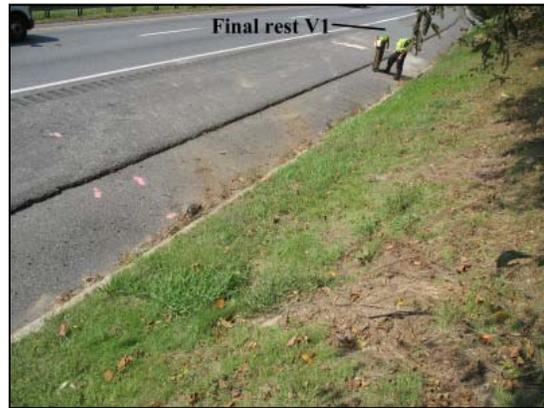
The Ford descended the embankment (**Figure 5**) and, as it approached the road shoulder, initiated a left side leading rollover (Event 5). The rollover type was considered a fall-over. The Ford reentered the roadway rolled 4-quarter turns and then ejected the (now) unrestrained and displaced front right passenger through the left rear quarter window onto the roadway. During the 5th-quarter turn, the left side of the Ford rolled over the child resulting in fatal injuries. The Ford then rolled one additional quarter turn (6-quarter turns total) onto its roof into the northbound travel lanes. The estimated uninterrupted roll distance was 16 m (52 ft). As the vehicle was sliding on its roof to final rest, its front plane was contacted by the Nissan in a minor impact (Event 6). The Ford came to rest on its roof facing westward in the outboard travel lane (**Figure 6**). The Nissan came to a controlled stop adjacent to the Ford facing north. It should be noted that the Nissan was moved prior to the time the on-scene images were taken by the police investigator.

Figure 5: View depicting the Ford's descent trajectory down the embankment, to the rollover and final rest.

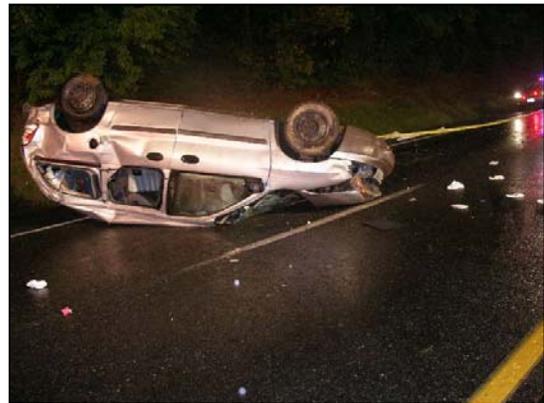
Figure 6: View of the Ford at final rest. Image supplied by the police investigator.

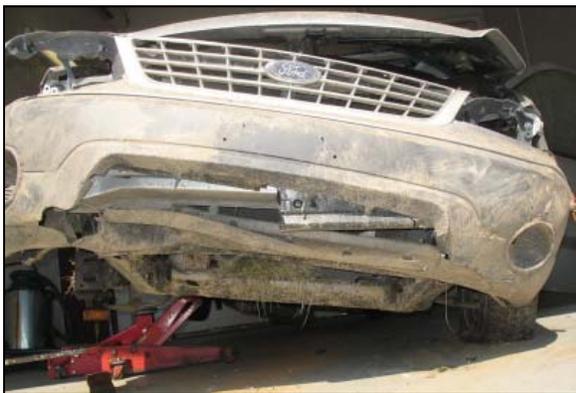
The multiple-event crash sequence resulted in moderate severity damage to the Ford. The undercarriage impact (Event 1) resulted in a 5 cm (2 in) right wheelbase reduction and a fracturing of the right front suspension lower control arm. The sidewall of the right front tire was cut and holed. Longitudinal abrasions with distributed dirt/grass debris were observed to the full width of the lower engine cradle (**Figure 7**). The Collision Deformation Classification (CDC) was 00UFDW3. Based on the crash reconstruction and a review of the EDR data, this impact resulted in the actuation of the front safety belt retractor pretensioners and the deployment of the vehicle's driver air bag.

Figure 7: View of the Ford's front undercarriage.

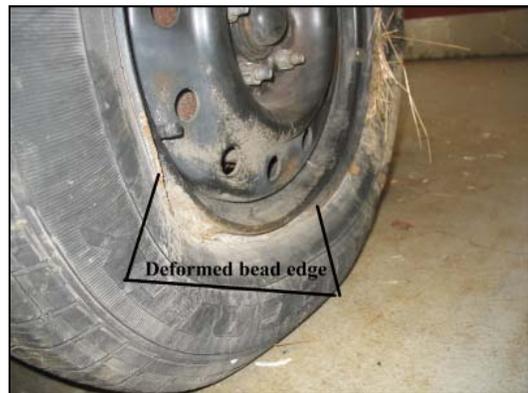
The CW rotation of the Ford was supported by the inspection of the left rear wheel rim. The rim deformation was linked to the impact the concrete rain gutter and the adjacent gouge (Event 2). The rim bead edge was folded inboard over a 30 cm (12 in) length (**Figure 8**). The CDC of this impact was 09LBWN1.

Figure 8: View of the deformed left rear wheel rim.

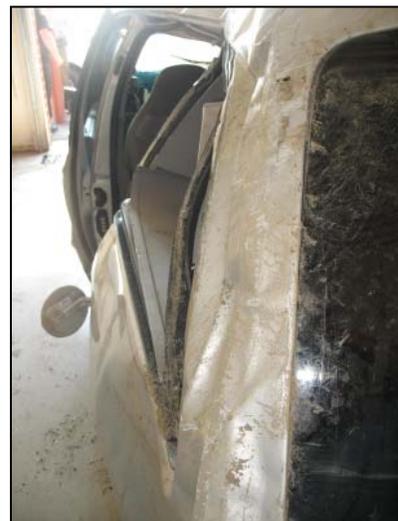
The upper aspect of the right D-pillar, the back plane and the upper area of the left D-pillar exhibited damage that was associated to the swiping impacts within the tree line (Events 3 and 4). The respective D-pillar body panels exhibited horizontal abrasions (**Figure 9**). Due to the contour of the Ford's body, the location and the orientation of these abrasions could not be associated to the rollover event. These two regions of damage wrapped around the corners onto the back plane. It was observed that debris from the tree line was embedded between the body panels and the surrounding rubber moldings. **Figure 9** is a view of the damage at the left upper D-pillar area. The reconstruction of the crash indicated that

Figure 9: View the damage at the Ford's left D-pillar area.

a separation, and then contact to the right rear corner area. The CDC for Event 3 was 00LBAW2. The CDC for Event 4 was 00RBAW2.

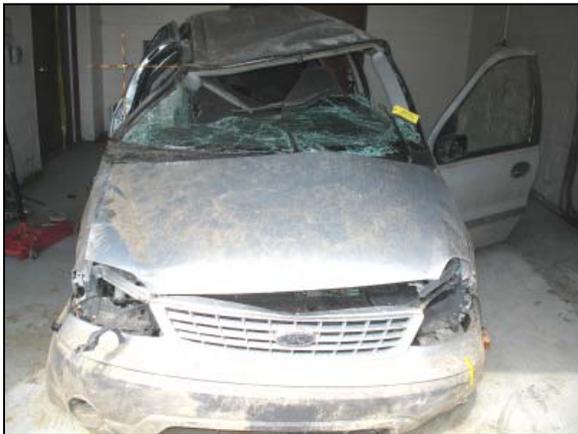
The Ford sustained damage to the top and both side planes as a result of the 6-quarter turn rollover (Event 5). Refer to **Figure 10**. The left plane and roof exhibited body panel deformation and abrasions consistent with contacting the ground twice. The abrasions along the left roof side rail and on the roof were oriented in two directions. The maximum lateral deformation was located at the junction of the left C-pillar and the roof side rail (**Figure 11**). The deformation measured 22 cm (8.5 in). The left roof area buckled vertically due to the deformation. The maximum vertical deformation occurred at the right A-pillar and measured 16 cm (6.2 in). The right A-pillar was also deformed laterally. The lateral deformation measured 17 cm (6.6 in). The right body panels and exposed edges of the panels exhibited deformation and abrasions indicative of a single ground contact consistent with a 6-quarter turn rollover. The CDC of the rollover event was 00LDAO3.

Figure 10: Front overall view of the Ford's rollover damage and maximum vertical damage at the right A-pillar.

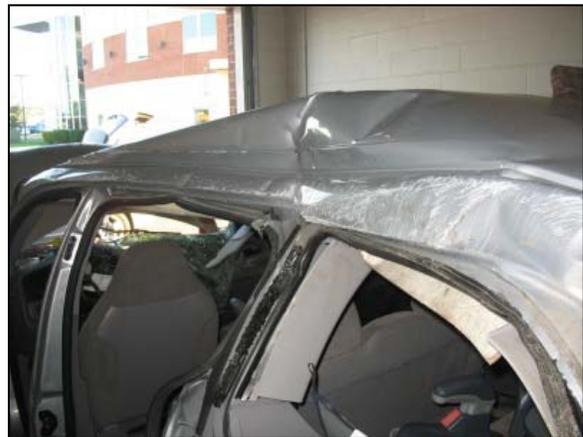
Figure 11: View of the maximum lateral deformation at the Ford's left roof side rail.

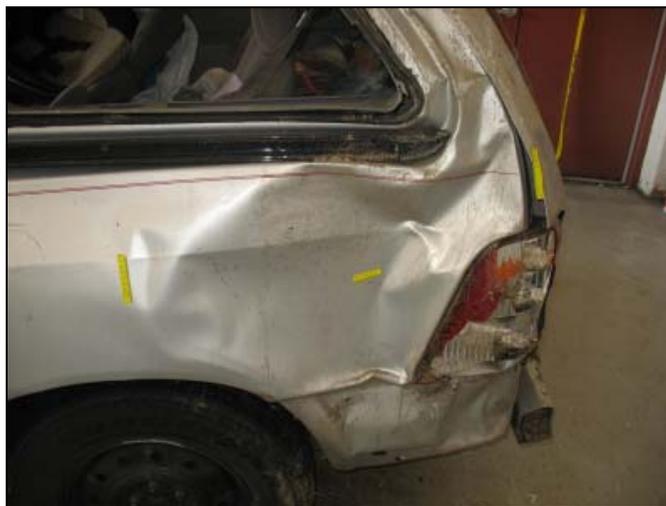
An isolated region of damage was noted below the left rear quarter window (**Figure 12**). This damaged region began immediately below the window and measured 71 cm x 41 cm (28 in x 16 in) length x height. The lateral deformation measured 9 cm (3.5 in). Bodily fluid evidence was observed within the deformation. This area was deformed by the head of the ejected child

passenger as the head became captured between the vehicle and the ground during the later stage of the rollover event.

Figure 12: View of the isolated damage to the Ford's left quarter panel.

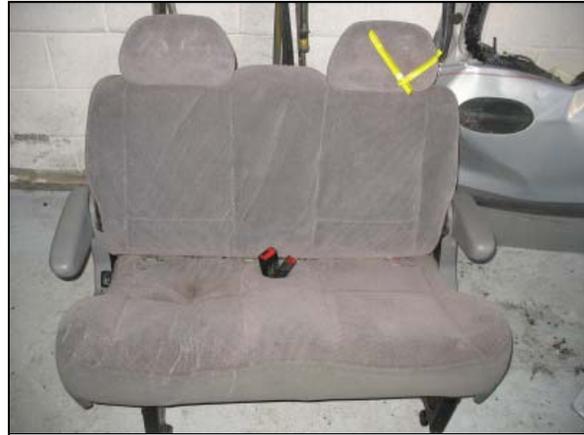
The second row seat was a two-passenger bench with a forward-folding back. The seat measured 122 cm (48 in) in width. The seat could be removed from the vehicle by releasing the two rear latches and pulling the seat rearward to release the two front hooks from the mounting points. During the crash sequence, the second row seat released from the floor mounts. A 12 x 8 cm (4.7 x 3.0 in) contact was noted to upper aspect of the left head restraint. This contact was attributed to the front right passenger during the ejection. This passenger's contact to the head restraint leveraged the seat from the mounting points.

Figure 13: View of the contact to the left head restraint of the second row seat.

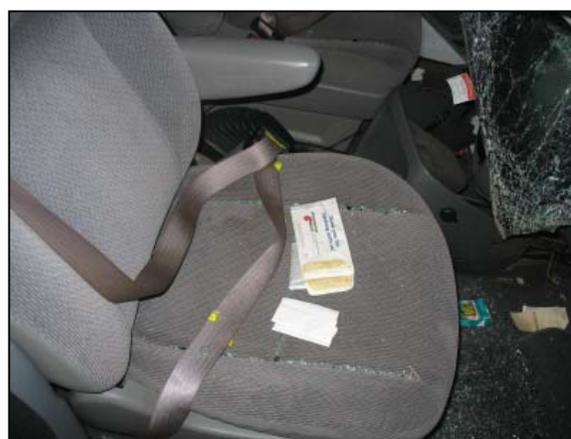
The front right manual restraint (**Figure 14**) was a 3-point safety belt utilizing continuous loop webbing, a light-weight-locking latch plate, an adjustable D-ring and an ELR. The retractor was equipped with a pretensioner that actuated as a result of the crash. The adjustable D-ring was in the full-down position. At the time of the SCI inspection, the latch plate was still buckled in the receiver and the webbing was locked in the extended position. The length of the exposed webbing measured 191 cm (75.0 in). The measurement was taken from the D-ring to

Figure 14: View of the front right safety belt.

the floor anchor. Examination of the webbing revealed a 20 cm (8.0 in) section of abrasions in the lap section. The abrasions began 51 cm (20.0 in) above the floor anchor. An 8 cm (3.0 in) region of webbing abrasions was observed at the latch plate. Based on the inspection of the restraint, the front right passenger was initially restrained at the time of the crash. The imaged EDR data recorded the status of the belt as buckled.

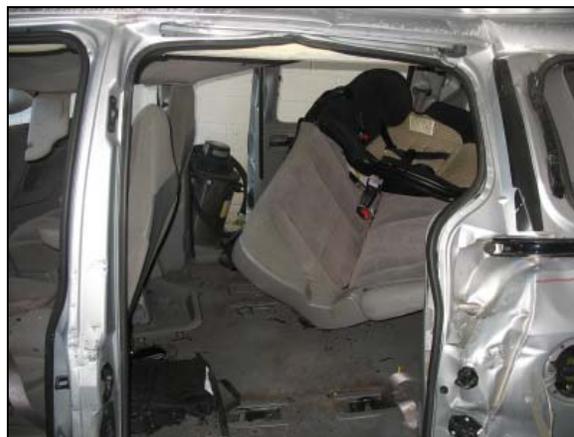
The second row right safety belt was used to secure the convertible CRS in a forward facing mode that was occupied by the 2-year-old male. At the time of the SCI inspection, the CRS was still installed in the second row right position with the webbing routed through the forward-facing belt path. The CRS was compressed into the seat cushion and tightly secured with minimal side-to-side movement. During the crash sequence, the second row seat had separated from its floor mounts. At the time of the SCI inspection, the safety belt webbing had retracted back onto the spool and elevated the seat into the position depicted in **Figure 15**.

Figure 15: View of the second row seat and installed CRS.

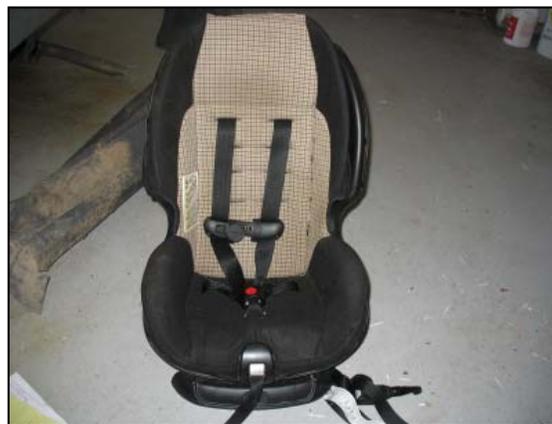
Figure 16: Front view of the Cosco Scenera.

This CRS was designed with an internal 5-point harness system. There were three harness slots in the back of the shell. The harness was found to be routed through the top slots. The base was designed with an adjustable foot that was to be extended during forward-facing use. The SCI inspection of the CRS installation determined that the foot was extended.

Further inspection of the CRS revealed abrasions at forward-facing belt path from interaction with the vehicle's safety belt webbing. There were no indications of stress marks or contact to the CRS shell. Examination of the 5-point harness was unremarkable. The top tether strap was not used. Based upon the age and weight of the 2-year-old male, the CRS was an appropriate selection for use.

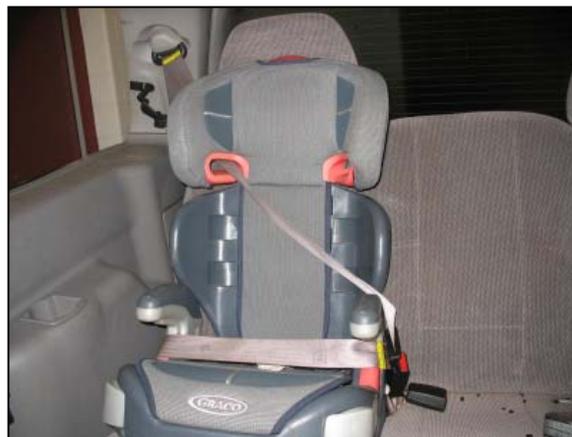
The 5-year-old male was restrained in a Graco Turbo Booster (**Figure 17**). This CRS was used as a high-back booster and had the model number: 8495STO. The high-back was removable. The date of manufacture was April 14, 2004. With the high-back in place, the CRS was designed for a child with a 97 to 145 cm (38 to 57 in) height and 14 to 45 kg (30 to 100 lb) weight. Examination of the CRS was unremarkable for stress marks or contact evidence. Based upon the age and weight of the 5-year-old male, the CRS was an appropriate selection for use.

Figure 17: View of the Graco booster CRS in the third row right position.
