**CALSPAN ON-SITE SIDE IMPACT INFLATABLE
OCCUPANT PROTECTION SYSTEM CRASH INVESTIGATION**

SCI CASE NO: CA08048

VEHICLE: 2005 ACURA TL

CRASH DATE: AUGUST 2008

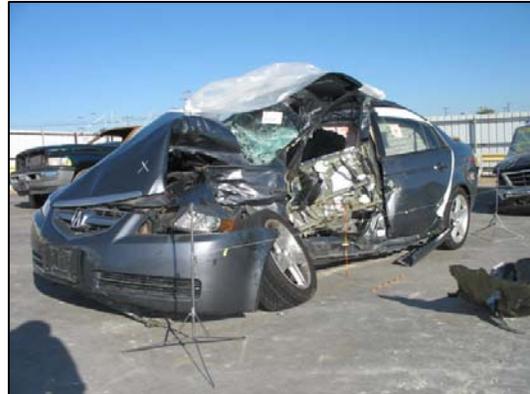
Figure 1: Left front oblique view of the Acura TL.

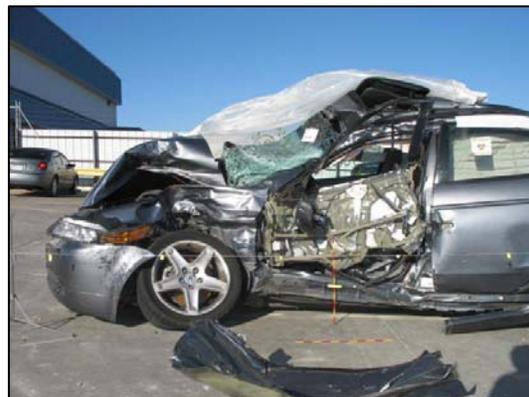
Figure 3 is a view of the left side damage to the Acura. The direct contact damage began 112 cm (44 in) forward of the left rear axle and extended 186 cm (72.25 in) forward to the left front corner of the bumper fascia. The combined induced and direct contact damage began at the left C-pillar and extended 323 cm (127.25 in) forward to the front

Figure 3: View of the Acura's left side impact damage.

corner. The maximum crush was 74 cm (29.1 in) located on the left front door beam 65 cm (25.5 in) forward of the B-pillar and 60 cm (23.5 in) above the ground. The crush profile was measured along the lower door level with the following results: C1 = 6 cm (2.4 in), C2 = 14 cm (5.5 in), C3 = 37 cm (14.6 in), C4 = 48 cm (18.9 in), C5 = 74 cm (29.1 in), C6 = 28 cm (11 in). The Acura's left wheelbase was reduced by 9 cm (3.5 in) when compared to exemplar measurements. The Collision Deformation Classification (CDC) for this direct damage pattern was 10LYAW5.

The left front door was jammed closed by the impact. The resulting body deformation jammed the both rear doors in the closed positions. The right front door remained closed during the crash and was operational post-crash. Rescue personnel pried the left front door open to extricate the driver from the vehicle. The windshield was 100 percent cracked with a partial bond separation at the upper left corner and a small perforation in the lower left quadrant from a fractured section of the upper instrument panel. The left front door glazing was disintegrated from impact forces. All other glazing remained intact.

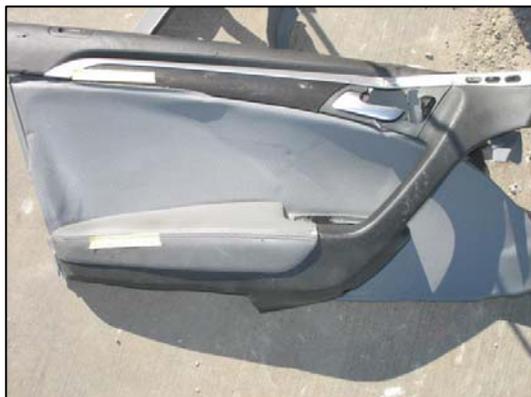
Interior damage exhibiting characteristics of occupant contact was identified to eleven separate areas within and adjacent to the driver's position. The first area of damage was located in the forward lower quadrant of the interior driver door panel (**Figure 4**), which consisted of deformation associated with occupant loading of this component by the driver's left lower leg. Multiple scuff marks and deformation were identified on the door armrest and the upper rear door quadrant that were attributed to contact with the driver's left hip and left flank areas, respectively. The fourth damaged component was identified as the intruded portion of the front left roof headliner, which exhibited scuff marks potentially created by contact with the top of the driver's head. The center console (**Figure 5**) was distorted and fractured from the driver's hip area as he was compressed between the console and the intruding left side structure. The left aspect of the front row right seatback and head restraint exhibited frictional abrasions and compression with body fluid transfers from contact from the driver's face, head, and right shoulder regions. The left aspect of the anterior portion of the driver's seatback, extending from 11 cm (4.3 in) to 19 cm (7.5 in) above the seat bight, was deformed by lateral intrusion and contact with the driver's left hip area. The area immediately forward of the left side seatback deformity contained the deployed seat-mounted air bag, which also exhibited loading evidence consistent with the same body region. Multiple scuff marks and deformation were identified on the left side kick panel located under the instrument panel, forward of the A-pillar, that were attributed to contact with the driver's left lower leg area. The left IC airbag exhibited frictional abrasions and compression type bodily fluid transfer marks to the inboard surface of the air bag created by contact with the left side of the driver's head and face.

Figure 4: Depicts occupant contact damage to the left front door panel and armrest.

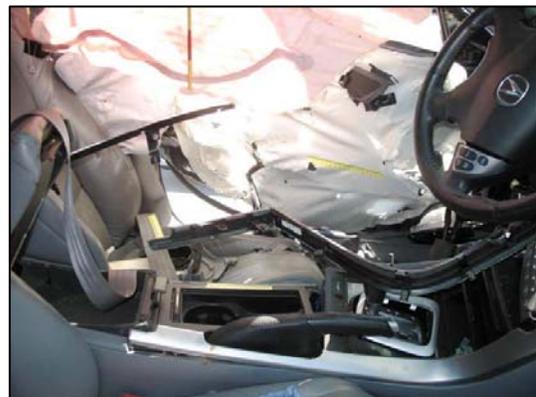
Figure 5: Depicts occupant contact damage to the center console.

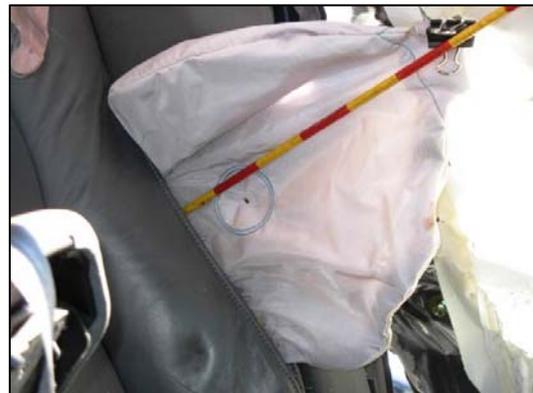
The Acura was equipped with a side impact air bag system that consisted of front seatback-mounted side impact air bags and roof side rail-mounted IC air bags. The left seatback-mounted air bag and the left IC air bag deployed in this side impact crash. The seatback air bag deployed from the forward stitch seam of the seat back that measured 22 cm (8.7 in) in height. The deployed air bag, in its deflated state, measured 30 cm x 25 cm (12 in x 9.75 in) height x width. The air bag was vented by a 1 cm (.25 in) vent port located

Figure 6: Depicts the inboard aspect of the deployed seat-mounted side impact air bag.

6 cm (2.4 in) forward of the tear seam on the inboard aspect of the air bag. There was no occupant contact evidence or damage to the deployed seatback air bag. **Figure 7** is a view of the deployed air bag.

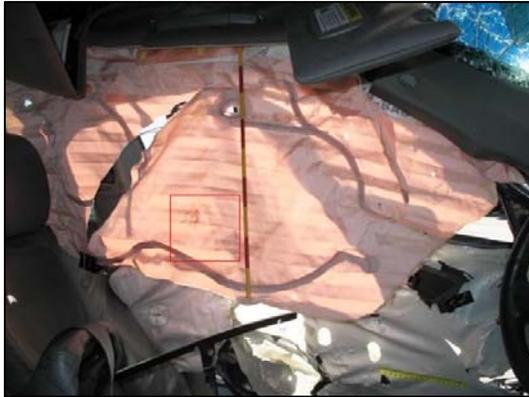
Figure 7: Depicts the front row aspect of the left IC airbag after the removed section was reattached.

The IC air bags were mounted within both roof side rails. The IC air bag system provided coverage for the outer seating positions of both rows. The left side IC air bag deployed as a result of the impact with the Ford. The IC measured 132 cm x 41 cm (52 in x 16 in) length x height in overall dimensions and provided coverage from the upper aspect of the A-pillar to the C-pillar area. A section from the forward most aspect of this air bag (**Figure 8**), measuring 57 cm x 35 cm (22.5 in x 13.75 in) length x height, was cut from the vehicle during the extrication of the driver. This section was realigned with the IC air bag's core section (**Figure 9**). A 30 cm (12 in) void in coverage was measured between the beltline region of the A-pillar and the forward edge of the IC. The deployed IC did not contain a sail panel or tethers within its construction. The vertical coverage of the IC extended 13 cm (5 in) below the beltline for both seating rows. Frictional abrasions and body fluids are highlighted within the red bordered areas of **Figure 8 and 9**, were recognized on the inboard surface of this air bag 28 cm (11 in) longitudinally rearward of the lower front corner and 12 cm (4.7 in) above the bottom edge of the curtain.

The driver contacted the deployed IC curtain with the left side of his face and head as evidenced by the documented scuff marks and compression-type body fluid transfer

marks to the air bag. This contact, coupled with the driver's corrective eyewear, caused a 2 cm (0.8 in) nasal bridge laceration. The driver's head loaded through the deployed IC air bag and engaged the front of the Ford pickup truck. This contact resulted in a brief loss of consciousness associated with head trauma as the front end of the Ford loaded through the IC air bag.

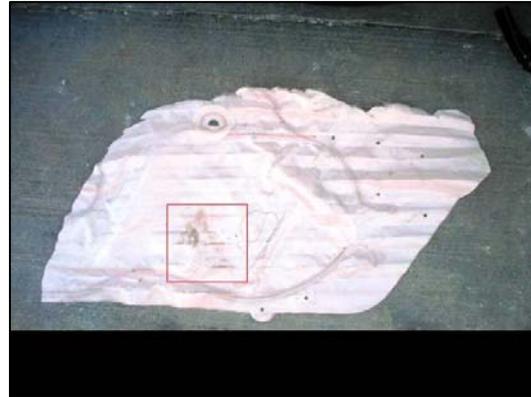
Figure 8: Depicts the on-scene cut and removed section of the front row portion of the left IC air bag.

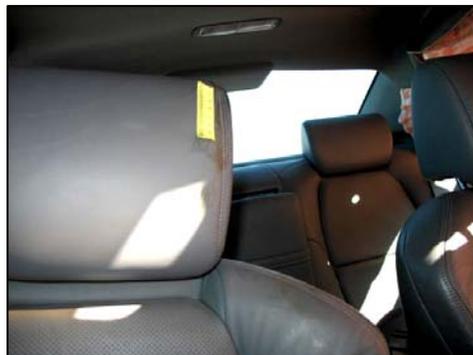
The left side intruding components, reinforced by the Ford's forward momentum, displaced the driver laterally rightward and forced his right flank against the right aspect of his seatback, center console and the left aspect of the front row right seatback and head restraint. **Figure 10** identifies the driver loading evidence consisting of frictional abrasions and compression type bodily fluid transfer marks to the left aspect of the front row right seatback and headrest. This occurrence caused three rib fractures to the top

Figure 10: Depicts driver loading evidence to the left aspect of the front right seatback and headrest.

aspect of the driver's right rib cage, a right chest contusion and an abrasion of the right upper extremities.
