ON-SITE CERTIFIED ADVANCED 208-COMPLIANT VEHICLE INVESTIGATION

CASE NUMBER - IN09001

VEHICLE - 2008 MERCURY MILAN PREMIER

CRASH DATE - October 2008

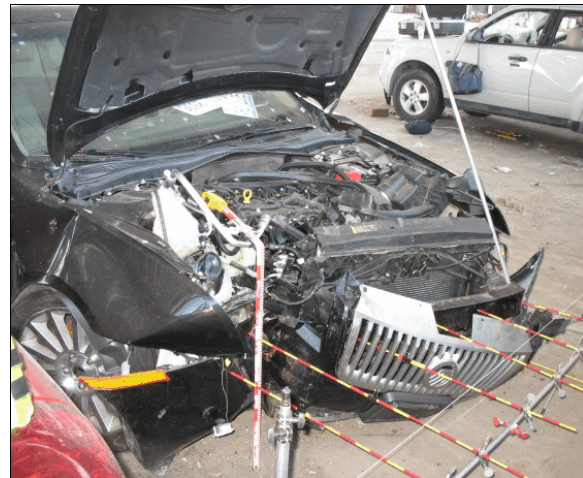
Figure 1: Front damage to the 2008 Mercury Milan Premier from impact with a tree

Exterior Damage: The damage from the curb impact involved the vehicle’s right front wheel. The rim was dented and abraded (**Figure 3**) but the tire was undamaged. The damage from the tree impact involved the front plane (**Figures 1 and 5**). The right headlamp/ turn signal assembly, bumper and hood were directly damaged. The direct damage began at the front right bumper corner and extended 42 cm (16.5 in) to the left along the front bumper. The maximum residual crush was 55 cm (21.7 in) and occurred at C₅ (**Figure 6**). The table below shows the vehicle’s front crush profile.

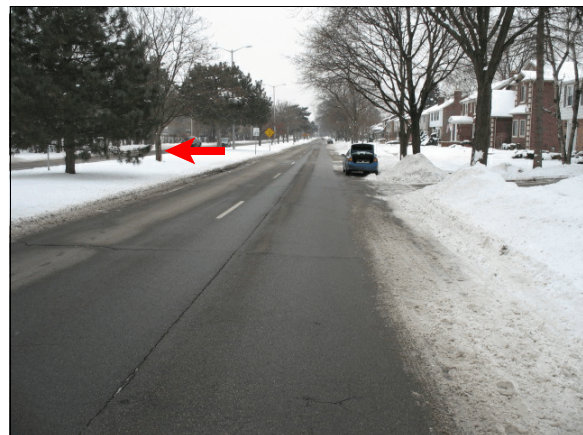
Figure 2: Approach of the Mercury to impact; arrow shows the impacted tree

was traveling southeast (**Figure 2**) in the right lane, and the driver veered sharply to the left and into the median. The driver's autopsy record indicated that his Blood Alcohol Content was 0.28. Drug tests were also performed and were negative.

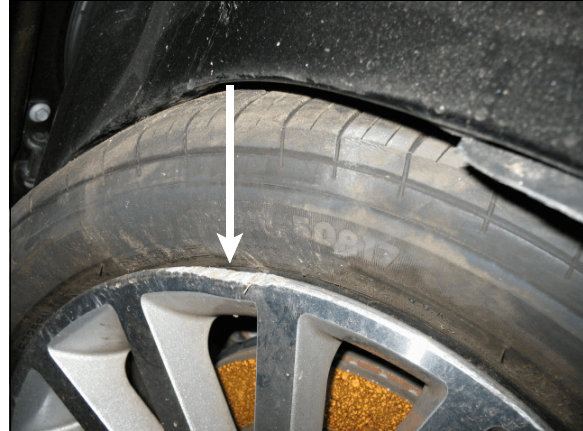
Crash: As the Ford departed the left side of the roadway, the right front wheel impacted the median curb damaging the rim (event 1, **Figure 3**). The vehicle traveled an unknown distance through the median (the location of the roadway departure point could no be determined due to snow cover) and the right corner of the vehicle's front plane impacted a 46 cm (18.1 in) diameter tree (event 2, **Figures 1 and 4**). The curb strike and any tire mark evidence that may have been present within the median was covered by snow, so the vehicle's motion as it approached the tree could not be determined from scene evidence. However, the angle of the front crush pocket, the occupant contact evidence within the vehicle, and the police schematic's depiction of the vehicle at final rest all indicated that the vehicle was in an approximate 30 degree counterclockwise yaw at the moment of impact with the tree. The resulting direction of principal force acting on the vehicle was within the 1 o'clock sector and the impact force was sufficient to trigger a deployment of the driver's frontal air bag. Based on the police crash schematic, the vehicle rotated counterclockwise approximately 35 degrees and came to final rest heading east with the front plane against the tree.

Figure 3: Arrow shows dent and abrasion on right front rim due to curb impact

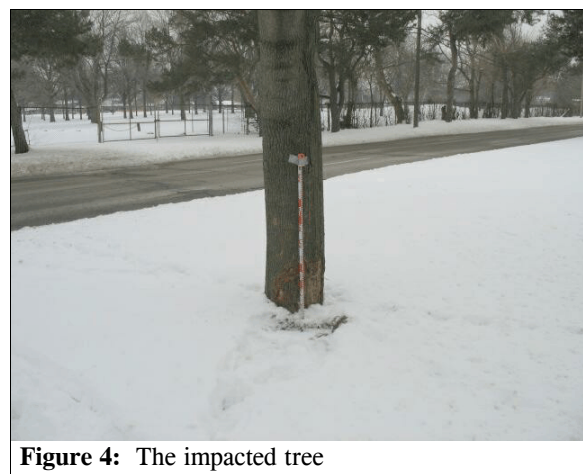
Figure 4: The impacted tree

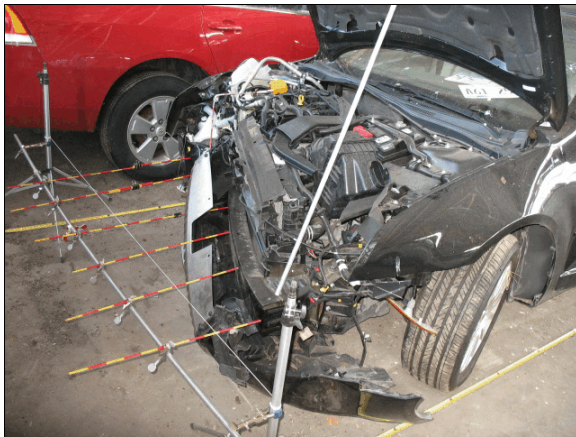
Figure 5: The Mercury’s front crush viewed from left front corner

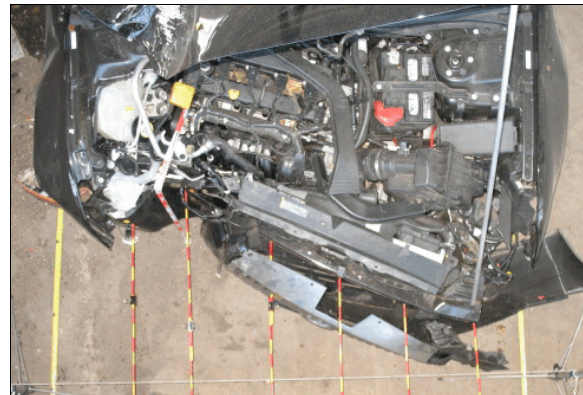
Figure 6: The Mercury’s front crush profile

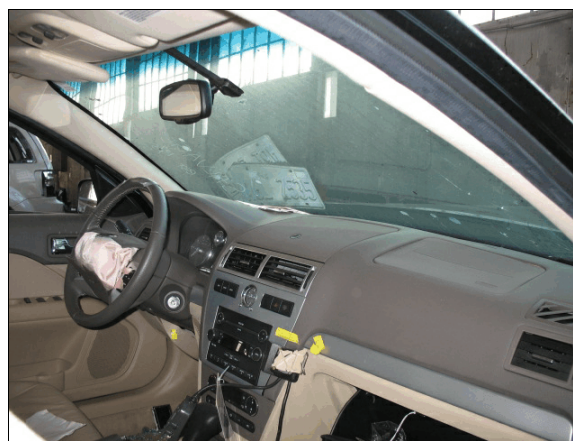
Vehicle Interior: The inspection of the Mercury’s interior (**Figure 7**) revealed a scuff mark and fiber transfer on the lower left instrument panel immediately left of the steering column due to contact by the driver’s left knee. The center console was cracked and displaced (**Figure 8**) to the right due to contact by the driver’s lower right leg and thigh. The vehicle was equipped with an after market Global Positioning System (GPS), which was mounted on a metal bracket on the center instrument panel located on the right side of the compact disc player. The GPS unit was broken off the bracket (**Figure 9**) and the bracket was bent against the instrument panel (**Figure 10**). The instrument panel was also scuffed in the same area due to contact by the driver’s head. There was a large accumulation of blood on the front right seat cushion, which indicated the driver’s head and upper torso came to rest on the front right seat. The driver sustained a large laceration on the right frontal scalp during the crash from loading the GPS unit. This injury was the source of the blood deposit on the front right seat cushion.

Figure 7: Steering wheel and instrument panel

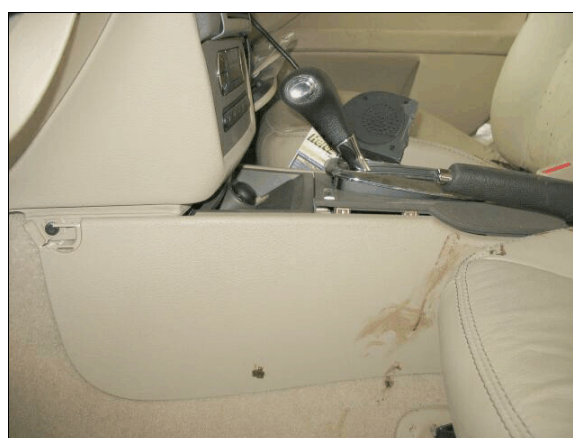
Figure 8: Center console was cracked and displaced to the right

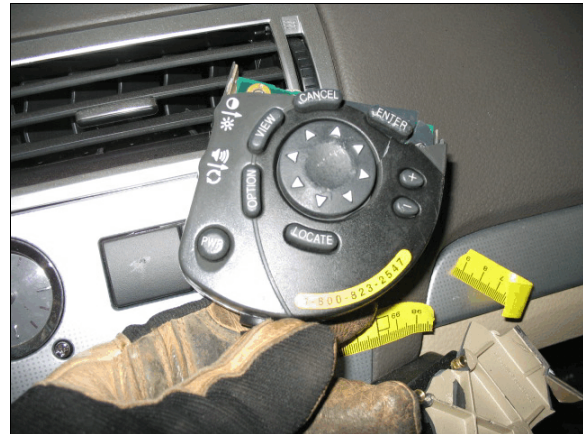
Figure 9: The broken GPS unit

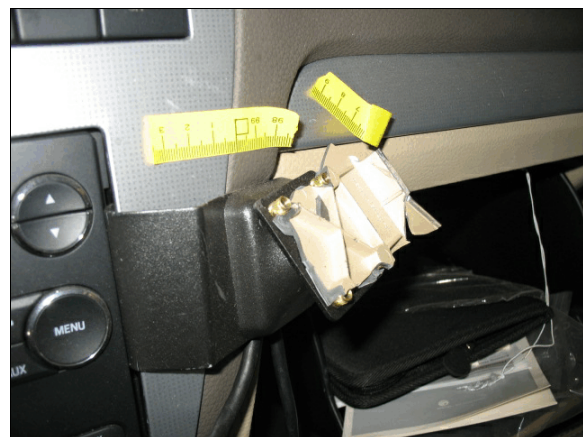
Figure 10: The bent GPS bracket

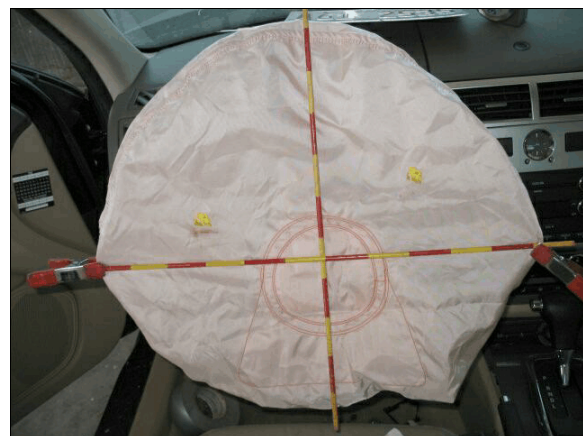
The driver's frontal air bag was located within the steering wheel hub and the module cover was a two flap configuration constructed of pliable vinyl. The top flap was 19 cm (7.5 in) in width at the top, 18 cm (7.1 in) at the bottom, and 9 cm (3.5 in) in height. The bottom flap was 18 cm (7.1 in) in width at the top, 8 cm (3.1 in) in width at the bottom, and 12 cm (4.7 in) in height. The cover flaps opened at the designated tear points and there was no damage to the deployed air bag. The air bag (**Figure 11**) was round with a diameter of 58 cm (22.8 in) and was designed with two tethers and two vent ports. The vent ports were located on the back of the air bag at the 3 and 9 clock positions. There was no discernable occupant contact evidence on the air bag. Two blood smears were present on the air bag, but they appeared to be related to blood splatter, which probably occurred during removal of the driver from the vehicle.

Figure 11: The driver's frontal air bag
