ON-SITE CERTIFIED ADVANCED 208-COMPLIANT VEHICLE INVESTIGATION

CASE NUMBER - IN09002

VEHICLE - 2007 FORD FOCUS XZ4

CRASH DATE - November 2008

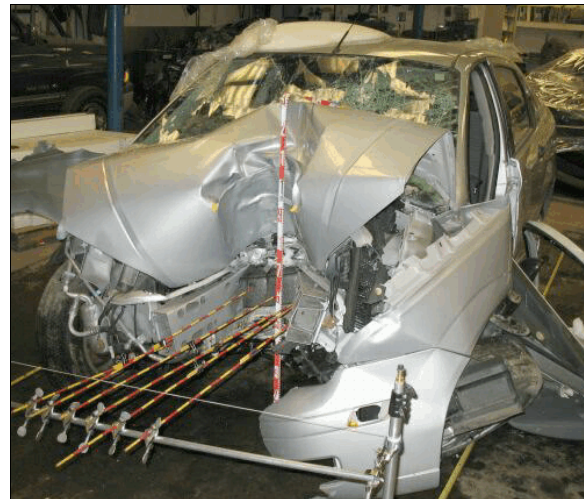
Figure 1: The damaged 2007 Ford Focus XZ4 SE

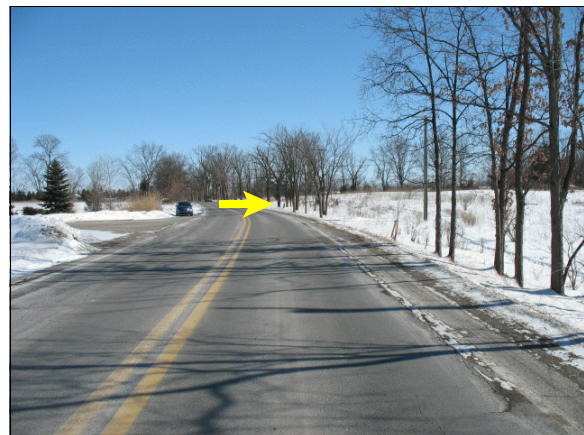
Pre-Crash: The Ford's unrestrained 28-year-old male driver was traveling east negotiating a left curve (**Figure 2**). He was leaning forward to the

Figure 2: Ford's approach to roadway departure and area of impact (arrow)

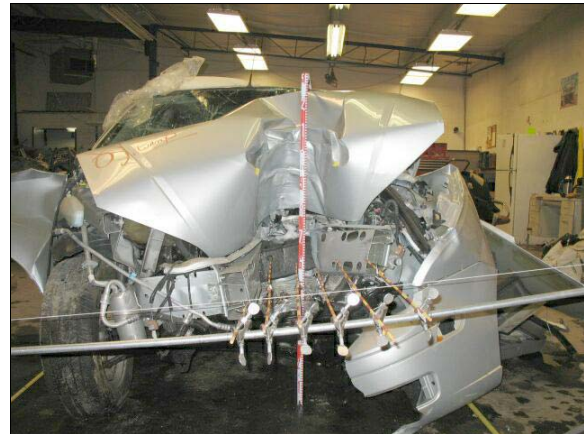
Figure 3: Ford's frontal damage

Exterior Damage: The damage from the tree impact involved the Ford's front plane (**Figure 3**). The bumper, bumper fascia, hood, and grille were directly damaged. The direct damage began 25 cm (10 in) right of the front right bumper corner and extended 27 cm (10.6 in) to the left along the front bumper. The maximum residual crush was 95 cm (37.4 in) and occurred at C₃ (**Figure 5**). The table below shows the vehicle's front crush profile.

Damage Classification: The Ford's Collision Deformation Classification was **12-FZEN-5** (0 degrees) for the front impact to the tree. The Barrier algorithm of the WinSMASH program calculated the vehicle's total Delta V as 84.0 km/h (52 mph). The longitudinal and lateral velocity changes were -84 km/h (-52 mph) and 0 km/h, respectively.

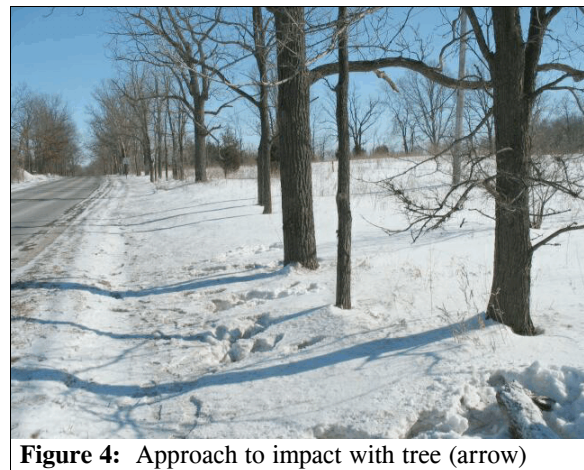
Figure 4: Approach to impact with tree (arrow)

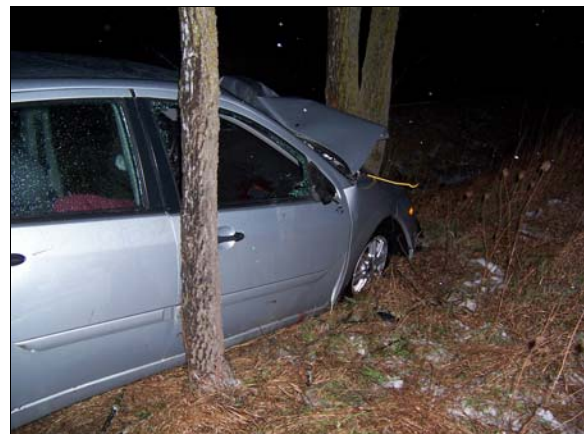
Figure 5: Police on-scene photo showing Ford's final rest position

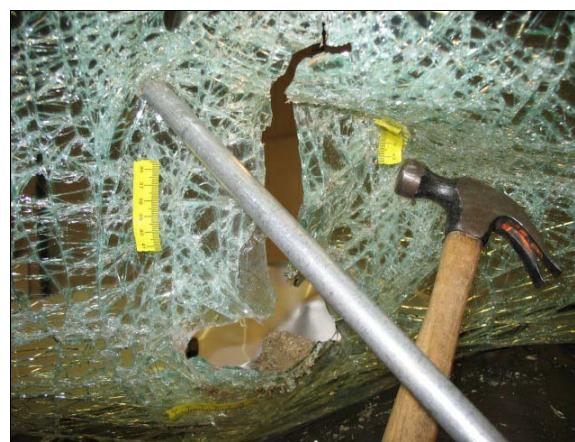
Vehicle Interior: The Ford's windshield was holed due to loading by the driver's head (**Figure 6**). Hair and tissue deposits were found on the glass and edges of the hole. Hair and tissue deposits were also present on the right sunvisor hinge and windshield header due to contact by the driver's head. The lower left instrument panel and left portion of the lower center instrument panel were deformed due to contact by the driver's left and right knees, respectively (**Figure 7**). The steering assembly was deformed as a result of loading by the driver's chest. The steering wheel rim was completely collapsed (**Figure 8**) with the upper half sustaining the primary deformation of 14 cm (5.5 in). The energy absorbing steering column was compressed approximately 10 cm (4 in) and displaced to the left 5 cm (2 in). There was also a significant blood deposit on the front portion of the right front door and upper right instrument panel, which indicated the probable final rest position of the driver within the vehicle.

Figure 6: Windshield holed by the driver's head

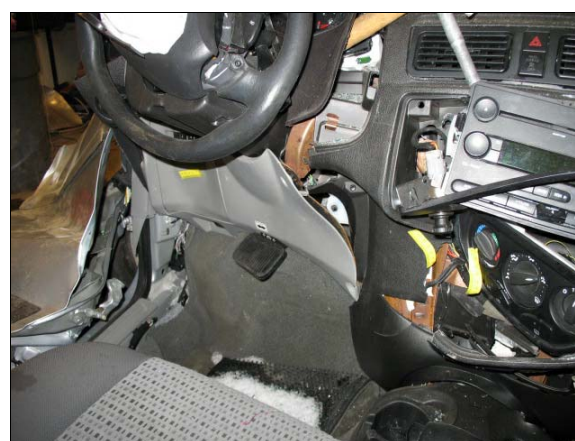
Figure 7: Knee bolster and instrument panel damage due to driver contact

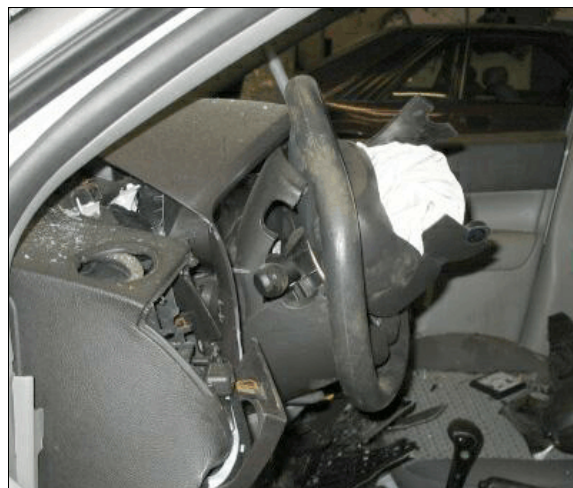
Figure 8: Left side view of deformation of the steering assembly

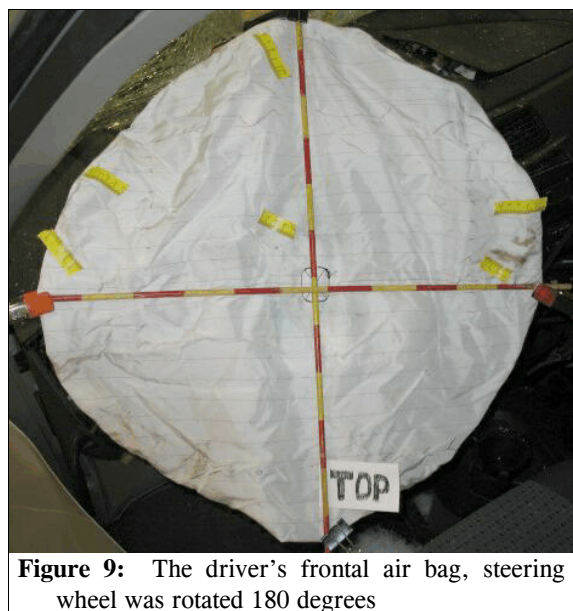
The driver's frontal air bag was located within the steering wheel hub and the module cover was a two flap configuration constructed of pliable vinyl. The top flap was 15 cm (5.9 in) in width at the top, 18 cm (7.1 in) at the bottom, and 5 cm (2 in) in height. The bottom flap was 18 cm (7.1 in) in width at the top, 6 cm (2.4 in) in width at the bottom, and 8 cm (3.1 in) in height. The cover flaps opened at the designated tear points and there was no damage to the deployed air bag. The deployed air bag (**Figure 9**) was round with a diameter of 58 cm (22.8 in) and was designed with two tethers and six small vent ports. The vent ports were located on the back of the air bag in groups of 3, at the 3 and 9 clock positions (**Figure 10**). There were two blood stains on the left middle portion of the air bag. Lighter blood smears were noted on the lower right portion of the air bag. The blood stains were probably related to the extrication of the driver when he was removed from the vehicle through the left front door.

Figure 9: The driver's frontal air bag, steering wheel was rotated 180 degrees

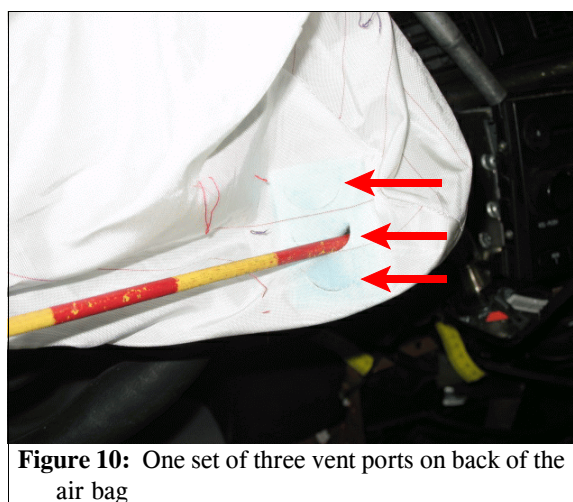
Figure 10: One set of three vent ports on back of the air bag
