## ON-SITE ROLLOVER INVESTIGATION

CASE NUMBER - IN09003

VEHICLE - 2008 CHEVROLET SILVERADO LS 4x4 K2500HD

CRASH DATE - January 2009

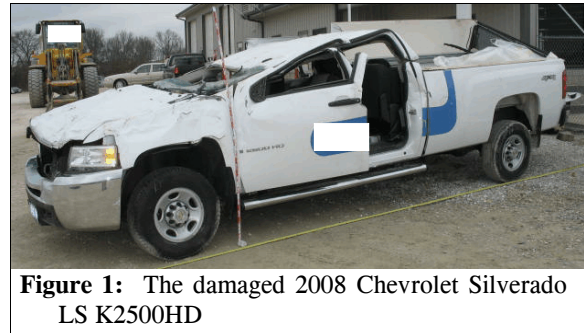
**Figure 1:** The damaged 2008 Chevrolet Silverado LS K2500HD

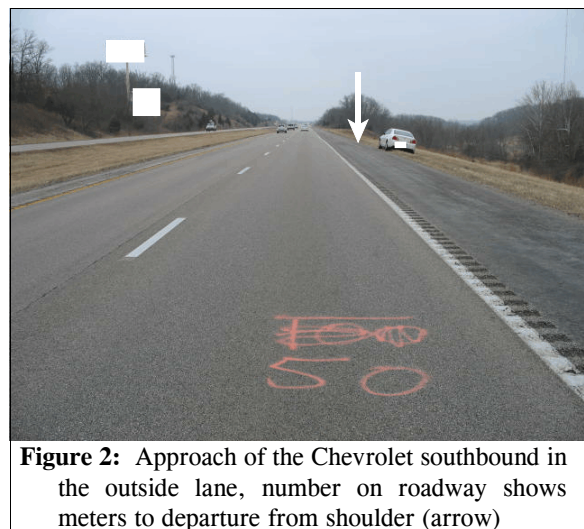
**Pre-Crash:** The Chevrolet's restrained 51-year-old male driver was traveling south in the outside lane (**Figure 2**). The vehicle lost traction on the ice-covered roadway and began to rotate clockwise. It departed the right (west) side of the road where the rollover began.

**Figure 2:** Approach of the Chevrolet southbound in the outside lane, number on roadway shows meters to departure from shoulder (arrow)

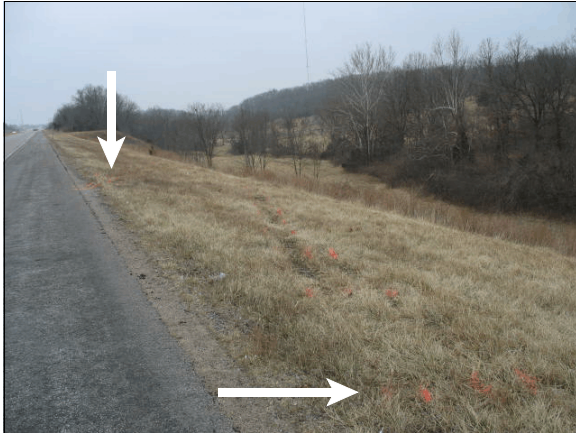
**Crash:** The Chevrolet yawed clockwise 75 degrees relative to its original southerly travel direction as it departed the west (right) shoulder and entered the grass (**Figure 3**). The vehicle traveled across the negative 4.4% grass slope and

**Figure 3:** Chevrolet departed the right shoulder in a clockwise yaw, arrows show tire marks in grass

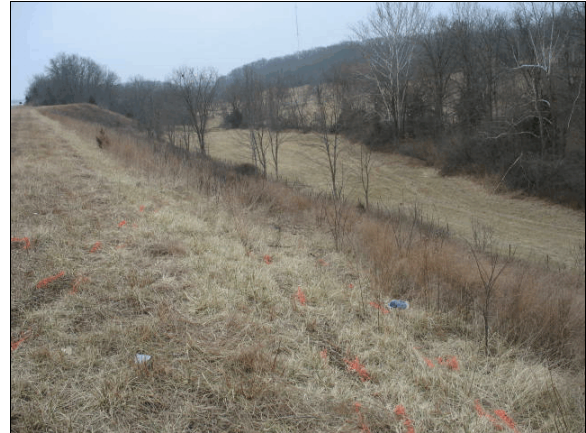
**Figure 4:** Path of the Chevrolet onto the embankment

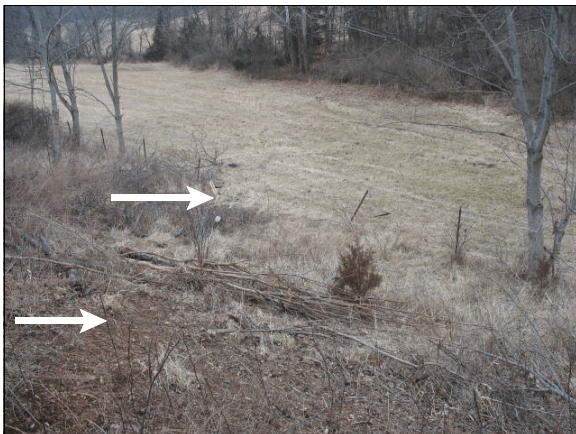
started down the embankment (**Figure 4**), which became increasingly steeper. As the vehicle traveled down the embankment, it continued to rotate clockwise and the right side tires furrowed into the ground (**Figure 5**) and it tripped right side leading (event 1). As the vehicle rolled over, it impacted and knocked down a 9 cm (3.5 in) diameter tree and a wire fence (**Figure 5**). The fence impact scratched the right side of the truck bed topper (event 2), but there was no visible damage due to the tree contact. The top plane of the vehicle sustained the primary damage (**Figures 6 and 7**) from the rollover. The vehicle came to final rest on its wheels in the horse pasture heading southwest (**Figure 8**).

**Figure 5:** Area where Chevrolet tripped and rolled over right side leading, arrow in foreground shows furrow from right front tire, arrow in background shows broken tree and wire fence

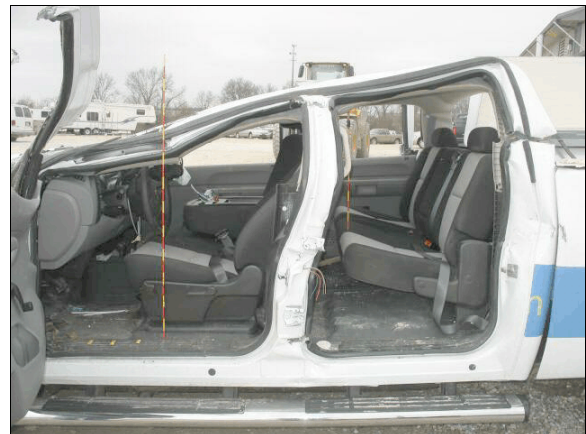
**Figure 6:** Roof crush viewed from the left side, each increment on measurement rod is 5 cm (2 in)

**Exterior Damage:** The damage from the rollover involved the top plane and both side planes of the vehicle. The direct damage on the top plane began at the front of the hood and extended rearward 601 cm (236.6 in). The direct damage also involved the full width of the top, 134 cm (52.8 in). The maximum vertical and lateral crush occurred at the top of the left A-pillar and were 28 cm (11 in) and 1 cm (0.4 in), respectively. The direct damage on the right side plane began 60 cm (23.6 in) forward of the right front axle and extended 345 cm (135.8 in) rearward. Intermittent scratches from the wire fence were located along the right side of the truck bed top. The direct damage on the left side plane began 61 cm (24 in) forward of the left front axle and extended 346 cm (136.2 in) rearward. The direct damage on the side planes involved only the cab of the truck and did not extend below the top of the front wheel wells or below the beltline on the side of cab.

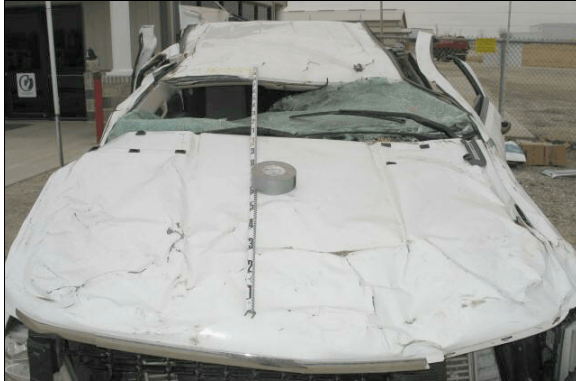
**Figure 7:** Front view of the top plane damage

**Damage Classification:** The Collision Deformation Classification was **00-TDDO-4** for the rollover (event 1). The CDC for the wire fence impact (event 2) was **00-RBGW-2**. The severity of the rollover damage was severe based on the extent of the roof crush.

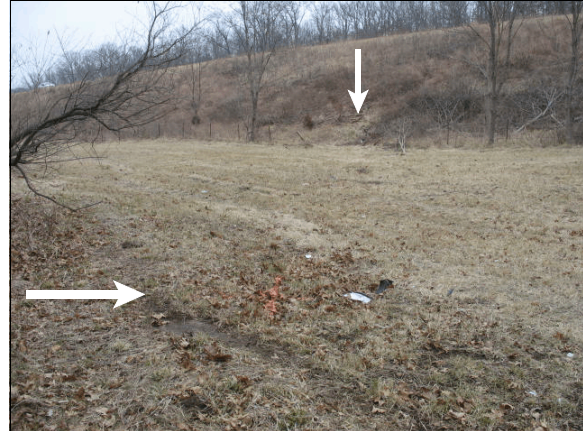
**Figure 8:** Arrow in foreground shows final rest location; arrow in background shows area of rollover initiation

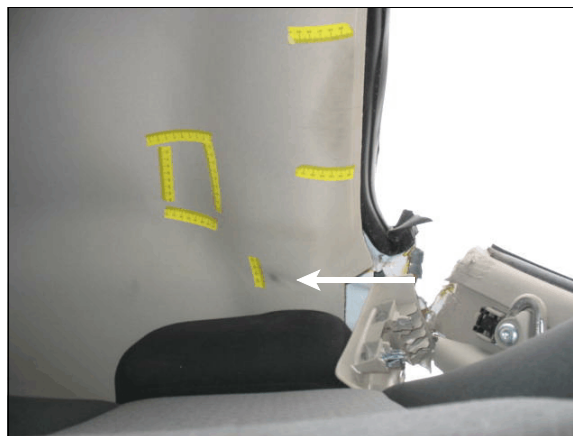
**Vehicle Interior:** The inspection of the Chevrolet's interior revealed a scuff mark and impression on the left roof side rail adjacent to the driver's seat back and a slight impression with a few small black hairs or fibers on the roof directly above the driver's seat (**Figure 9**). These marks were probably the result of loading by the driver's left shoulder and head, respectively. A mark was also present on the roof directly above the head restraint, which was due to roof contact. It is possible that the roof contact displaced the seat back rearward during the rollover. The recline position of the seat back was 50 degrees.

**Figure 9:** View from driver's seat cushion of occupant contact marks on the roof and left roof side rail, arrow shows mark on roof from contact with head restraint

The occupant contact evidence observed within the vehicle indicated that as the roof was crushed during the rollover, the driver loaded his head on the roof which resulted in a nonanatomic brain injury and an abrasion on the left forehead. The driver also probably loaded his left shoulder on the left roof side rail; although, no injury was documented. He remained restrained in his seat throughout the rollover sequence and rescue personnel cut the seat belt off of him in order to remove him from the vehicle.

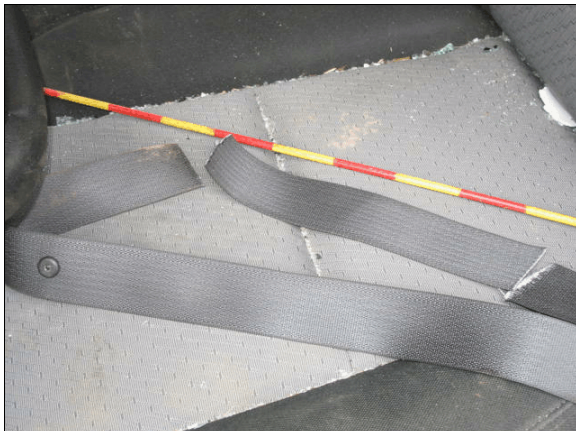
The driver's latch plate was found latched in the buckle and the seat belt had been cut by rescue personnel (**Figure 10**). Inspection of the latch plate belt guide revealed slight abrading due to belt loading (**Figure 11**). The evidence supported by the EDR data indicated that the driver was restrained by the lap-and shoulder belt at the time of the crash. The remaining seat positions were unoccupied.

**Figure 10:** The driver's seat belt was cut by rescue personnel

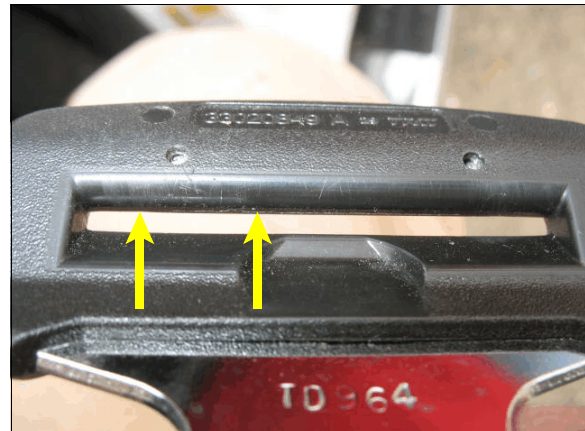
**Figure 11:** Arrows show abrasions on driver's latch plate belt guide
