On-Site Rollover Investigation
Dynamic Science, Inc. (DSI), Case Number DS09005
2008 Ford Focus
Arizona
December 2008

1. Report No. DS09005	2. Government Accession No.		3. Recipient Catalog No.	
4. Title and Subtitle On-Site Rollover Investigation			5. Report Date September 8, 2009

This on-site investigation focused on a 2008 Ford Focus that was involved in a rollover crash (**Figure 1**). The Ford was traveling eastbound on a divided interstate highway and was being driven by a 40-year-old male. The driver lost control of the vehicle and departed the roadway on the right side. The vehicle initiated a right side leading rollover that included 8 quarter-turns. During the crash, the vehicle's seat-mounted side air bags and side impact inflatable curtain (IC) air bags deployed. The driver was completely ejected from the vehicle through the left front window. The driver sustained blunt force trauma injuries to his head and chest, and was pronounced deceased at the scene. The Ford was towed from the scene due to damage and was later declared a total loss by the insurance company.

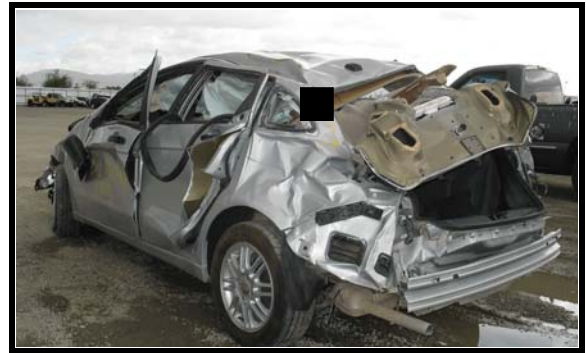
Figure 1. Subject vehicle, 2008 Ford Focus

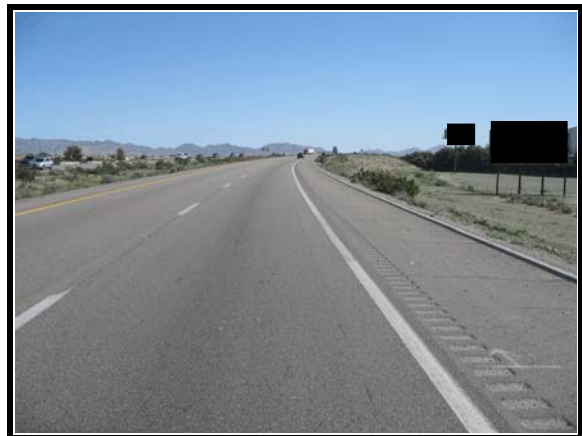
This single vehicle crash occurred in December 2008 at 0715 hours. The crash occurred off-road adjacent to the eastbound lanes of an interstate highway (**Figure 2**). The two eastbound travel lanes were separated from the westbound lanes by a depressed dirt median. The lanes were bounded on the left by a solid yellow line and an asphalt shoulder. The lanes were bounded on right by a solid white line, a rumble strip, an asphalt shoulder, and a concrete curb. The curb measured 9 cm (3.5 in) high by 17 cm (6.7 in) wide. Beyond the curb to the south, there was an extended sandy descending embankment. The embankment had a negative grade that measured 16% near the area of roadway departure to 20% near the area of final rest. At this location, the roadway curved slightly to the right and there was a 1.2% positive grade.

Figure 2. Eastbound path of travel

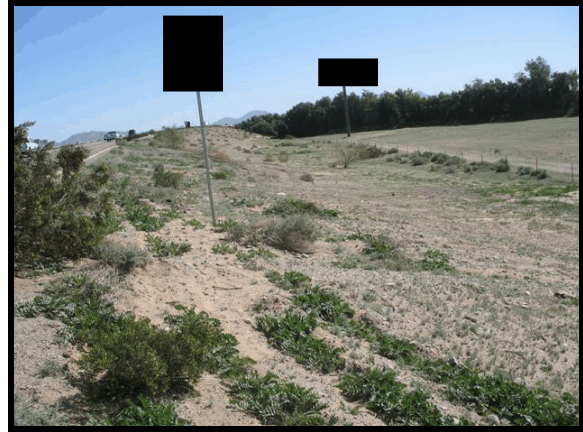
The vehicle began a counterclockwise rotation and traveled approximately 36 m (118 ft) before the right side tires dug into the ground (**Figure 3**). The vehicle tripped and began a rollover with its right side leading. While rolling over, the vehicle struck and knocked down a roadway sign. The plane of the contact is not known. Any contact damage sustained in the event was masked by overlapping damage to the vehicle. The vehicle rolled at least eight quarter-turns. Near the end of the rollover event, the driver was fully ejected through the driver's window and landed on the south roadside (**Figure 4**). The distance from the trip point to final rest was 69 m (225 ft).

Figure 3. Area of impact with sign and rollover

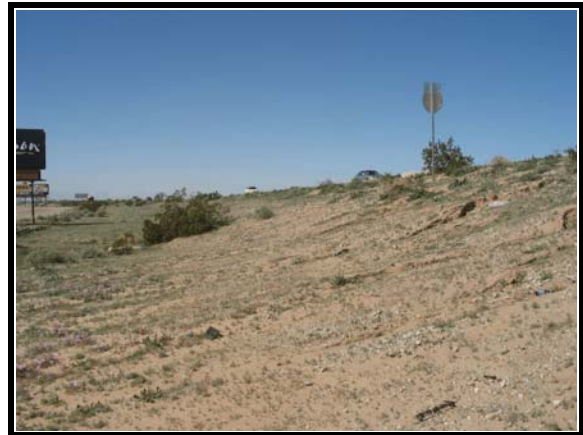
Figure 4. Look back view from final rest (west)

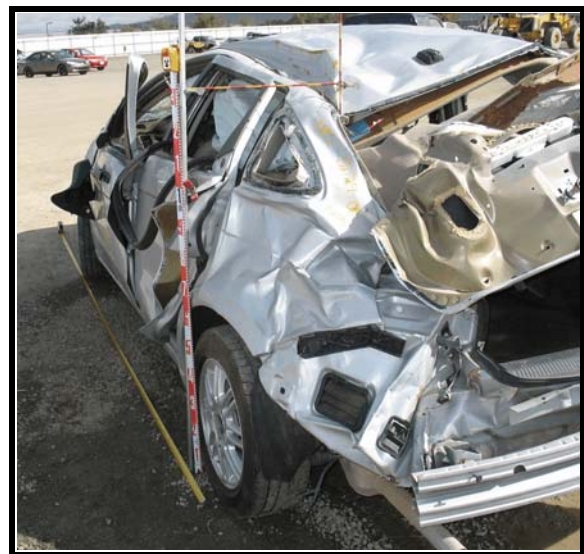
The Ford sustained moderate damage from the rollover event. The damage to the top of the vehicle measured 429 cm (168.8 in) longitudinally and extended laterally from roof rail to roof rail. The damage along the left side extended from bumper corner to bumper corner and measured 445 cm (175.1 in). The damage along the right side extended from bumper corner to bumper corner and measured 445 cm (175.1 in). The front and rear bumper fasciae were dislodged from the vehicle. Both left side doors were jammed shut. The right rear door would not close or latch due to deformation. The maximum vertical crush was located at the left backlight header and measured 22 cm (8.7 in) (**Figure 5**). The maximum lateral crush was located at the left roof side rail and measured 14 cm (5.5 in).

Figure 5. Area of maximum vertical crush

The Collision Deformation Classification (CDC) for the rollover was 00TDDO3.

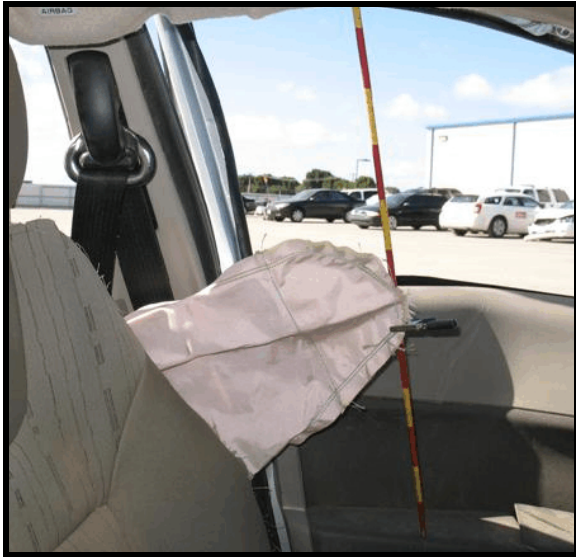
The left and right seat-mounted side air bags deployed during the rollover event (**Figure 6**). The air bags measured 27 cm (10.6 in) in length and 25 cm (9.8 in) in height. The air bags were not configured with tethers or vent ports.

Figure 6. Driver's seat-mounted side air bag

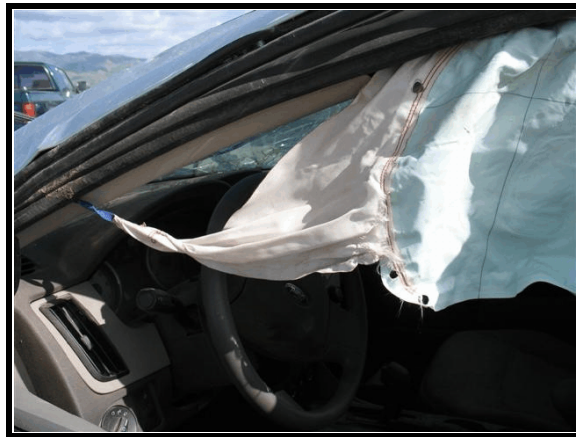
There was a 10 cm (3.9 in) tear between the sail and the IC air bag on the left side (**Figure 7**). The tear began at the bottom and extended upwards (**Figure 8**). The damage probably occurred as a result of loading during the driver's ejection while the air bag was still inflated. The tear occurred at a seam and appears to have been displaced outward. There were no indications of external contacts such as abrasions or dirt deposits near the damaged area.

Figure 7. Driver's side curtain air bag

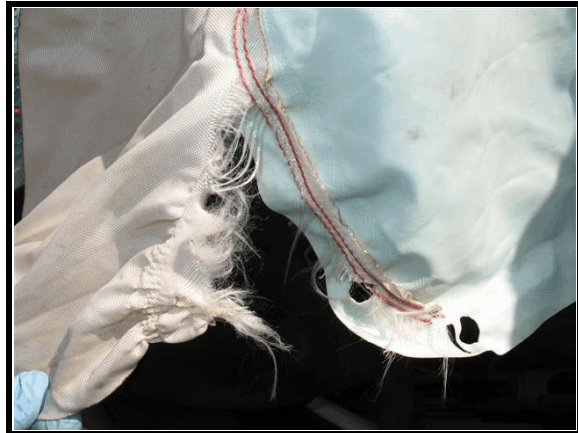
Figure 8. Tear between sail and side curtain air bag

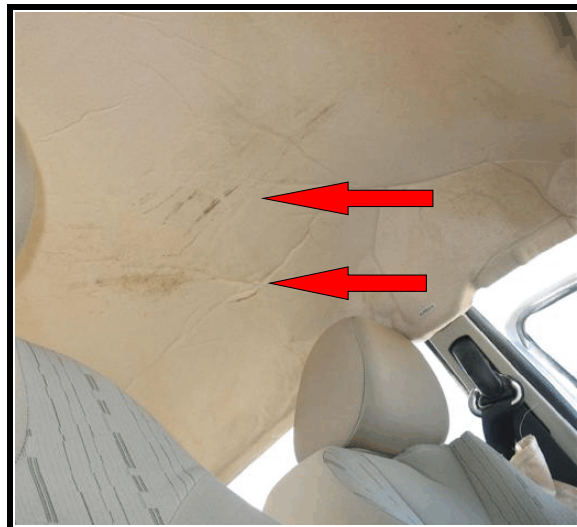
The Ford sustained minor damage as a result of occupant loading during the rollover and the subsequent ejection. The left interior door panel exhibited scratches in the area of the maximum deformation of the door. The diagonal scratches were located at the rear upper quadrant of the door and measured 10 cm (3.9 in) in length and 2 cm (0.8 in) in width. The scratches ended 3 cm (1.2 in) below the top of the door panel. The left arm rest fractured at a point 8 cm (3.1 in) forward of the scratches. There was a smudge on the steering wheel hub and the key was broken off in the ignition. There was a hair deposit on the roof that began 28 cm (11.0 in) inboard of the left roof side rail and approximately 10 cm (3.9 in) aft of the driver's head restraint and measured 15 cm (5.9 in) by 5 cm (1.9 in). There was a grouping of seven longitudinally oriented black marks forward of the hair deposit. The marks began 32 cm (12.6 in) inboard of the left side roof rail. The longest mark measured 10 cm (3.9 in) in length.

Figure 9. Hair deposit and black marks on roof

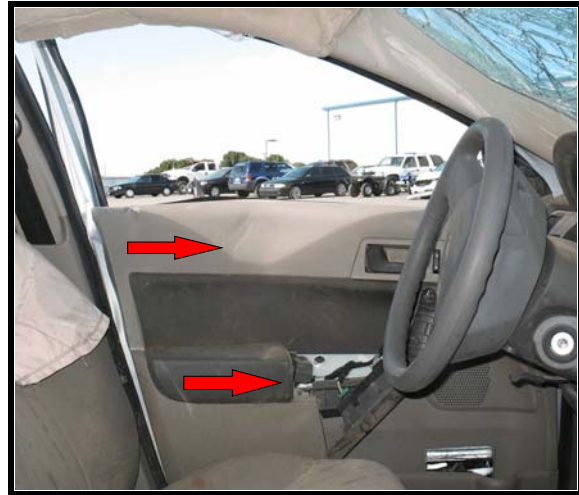
The 40-year-old male driver was seated in an unknown posture. He was not wearing the 3-point manual lap and shoulder belt. As the vehicle began the counterclockwise rotation down the roadside and tripped, the driver moved inboard and up. As the vehicle rolled, the driver contacted the roof with his head (**Figure 9**) and then engaged the left door as he was fully ejected from the vehicle through the driver's window (**Figure 10**). The driver's door was

Figure 10. Scratches to door panel and fractured arm rest

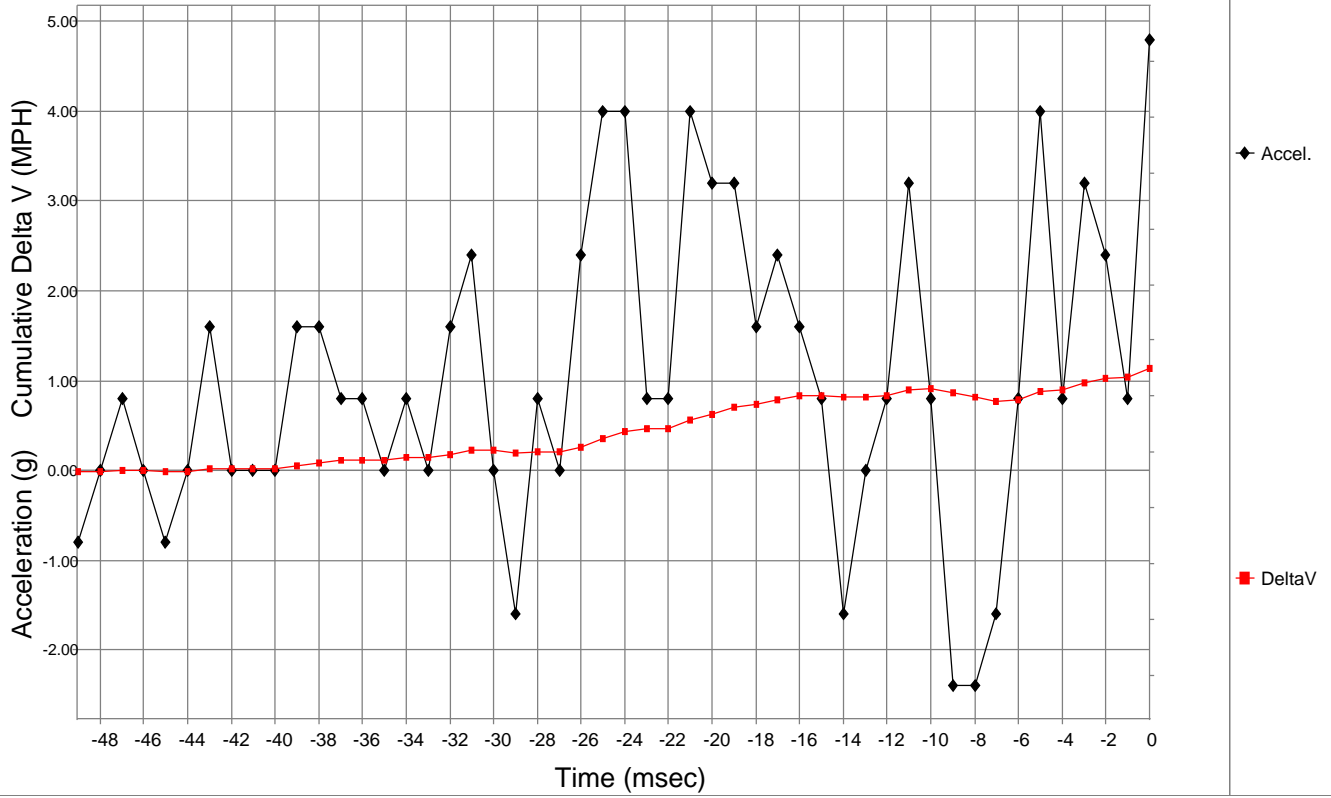
1FAHP35N78W***** Lateral Crash Pulse (First Record)

The lateral crash pulse for the first record indicated a cumulative Delta-V of -0.3 km/h (-0.02 mph) at -48 msec to 1.83 km/h (1.14 mph) at 0 msec. There was no recorded longitudinal crash pulse.
