## **ON-SITE CERTIFIED ADVANCED 208-COMPLIANT VEHICLE INVESTIGATION**

CASE NUMBER - IN09005

VEHICLE - 2008 CHEVROLET IMPALA LT

CRASH DATE - February 2009

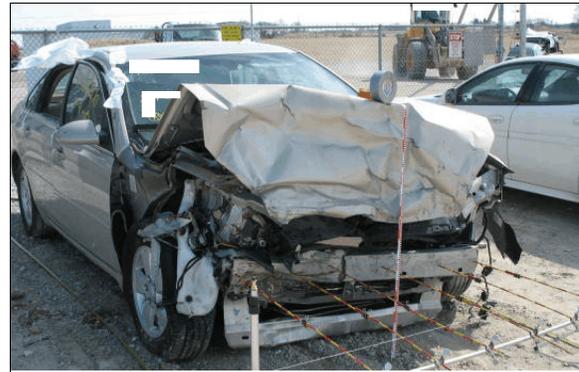
**Figure 1:** The damaged 2008 Chevrolet Impala LT

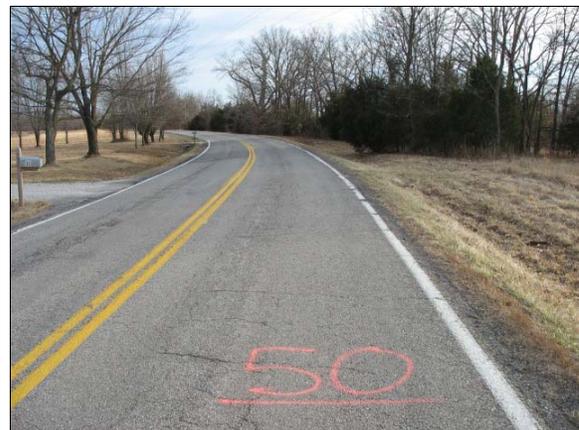
**Figure 2:** Chevrolet's approach; number on pavement shows meters to impact

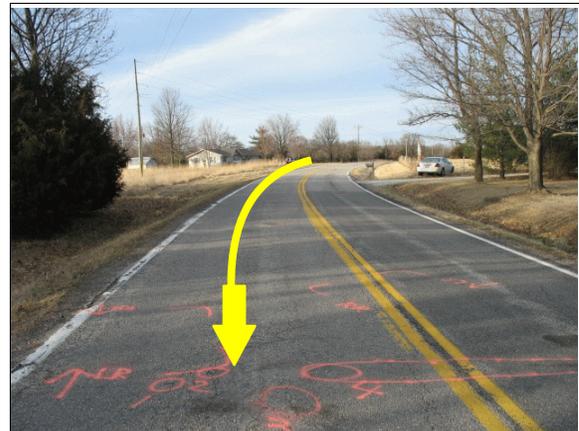
Figure 3: Impact area; arrow shows Chevrolet's path of travel to impact

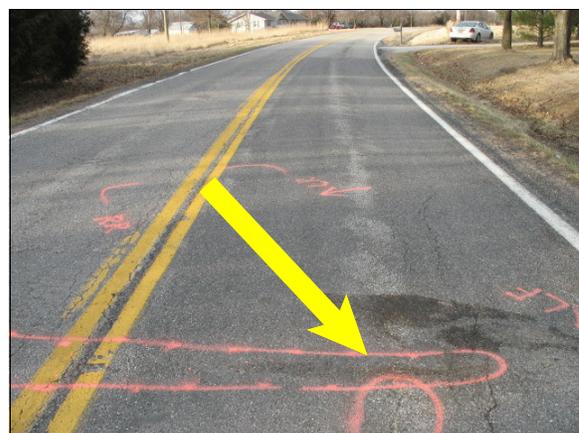
Figure 4: Arrow indicates Chevrolet's final rest position and heading angle

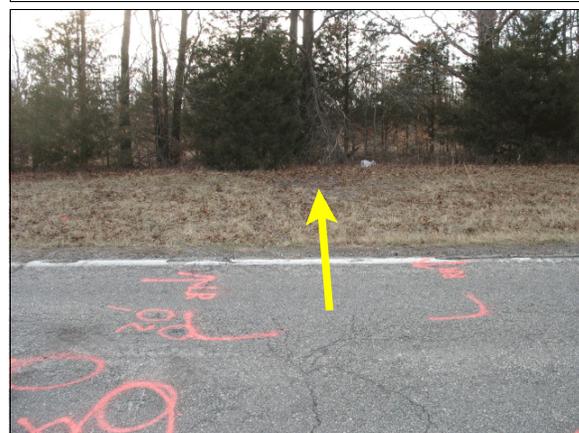
Figure 5: Arrow indicates Oldsmobile's final rest position and heading angle

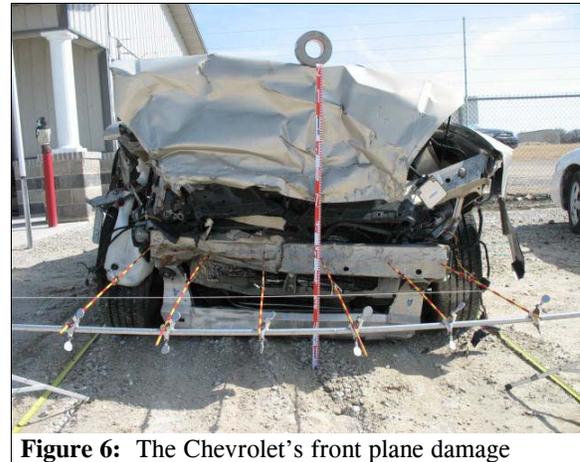
Figure 6: The Chevrolet’s front plane damage

**Exterior Damage:** The Chevrolet’s impact with the Oldsmobile involved the entire front plane. The front bumper, hood, grille, radiator, right fender, and right headlamp/turn signal assembly were directly damaged. The direct damage began at the front right bumper corner and extended 123 cm (48.4 in) across the bumper bar (Figure 6). The crush measurements were taken on the bumper bar and the maximum residual crush was 88 cm (34.6 in) occurring at C<sub>4</sub> (Figure 7). The table below shows the vehicle’s front crush profile.

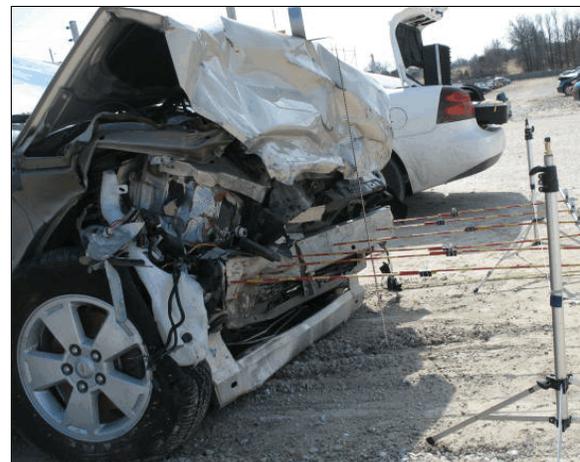
The vehicle’s left side wheelbase was reduced 10 cm (3.9 in) while the right side wheelbase was reduced 23 cm (9.1 in). The induced damage involved the hood, both fenders, the windshield, both front wheel assemblies, the right front and rear doors, and the left roof side rail.

Figure 7: Right side view of the Chevrolet’s front crush profile; each stripe on the measurement rods is 5 cm (2 in)

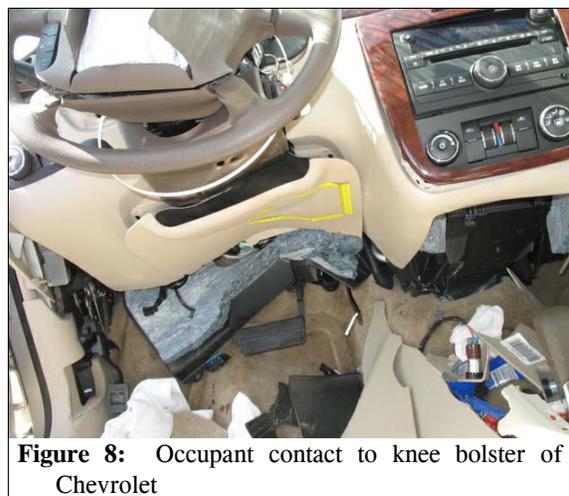
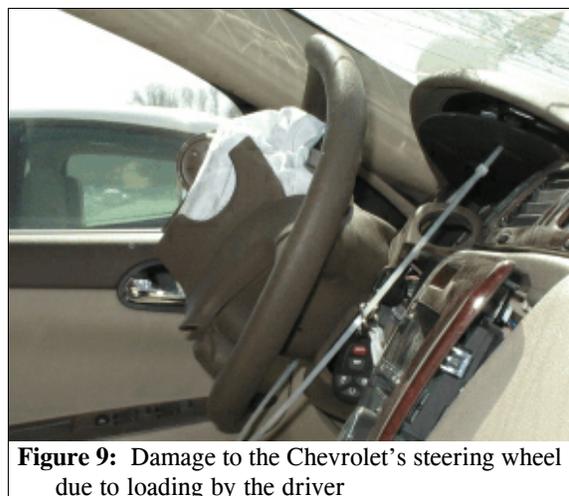
**Vehicle Interior:** Inspection of the Chevrolet’s interior revealed scuffs and deformation on the left lower instrument panel (**Figure 8**) immediately to the right of the steering column, which was due to loading by the driver’s right knee. The driver loaded the air bag and her chest, abdomen, and thighs loaded the steering column, displacing it forward 9 cm (3.5 in). The steering column was also displaced upward, but its original tilt position could not be determined and the extent of vertical displacement was unknown. The steering wheel rim sustained significant deformation with the most severe displacement of 10 cm (3.9 in) occurring on the lower half section (**Figure 9**). The seat back was undamaged and found reclined approximately 40 degrees. It was probably repositioned by rescue personnel during the removal of the driver from the vehicle, or at some time during the handling of the vehicle by salvage personnel.

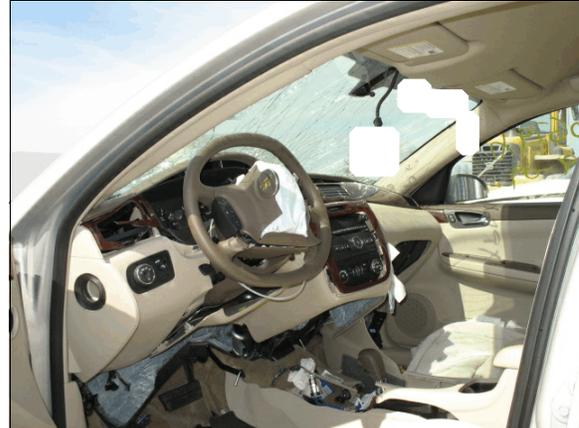
The Chevrolet sustained six passenger compartment intrusions. The intrusions that occurred within the driver's occupant space involved the left toe pan and instrument panel. The toe pan intruded longitudinally 18 cm (7.1 in) while the instrument panel was displaced upward (**Figure 10**) 10 cm (3.9 in) as a result of loading by the driver.

**Figure 10:** Left side view of the vertical displacement of the instrument panel and steering assembly

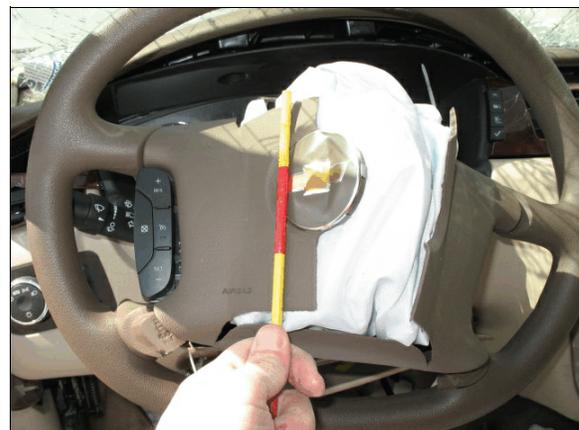
The driver's frontal air bag was located within the steering wheel hub and the module cover (**Figure 11**) was a two flap configuration constructed of pliable vinyl. Each cover flap was

**Figure 11:** The driver's air bag module cover flaps

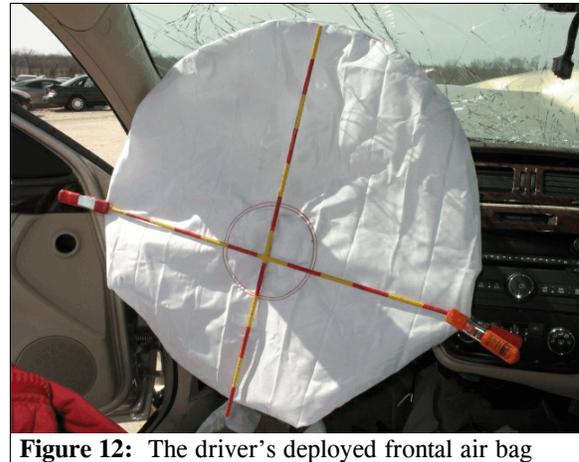
5 cm (2 in) in width and 13.5 cm (5.3 in) in height. The cover flaps opened at the designated tear points. The deployed air bag (**Figure 12**) was 63 cm (24.8 in) in diameter and was designed with two vent ports and three tethers. The vent ports were located at the 11 and 1 o'clock positions. Inspection of the air bag revealed no damage and no discernable occupant contact evidence.

**Figure 12:** The driver's deployed frontal air bag

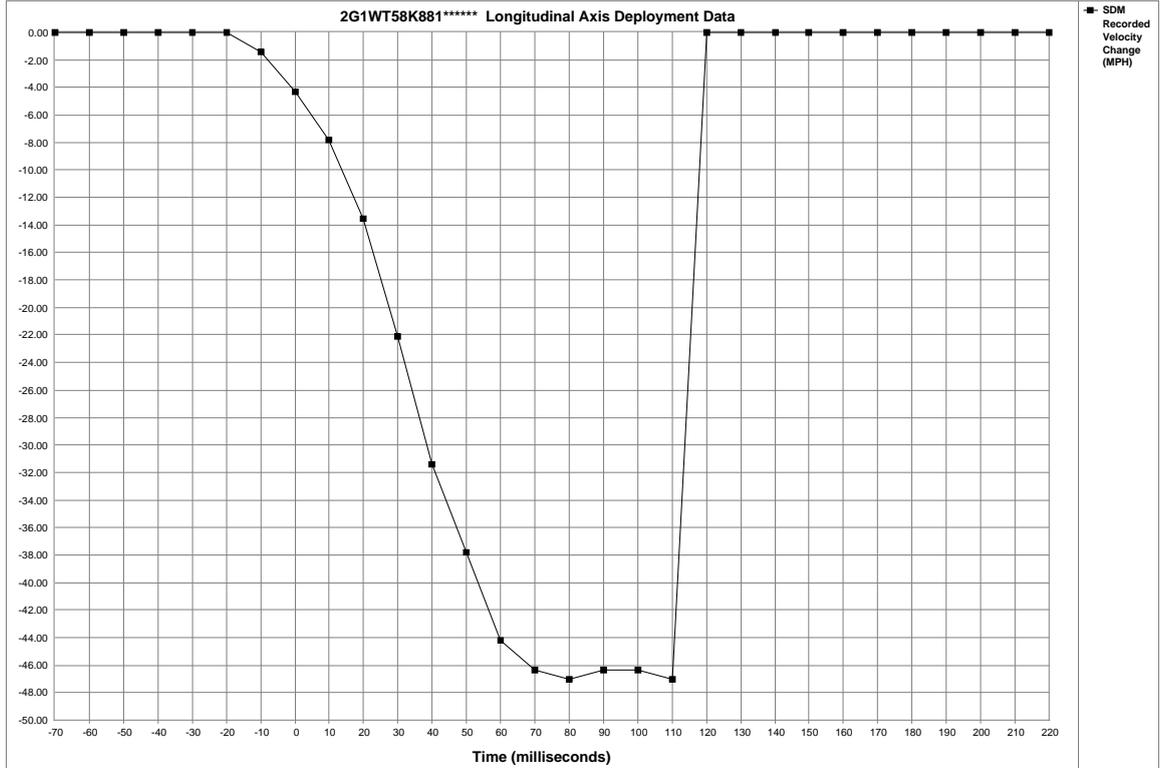
Time (milliseconds)	-70	-60	-50	-40	-30	-20	-10	0	10	20	30	40	50	60	70
SDM Longitudinal Axis Recorded Velocity Change (MPH)	0.00	0.00	0.00	0.00	0.00	0.00	-1.43	-4.28	-7.84	-13.54	-22.10	-31.37	-37.78	-44.20	-46.34
Time (milliseconds)	80	90	100	110	120	130	140	150	160	170	180	190	200	210	220
SDM Longitudinal Axis Recorded Velocity Change (MPH)	-47.05	-46.34	-46.34	-47.05	0.00	0.00	0.00	0.00	0.00	0.00	0.00	0.00	0.00	0.00	0.00

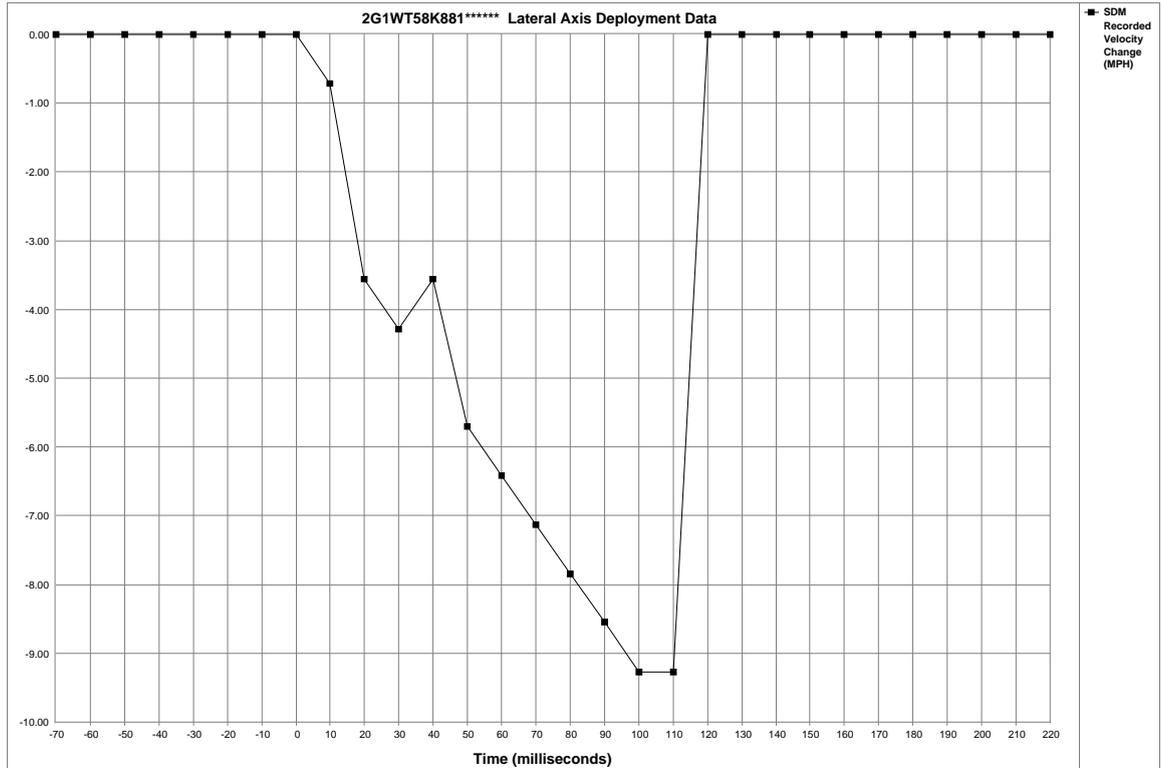
Time (milliseconds)	-70	-60	-50	-40	-30	-20	-10	0	10	20	30	40	50	60	70
SDM Lateral Axis Recorded Velocity Change (MPH)	0.00	0.00	0.00	0.00	0.00	0.00	0.00	0.00	-0.71	-3.56	-4.28	-3.56	-5.70	-6.42	-7.13
Time (milliseconds)	80	90	100	110	120	130	140	150	160	170	180	190	200	210	220
SDM Lateral Axis Recorded Velocity Change (MPH)	-7.84	-8.55	-9.27	-9.27	0.00	0.00	0.00	0.00	0.00	0.00	0.00	0.00	0.00	0.00	0.00
